Reserve Study

Southern Village HOA

Chapel Hill, NC

December 19, 2007

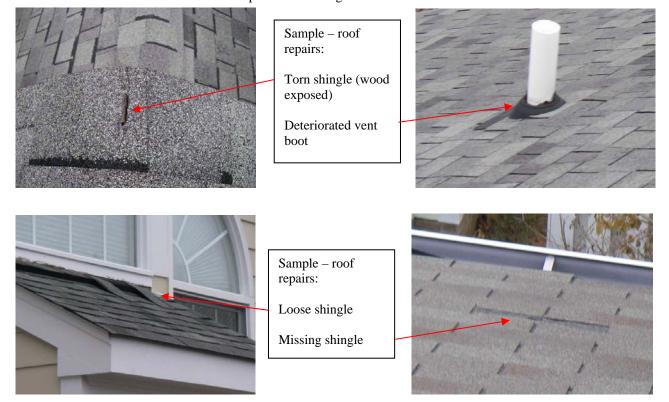
• **Repair:** All of the walked roofs were in need of minor repair: torn shingles (exposed wood), deteriorated vent boots, loose shingle and missing shingles. Table II includes monies to repair all townhome roofs on the buildings listed in the "Exterior Wood Trim, Door and Fences Maintenance on Southern Village Townhomes" chart provided. The estimate assumes that the roofs inspected from the ground will have similar issues.

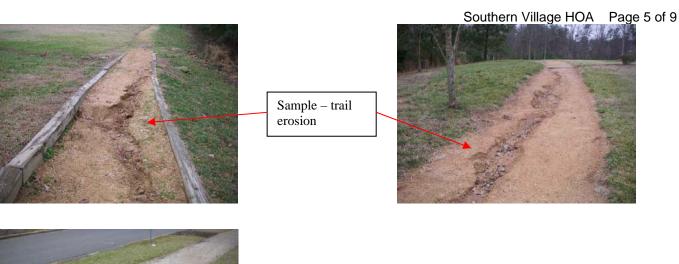
• **Repair:** The trail around the playing field in central Park is severely eroded. The erosion run-off is being deposited on the sidewalk on Brookgreen. Measures to prevent new erosion should be employed. The estimate in the Table II is a rough estimate. It is recommended a qualified landscaper be contracted to provide a firm estimate.
