Reserve Study

Southern Village HOA, Parks

Chapel Hill, NC

January 13 & 14, 2016

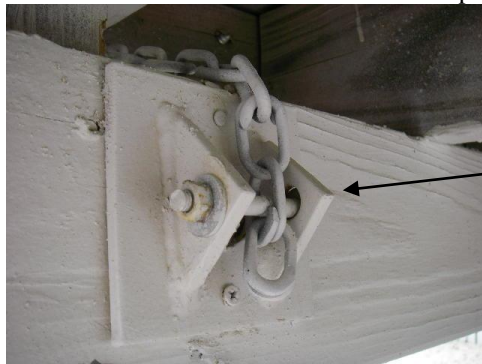
- **Repair: Meeting Park** -The swinging bridge within the climbing structure has been repaired at least once. The chain supporting the swing appears to be undersized. It is doubtful that this structure would meet today's standards for playground equipment. Consideration to replace the structure should be given. At a minimum, it is recommended that the chain and its attachment be replaced with a more appropriate sized chain.

Repair chain

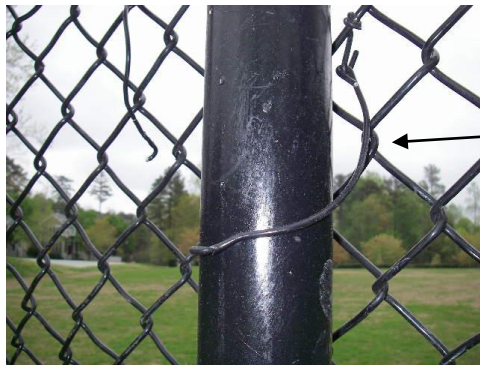
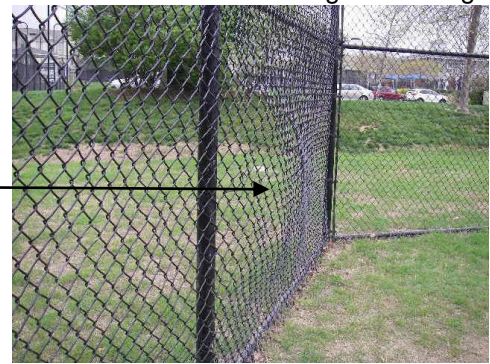
- **Repair: Central Park** - The backstop fencing needs minor repair as several of the loops attaching the fencing to the metal frame have come loose. This has allowed the fence to "droop". New loops should be installed to prevent additional movement of the fencing.

Loose strap
“Drooping” fence

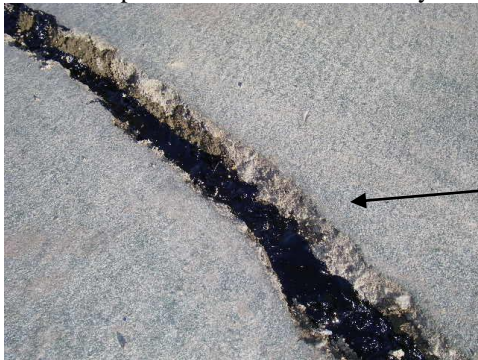
- **Repair:** Central Park –As reported in 2015 report: “The asphalt basketball court should be repaired as it is cracked.” The cracks have been partially filled. The fill material has settled and additional material is required to fill the cracks. The current condition of the cracks will allow vegetation to grow in the cracks and will also allow water to infiltrate below the asphalt. Both of these conditions will lead to premature deterioration of the court. Repair will prevent court replacement for several more years.

Sample – partially filled cracks

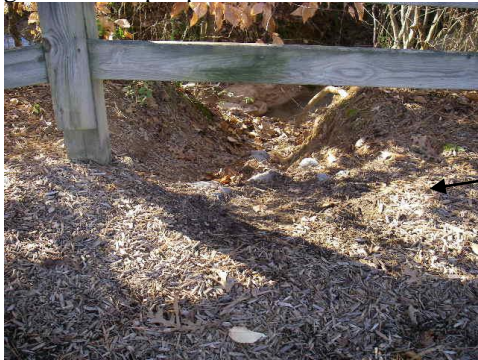
Repair: Edgewater/Graylyn - There is erosion at one location under the fence. As reported in 2015 there were two places – one location has been repaired and the attempted repair at the second location needs additional work. The areas should be re-graded and rip/rap added to allow storm water to exit the playground without creating an erosion issue.

Eroded area under fence

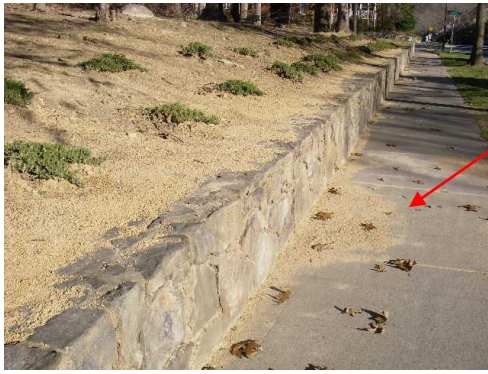
- **Repair:** Arlen –The lack of vegetation along the stone wall along Parkside Circle and Eastgreen Drive has allowed erosion to take place. In addition, the uncontrolled overflow of water has caused stones to come loose along the Eastgreen side. Vegetation (running cedar) similar to the vegetation near the Arlen Park steps should be added to control the erosion

Erosion along
Parkside Circle

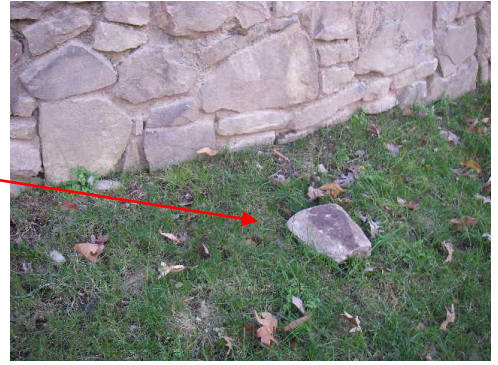
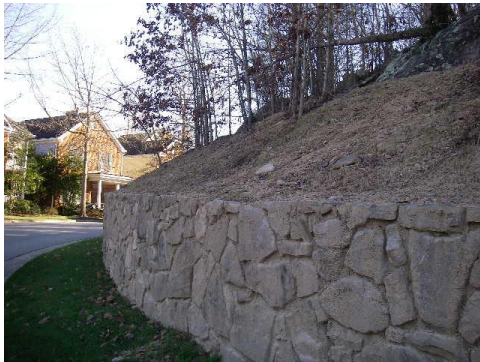
Loose stone
along Eastgreen

Lack of
vegetation

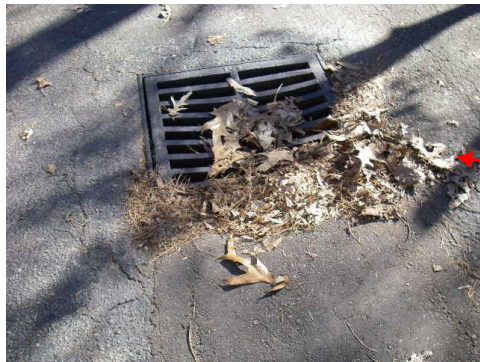
- **Observation:** The alleyway catch basins and curb drains need to be periodically cleaned. The reserves have money allocated to cleaning periodically; however after a storm any collected debris should be removed. .

Remove collected debris

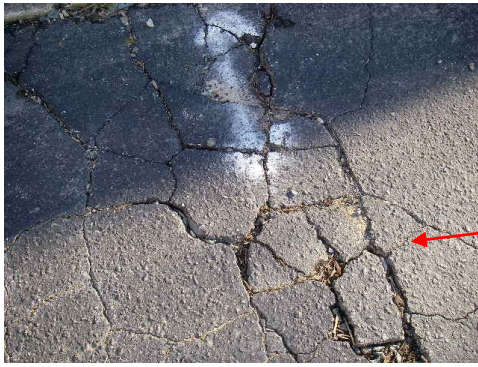
- **Repair:** A small section of the alleyway behind 114 Westgreen is damaged and should be repaired (cut damaged area and re-store foundation and patch).

Area to be
patched

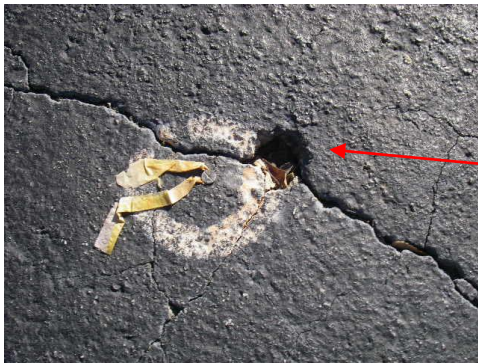
- **Repair:** There is a hole in the alleyway pavement between Edgewater and Brookgreen near the top of the alleyway. The hole needs to be appropriately filled to prevent water intrusion.

Hole to be filled

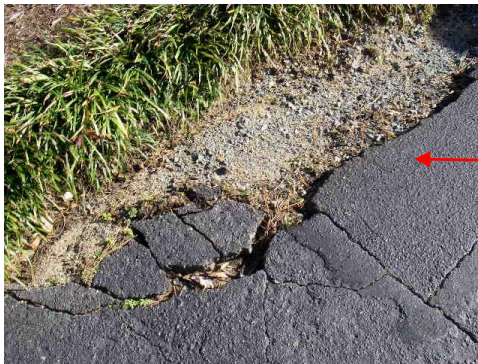
- **Repair:** The alleyway pavement near the “T” intersection on the alleyway between Brookgreen and Tharrington is damaged and needs to be patched (cut damaged area and re-store foundation and patch).

Area to be
patched

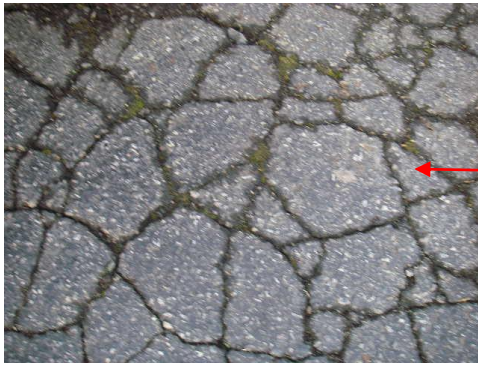
- **Repair:** The alleyway pavement near the “T” intersection on the alleyway between Tharrington and Parkside is damaged and needs to be patched (cut damaged area and re-store foundation and patch).

Area to be
patched

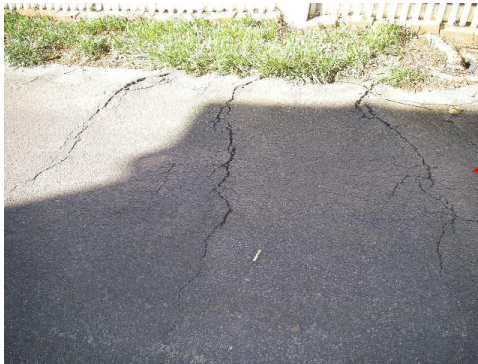
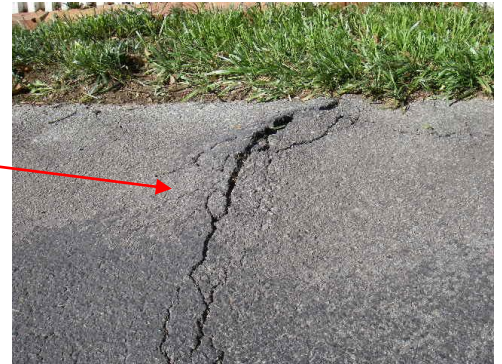
- **Repair:** The alleyway pavement on the side spur to Parkside of the alleyway between Tharrington and Parkside is damaged (rippled) and needs to be patched (cut damaged area and re-store foundation and patch).

Rippled
pavement

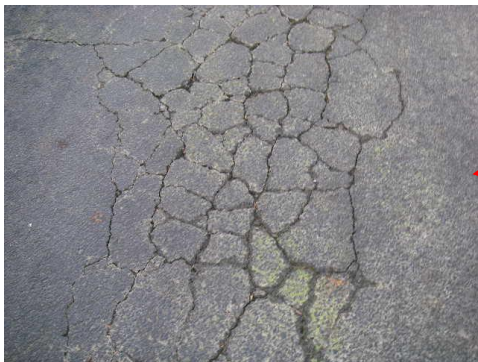
- **Repair:** The alleyway pavement in the curve close to Parkview of the alleyway between Highgrove and Hillspring is damaged and needs to be patched (cut damaged area and re-store foundation and patch).

Area to be
patched

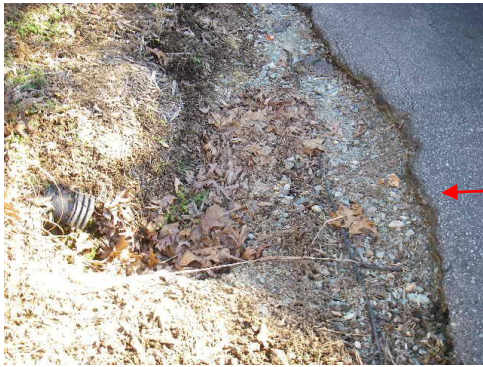
- **Repair:** The alleyway pavement behind 212 Glade of the alleyway between Glade and Westside is damaged and needs to be patched (cut damaged area and re-store foundation and patch).

Area to be
patched

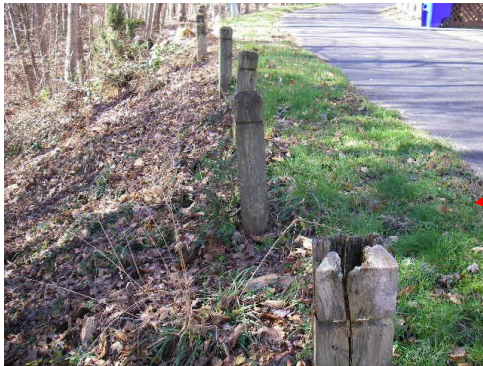
- **Repair:** The guard posts along the alleyway behind Parkside are deteriorating and should be replaced.

Deteriorated
posts

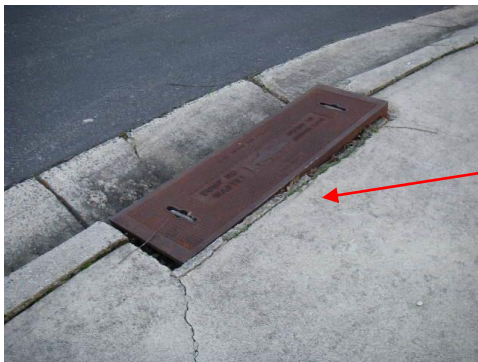
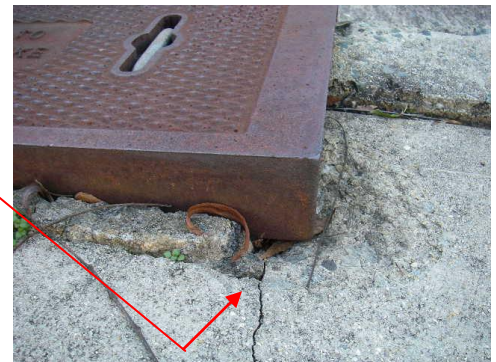
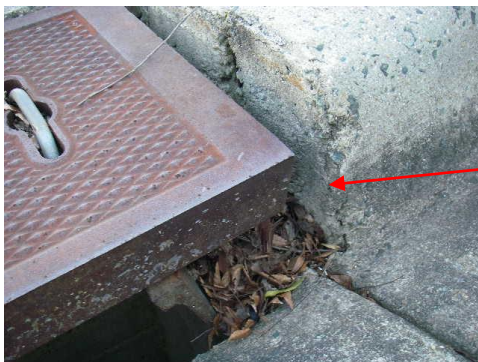
- **Repair:** The alleyway curb drain at the corner near the rear of 415 Copperline is damaged. The curb needs to be repaired and the drain cover re-set. .

Damaged curb
drain

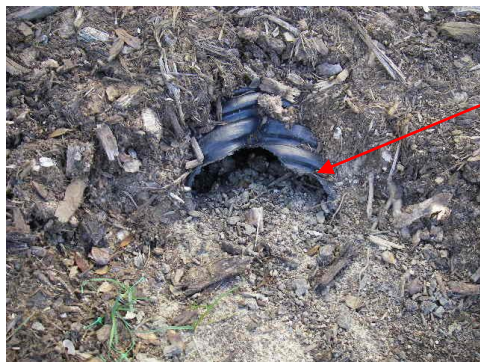
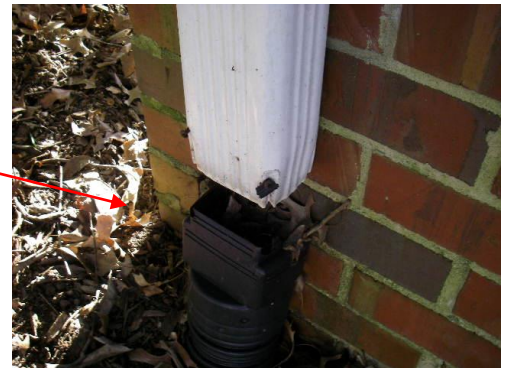
- **Observation:** Drainage is very important to the life of a building. Many leaders (pipe connected to downspouts) were buried (clogged) or crushed. Some leaders were not properly connected to their downspouts. All leaders should be checked and repaired or replaced.

Sample –
buried/clogged leader

Sample – poor leader
connection

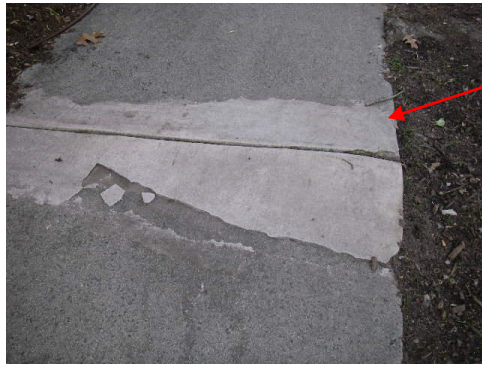
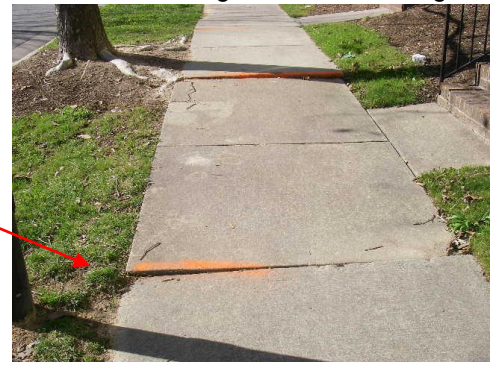
- **Observation:** In many locations, the trees along the sidewalks have lifted sidewalk pads making a trip hazard. This condition was observed in many locations throughout Southern Village including in front of TH-I buildings. This is not an HOA issue; however, the trip hazard should be noted to the city maintenance department. In some locations the raised sidewalk has warning paint. In some locations cement has been added; however as it tappers the thin edge is becoming broken.

Sample – raised side walk, attempted repair (broken edge)

Sample – painted side walk

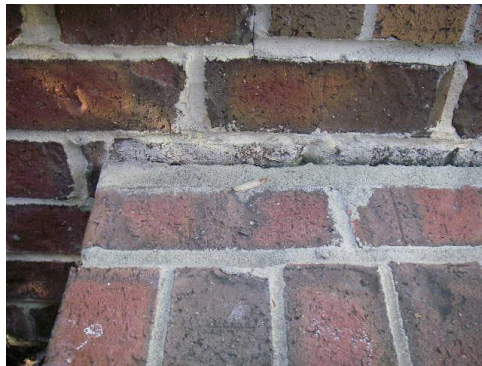
- **Observation:** As noted during the 2012 study the stoops in front of the townhomes located along Westgreen have settled. This may be a safety issue as the first step down is significantly larger than the others (trip hazard) are. This is an individual owner responsibility.

Front step settlement

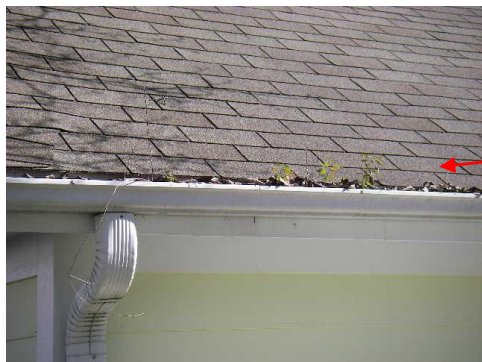
- It is assumed that gutter cleaning is included in the routine maintenance budget. Some gutters will require more frequent cleaning than others will (determined by location and surrounding trees).

Sample: gutter needing cleaning

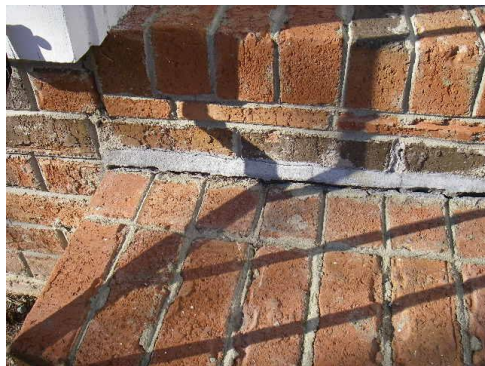
- **Observation:** As noted during the 2012 study, the stoops in front of the townhomes located in 500-516 Copperline have settled. This may be a safety issue as the first step down is significantly larger than the others (trip hazard) are. This is an individual owner responsibility.

Excessive settlement

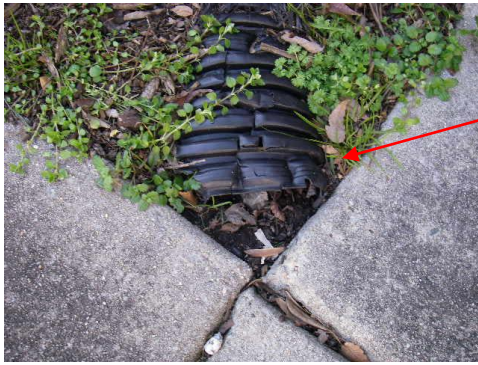
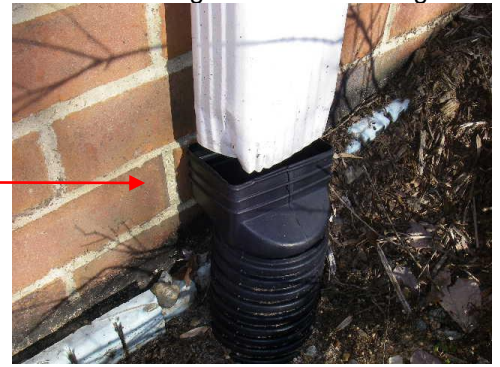
- **Observation:** Drainage is very important to the life of a building. Many leaders (pipe connected to downspouts) were buried (clogged) or crushed. Some leaders are not properly connected to their downspouts. All leaders should be checked and repaired or replaced.

Sample – crushed leader

Improper connection

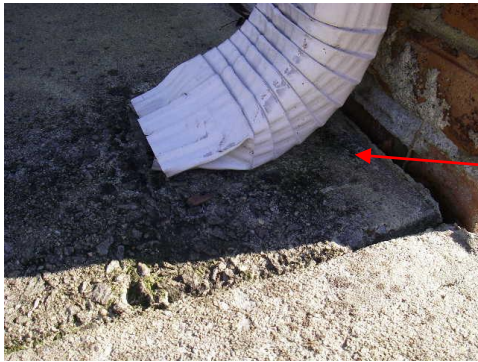
- **Observation:** The downspout behind 520 Copperline is crushed and needs to be replaced.

Sample – crushed downspout

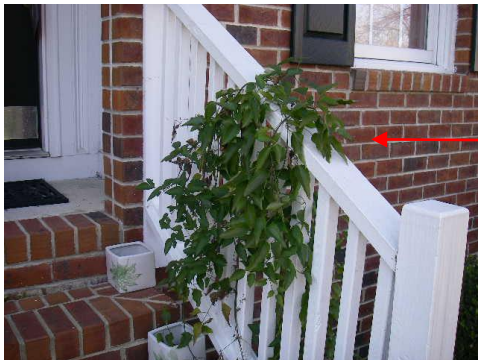
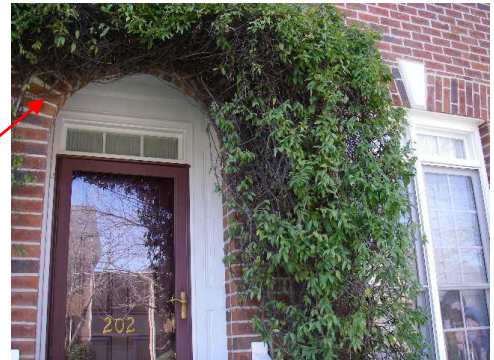
- **Observation:** Vegetation should be removed from areas where it is in contact with buildings. Vegetation too close to a building holds moisture next to a building and provides easy egress for insects.

Sample – vegetation too close to building

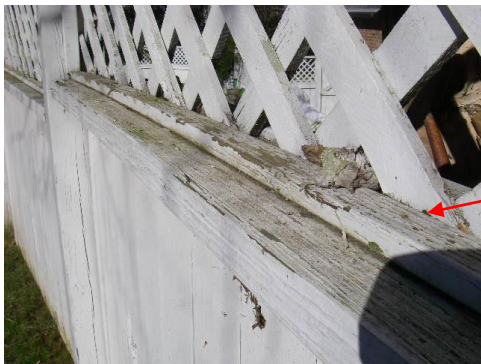
- **Observation:** It is unknown if privacy fences are part of the sub-associations responsibility. The fences need painting and minor repairs.

Sample – fence
needing paint

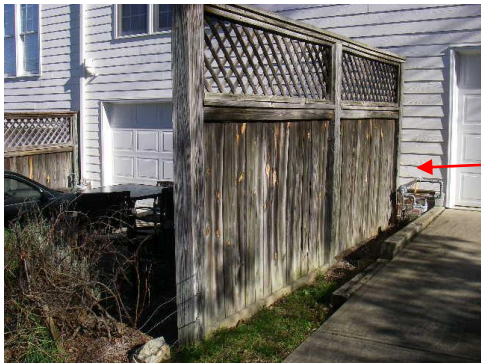
- **Observation:** As noted above it is unknown if privacy fences are part of the sub-associations responsibility. The privacy fences behind the Copperline units are pressure treated and should be replaced in the next 5 to 10 years.

Sample – privacy
fence to be replaced
in the near future

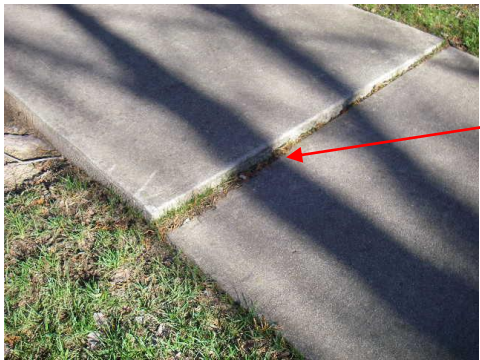
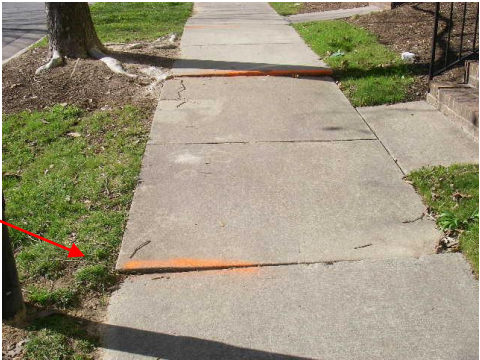
- **Observation:** In many locations, the trees along the sidewalks have lifted sidewalk pads making a trip hazard. This condition was observed in many locations throughout Southern Village including in front of TH-II buildings. This is not an HOA issue; however, the trip hazard should be noted to the city maintenance department. In some locations the raised side walk has warning paint.

Sample – raised
side walk

Sample – painted
side walk

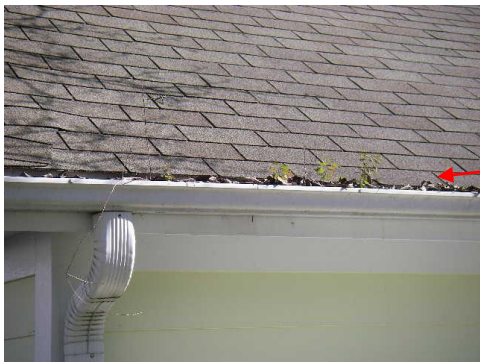
- It is assumed that gutter cleaning is included in the routine maintenance budget. Some gutters will require more frequent cleaning than others will (determined by location and surrounding trees).

Sample: gutter
needing cleaning

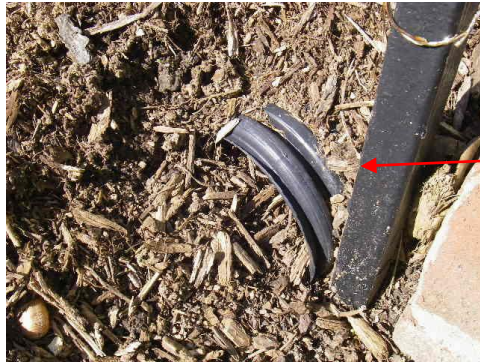
- **Observation:** Drainage is very important to the life of a building. Many leaders (pipe connected to downspouts) were buried (clogged) or crushed. All leaders should be checked and repaired or replaced.

Sample –
buried/clogged leader

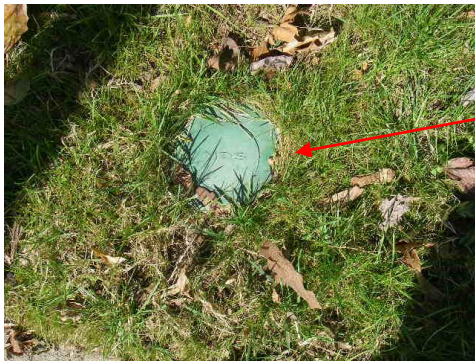
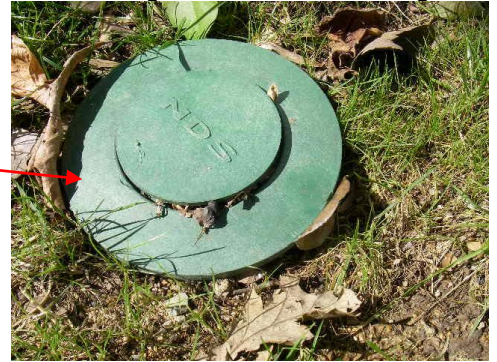
- **Observation:** Several of the downspout leaders use “pop-ups” at their end. These need to be periodically checked to assure they function freely. They can easily become clogged or covered.

Pop-up

Pop-up with debris in unit (unit was cleaned at inspection)

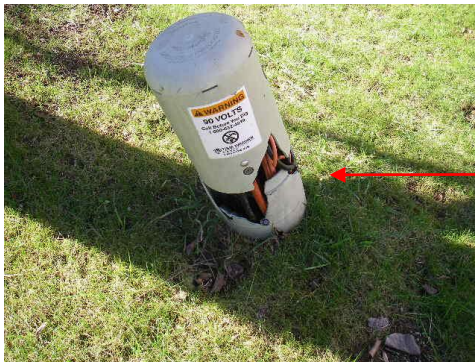
- **Observation:** The Time Warner cable box behind 1018 Highgrove is damaged. The cable provider should be contacted to have the box repaired. .

Damaged cable box

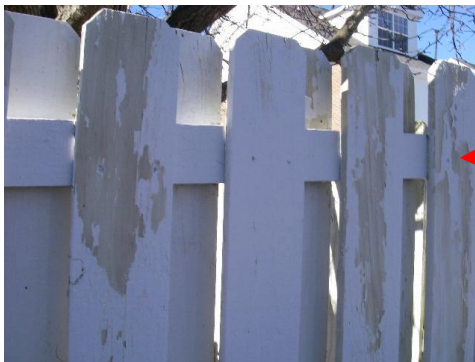
- **Observation:** It is unknown if privacy fences are part of the sub-associations responsibility. The fences need painting and minor repairs.

Sample – fence needing paint

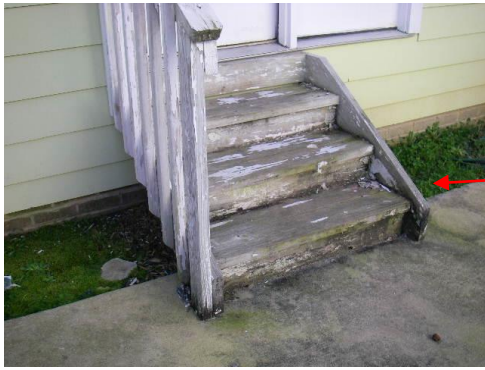
- **Observation:** The rear wooden steps on several units are in need of paint. Based on their condition and the condition of the exterior of the building, it appears as these steps are not HOA responsibility.

Paint steps

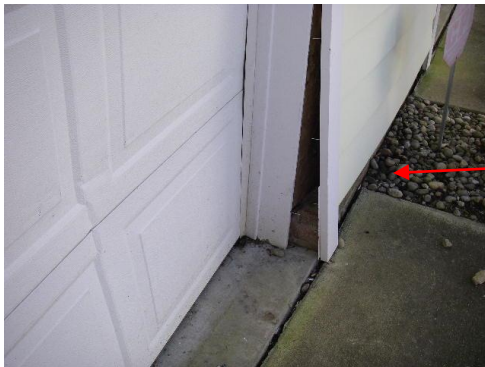
- **Observation:** The garage trim at 1014 Highgrove is damaged, most likely being hit by a car. This should be repaired to prevent water intrusion. It is assumed that is not an HOA responsibility.

Damaged
garage trim

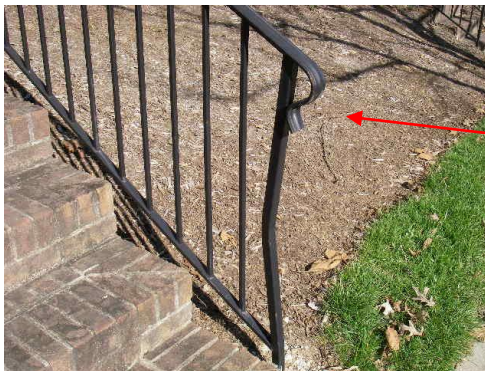
- **Observation:** The railing in front of 904 Highgrove is bent and should be repaired. It is assumed that is not an HOA responsibility.

Bent railing

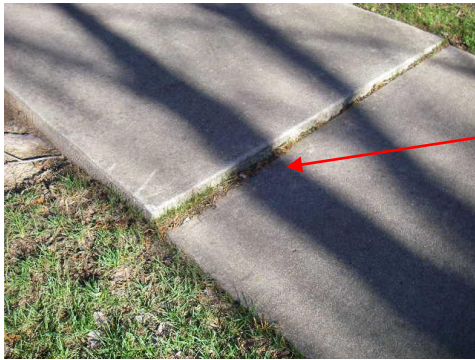
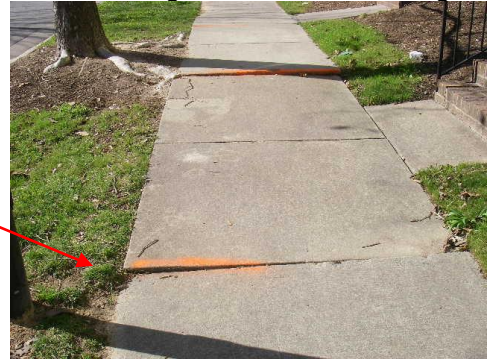
- **Observation:** In many locations, the trees along the sidewalks have lifted sidewalk pads making a trip hazard. This condition was observed in many locations throughout Southern Village including in front of Westend buildings. This is not an HOA issue; however, the trip hazard should be noted to the city maintenance department. In some locations the raised side walk has warning paint.

Sample – raised
side walk

Sample – painted
side walk

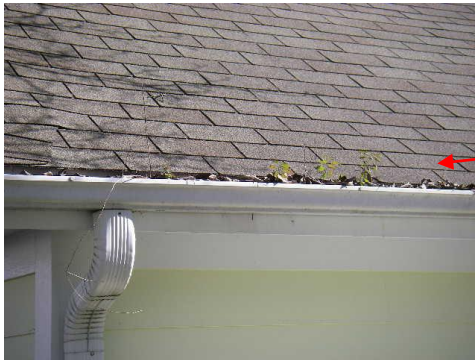
- It is assumed that gutter cleaning is included in the routine maintenance budget. Some gutters will require more frequent cleaning than others will (determined by location and surrounding trees).

Sample: gutter
needing cleaning

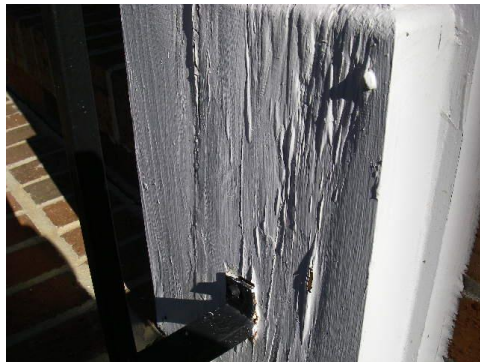
- **Observation:** When buildings are re-painted, all wood rot needs to be addressed. In several locations, it appears that trim rot was over painted.

Sample – painted
over rot

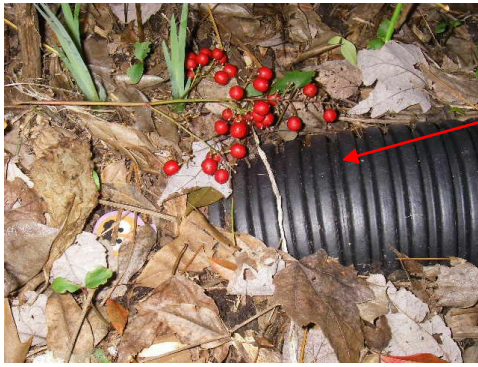
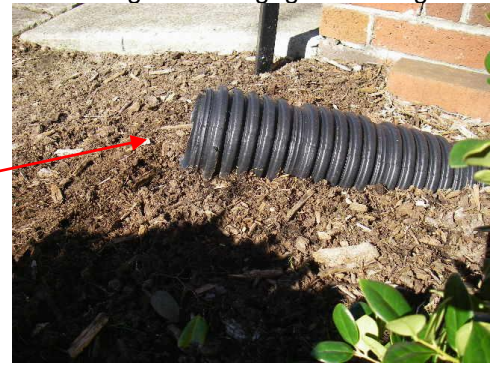
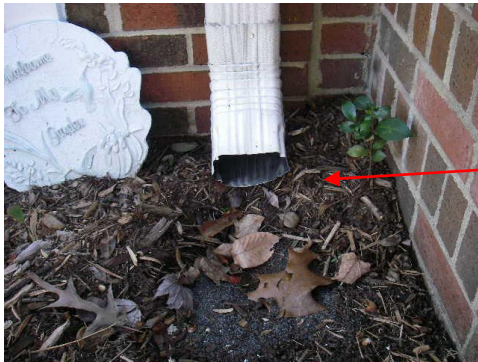
- **Observation:** Drainage is very important to the life of a building. Many leaders (pipe connected to downspouts) were buried (clogged) or crushed. Some downspouts had no leaders allowing water to collect at the building. All leaders should be checked and repaired or replaced.

Sample – buried leader

Leader runs uphill

Sample – missing leader

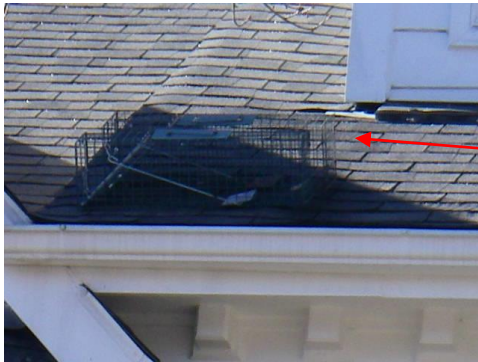
- **Observation:** There is a “have-a-heart” animal trap located on the front roof in the middle of 101-123 Nolen. It should be removed.

Trap on roof

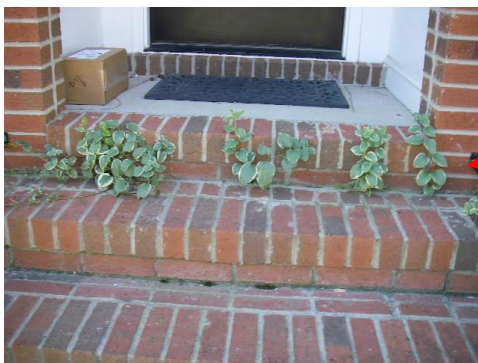
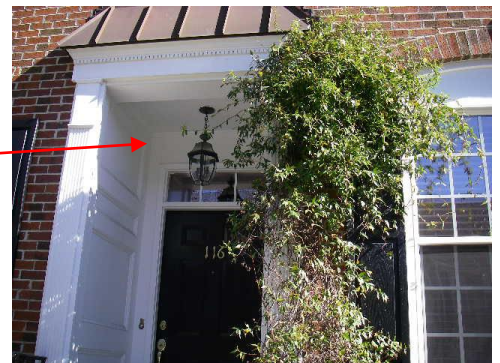
- **Observation:** Vegetation should be removed from areas where it is in contact with buildings. Vegetation too close to a building holds moisture next to a building and provides easy egress for insects.

Sample – vegetation too close to building

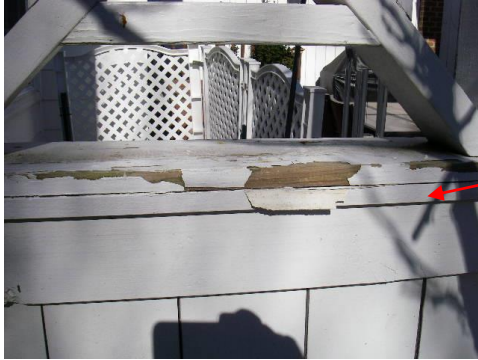
- **Observation:** It is unknown if privacy fences are part of the sub-associations responsibility. The fences need painting and minor repairs.

Sample – fence
needing paint

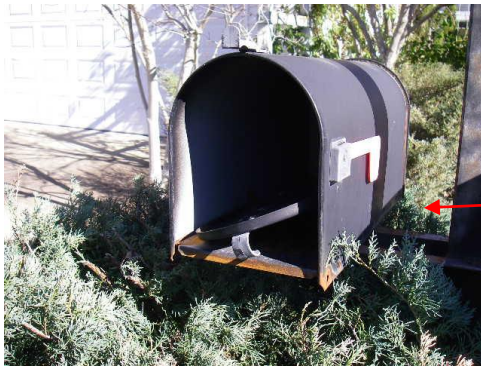
- **Observation:** The mailbox behind 103 West side is damaged and should be replaced. It is assumed that is not an HOA responsibility.

Replace mailbox

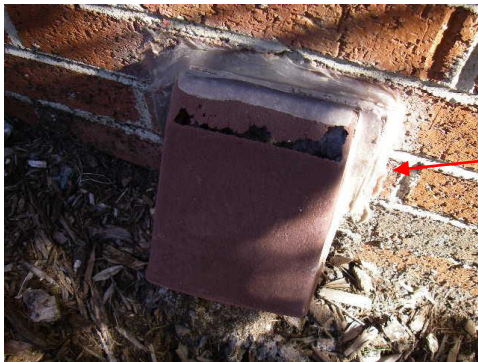
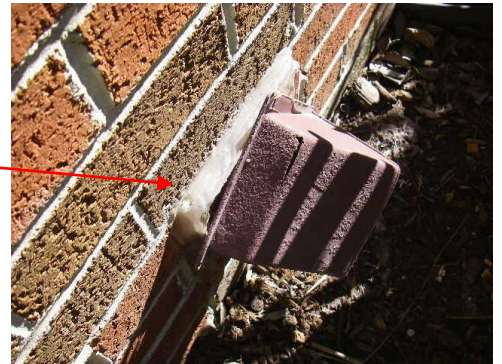
- **Observation:** Most of the plastic vent hoods are damaged and in need of replacement. It is assumed that is not an HOA responsibility.

Replace vent
hoods

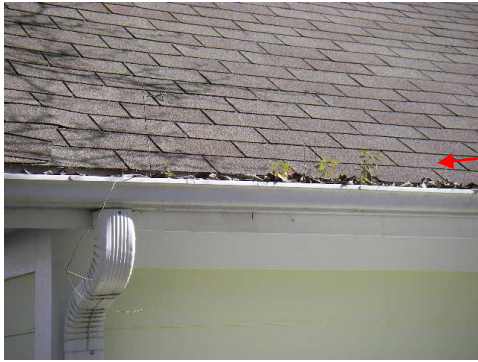
- It is assumed that gutter cleaning is included in the routine maintenance budget. Some gutters will require more frequent cleaning than others will (determined by location and surrounding trees).

Sample: gutter
needing cleaning

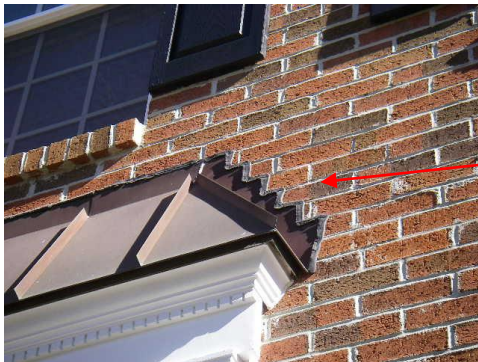
- The caulking around the copper front dormer windows and doors should be replaced when re-roofing.

Re-caulk when
re-roofing
