Client Log - Triangle

Dragonfly Maintenance Report	
Property	SOUTHERN VILLAGE
Client Name	Patsy Smith, Michelle Johnson, John Christian
Client Email Address	patsysmith7077@gmail.com
Client Email Address 2	michelle@berkeleychapelhill.com
Client Email Address 3	wego4@mac.com
Client Email Address 4	
Number of Ponds & Pond Type	4 Wet Ponds
Service Type	
Standard	
Mowing Schedule	2 Mowings Per Year
Mowing Service	
Mowing occurs inside of the fence.	
Special Instructions	
None	
Pond Locations	https://imageshack.com...

Pond Name	WP 1
Access Address	400 Market St, Chaple Hill, NC
Service Date	01/30/2018
Trash Pickup	SC= Service Completed
Treat Invasives	NN= Service Not Needed
Inlet service	SC= Service Completed
Outlet Service	WN= Work Needed
Unclog Drain	NN= Service Not Needed
Clean Riser/Trash rack	SC= Service Completed
Add Dye?	NN= Service Not Needed
Fountain/Aerator Condition	N/A= Not Applicable
Mow/Weed eat	NN= Service Not Needed
Overview of the pond

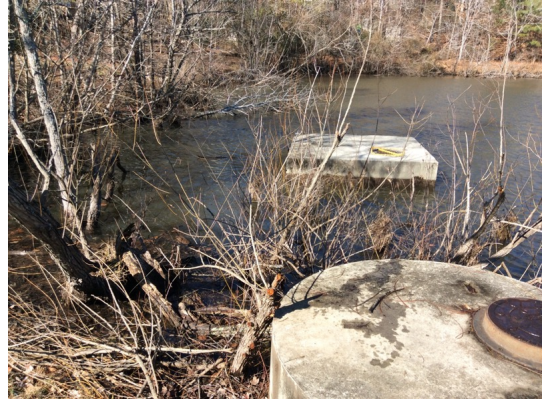
Noted Image 1

Image one shows tree growth between the riser and junction box over the outlet pipe. These trees need to be removed to prevent damage to the pipe, riser, and junction box.

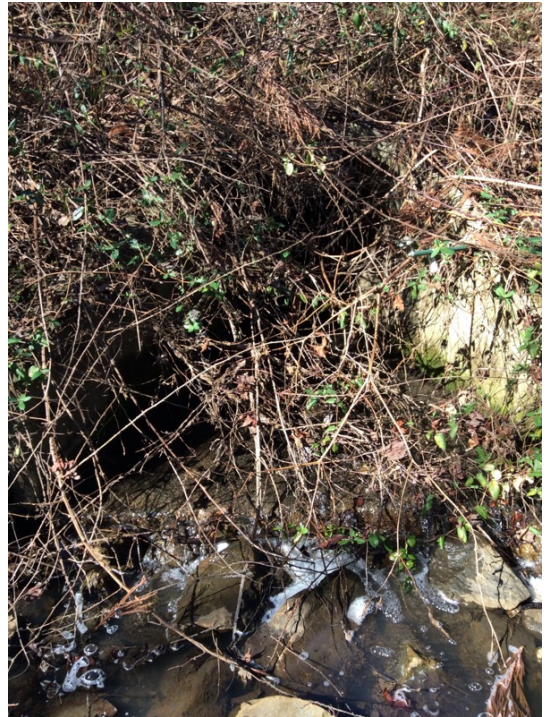
Noted Image 2

Image two shows overgrowth around the outlet. The vegetation needs to be removed to allow water to flow unimpeded.

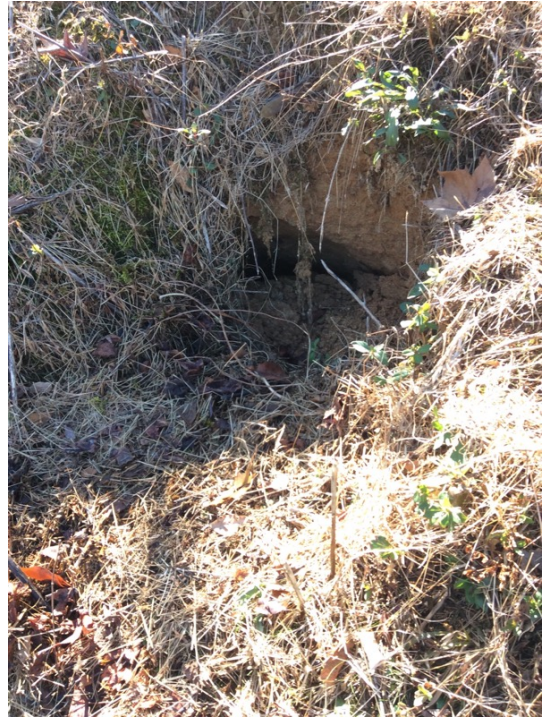
Noted Image 1

Image one shows muskrat damage on the backside corner embankment. This area need to be regraded to prevent erosion damage.

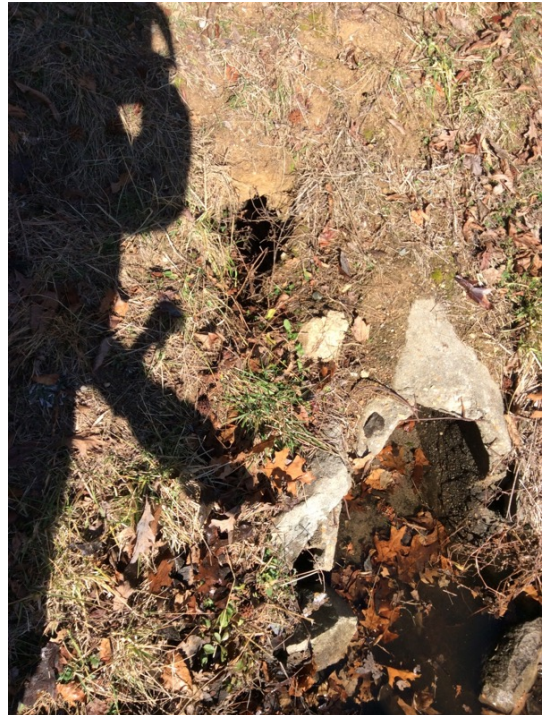
Noted Image 2

Image two shows undercutting of the inlet pipe and settling, possibly due to separation. The area around the pipe needs to be regraded and pipe inspected further.

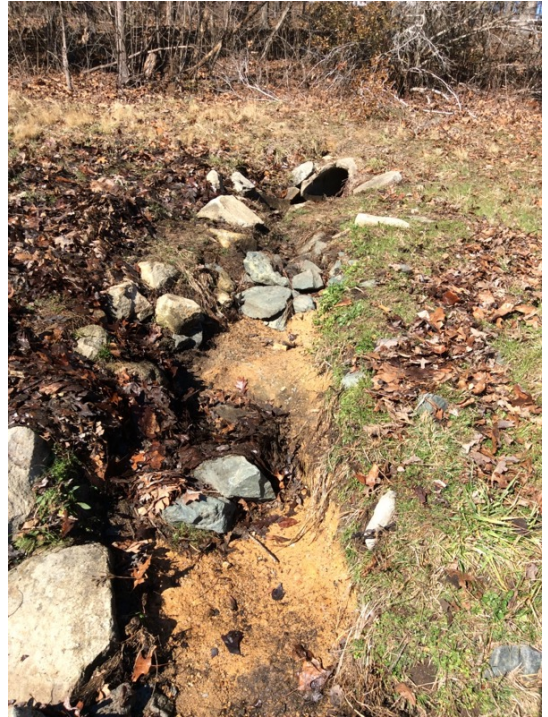
Noted Image 3

Image three shows a lack of riprap in the riprap pad below the inlet. Additional riprap needs to be added to prevent erosion.

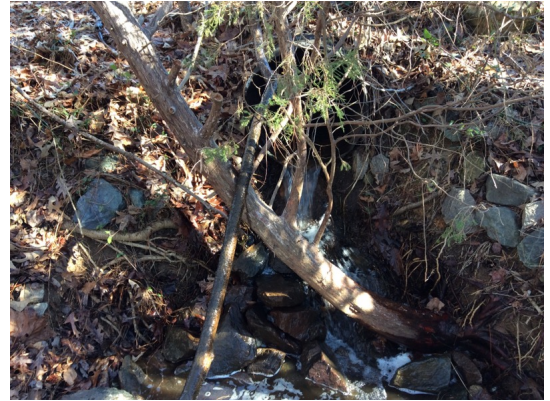
Noted Image 1

Image one shows a cedar tree blocking the outlet. The tree needs to be removed to allow water to flow unimpeded.
