Client Log - Triangle

Date: 05/31/2018

Dragonfly Maintenance Report

Property	SOUTHERN VILLAGE
Client Name	Patsy Smith, Tony Smith
Client Email Address	patsysmith7077@gmail.com
Client Email Address 2	tony@berkeleychapelhill.com
Client Email Address 3	
Client Email Address 4	
Number of Ponds & Pond Type	4 Wet Ponds
Service Type	
Standard	
Mowing Schedule	2 Mowings Per Year
Mowing Service	
Mowing occurs inside of the fence.	
Special Instructions	
None	
Pond Locations	https://imageshack.com...

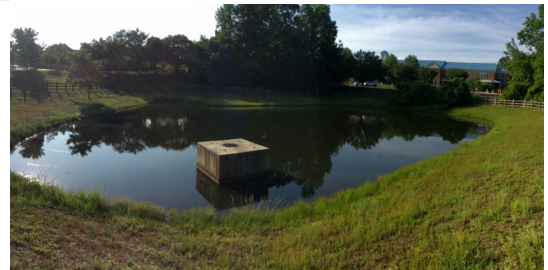
Pond Name	WP 4
Access Address	400 Market St, Chaple Hill, NC
Service Date	05/24/2018
Trash Pickup	SC= Service Completed
Treat Invasives	NN= Service Not Needed
Inlet service	SC= Service Completed
Outlet Service	SC= Service Completed
Unclog Drain	NN= Service Not Needed
Clean Riser/Trash rack	SC= Service Completed
Add Dye?	NN= Service Not Needed
Fountain/Aerator Condition	N/A= Not Applicable
Mow/Weed eat	NN= Service Not Needed
Overview of the pond

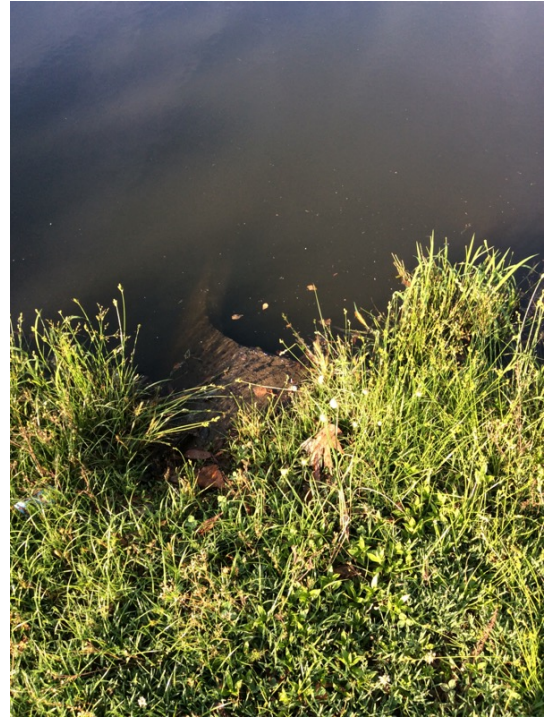
Inlet

No invasive species were present in the pond and trash was removed. The inlet image shows the inlet pipe under the water.

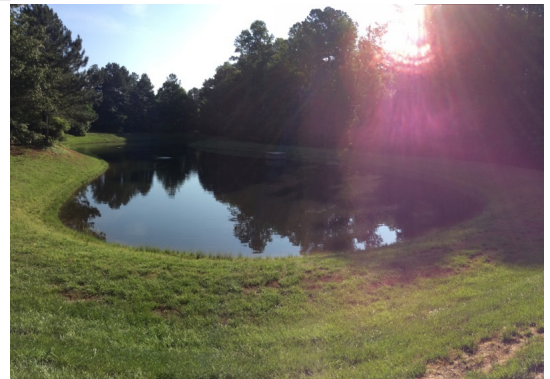
Pond Name	WP 2
Access Address	400 Market St, Chaple Hill, NC
Service Date	05/24/2018
Trash Pickup	SC= Service Completed
Treat Invasives	NN= Service Not Needed
Inlet service	SC= Service Completed
Outlet Service	SC= Service Completed
Unclog Drain	NN= Service Not Needed
Clean Riser/Trash rack	SC= Service Completed
Add Dye?	NN= Service Not Needed
Fountain/Aerator Condition	FF= Fully Functional
Mow/Weed eat	NN= Service Not Needed
Overview of the pond

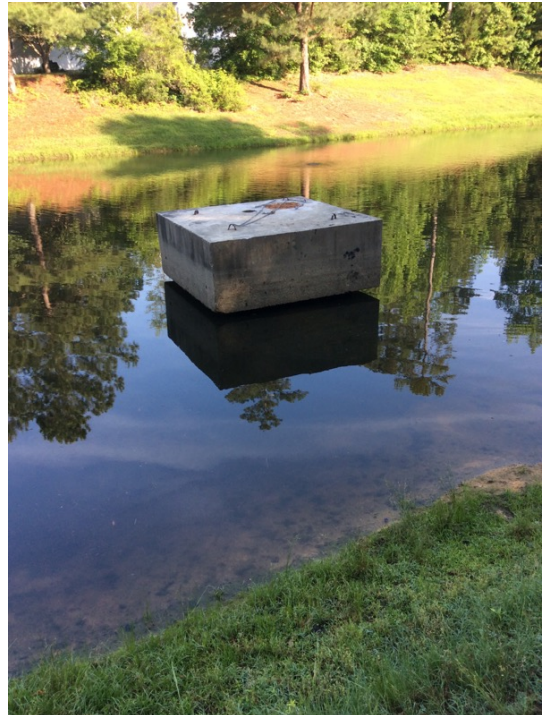
Riser

No invasive species were present in the pond and trash was removed. The inlet image shows the inlet pipe under the water. The riser and aeration system are functioning properly.

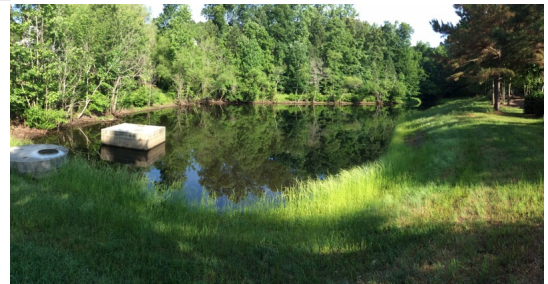
Pond Name	WP 1
Access Address	400 Market St, Chaple Hill, NC
Service Date	05/24/2018
Trash Pickup	SC= Service Completed
Treat Invasives	NN= Service Not Needed
Inlet service	SC= Service Completed
Outlet Service	SC= Service Completed
Unclog Drain	NN= Service Not Needed
Clean Riser/Trash rack	SC= Service Completed
Add Dye?	NN= Service Not Needed
Fountain/Aerator Condition	N/A= Not Applicable
Mow/Weed eat	N/A= Not Applicable
Overview of the pond

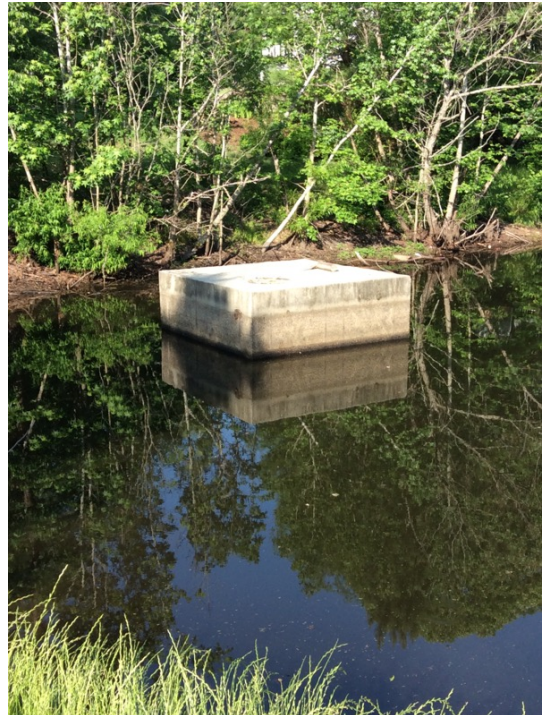
Riser

No invasive species were present in the pond and trash was removed. The riser is flowing properly. Image 1 shows an additional image of the overview of the pond.

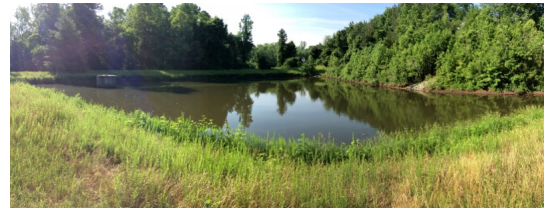
Pond Name	WP 3
Access Address	400 Market St, Chaple Hill, NC
Service Date	05/24/2018
Trash Pickup	SC= Service Completed
Treat Invasives	NN= Service Not Needed
Inlet service	SC= Service Completed
Outlet Service	SC= Service Completed
Unclog Drain	NN= Service Not Needed
Clean Riser/Trash rack	SC= Service Completed
Add Dye?	NN= Service Not Needed
Fountain/Aerator Condition	N/A= Not Applicable
Mow/Weed eat	NN= Service Not Needed
Overview of the pond

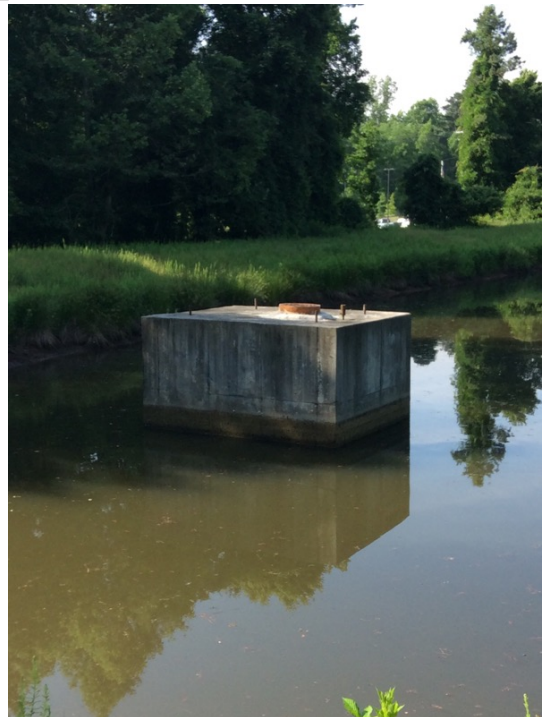
Riser

No invasive species were present in the pond and trash was removed. The riser is flowing properly.
