Client Log - Triangle

Date: 08/03/2018

Dragonfly Maintenance Report

Property	SOUTHERN VILLAGE
Client Name	Patsy Smith, Tony Smith
Client Email Address	patsysmith7077@gmail.com
Client Email Address 2	tony@berkeleychapelhill.com
Client Email Address 3	
Client Email Address 4	
Number of Ponds & Pond Type	4 Wet Ponds
Service Type	
Standard	
Mowing Schedule	2 Mowings Per Year
Mowing Service	
Mowing occurs inside of the fence.	
Special Instructions	
None	
Pond Locations	https://imageshack.com...

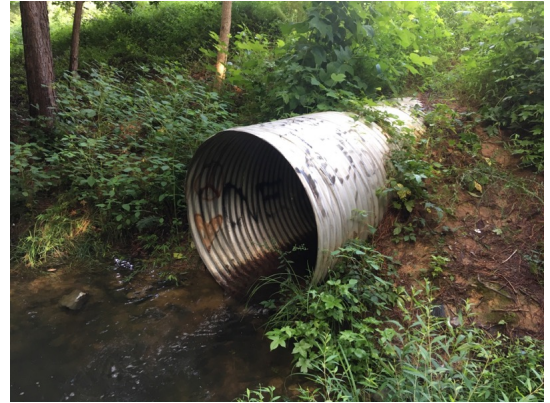
Outlet

Invasive vegetation in the outlet area was treated. Water level was above drawdown height upon arrival but seems to be draining efficiently.

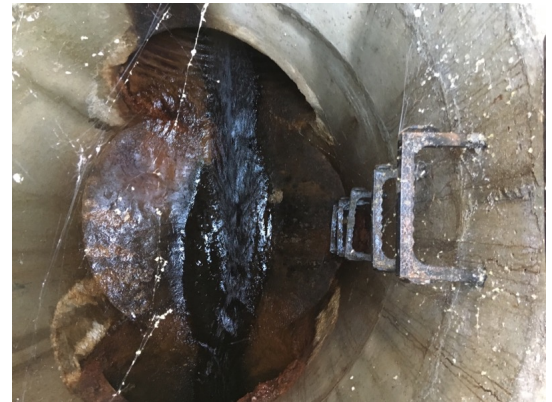
Noted Image 1

Water level was above drawdown height upon arrival but seems to be draining efficiently as shown in image 1. Pond was treated aggressively for invasive aquatic vegetation. Invasive vegetation in the outlet area was also treated. The addition of an aerator system would likely improve overall water quality.

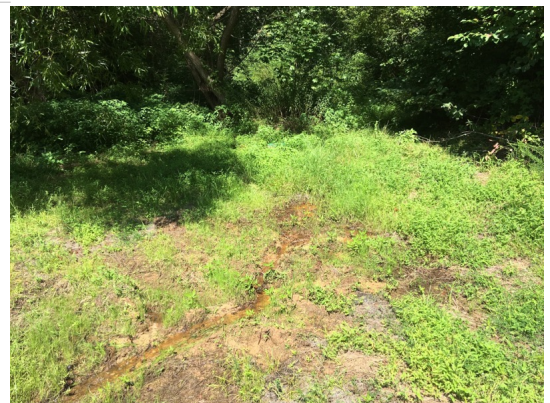
Noted Image 1

Image 1 shows erosion caused by an additional inlet source where rip rap may be needed. Images 2 and 3 show before and after rip rap was rearranged to cover exposed matting. Images 4-6 show the additional inlets. Image 7 shows bare soil on the slope where vegetation is needed. Invasive vegetation in the rip rap was treated. Water level was above drawdown height upon arrival but seems to be draining efficiently.

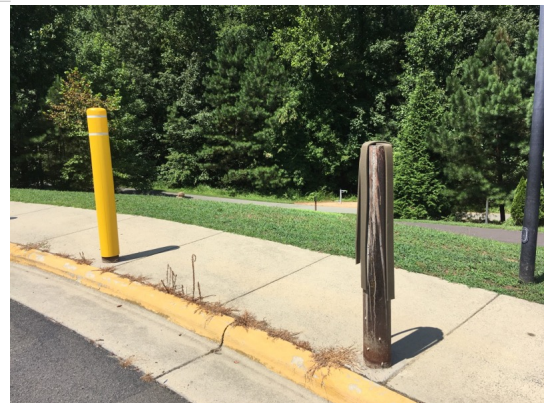
Noted Image 1

Road barrier cover was found floating in the center of the pond upon arrival. Images 1 and 2 show before and after barrier was put back after being removed from the pond. Note there is a lock on the gate as shown in image 3 - combination is needed for equipment access. Invasive vegetation in the rip rap was treated.
