Client Log - Triangle

Date: 08/31/2018

### Dragonfly Maintenance Report

Property	SOUTHERN VILLAGE
Client Name	Patsy Smith, Tony Smith
Client Email Address	patsysmith7077@gmail.com
Client Email Address 2	tony@berkeleychapelhill.com
Client Email Address 3	
Client Email Address 4	
Number of Ponds & Pond Type	4 Wet Ponds
Service Type	
Standard	
Mowing Schedule	2 Mowings Per Year
Mowing Service	
Mowing occurs inside of the fence.	
Special Instructions	
Pond 4 #5150	
Pond Locations	<a href="https://imageshack.com...">https://imageshack.com...</a>

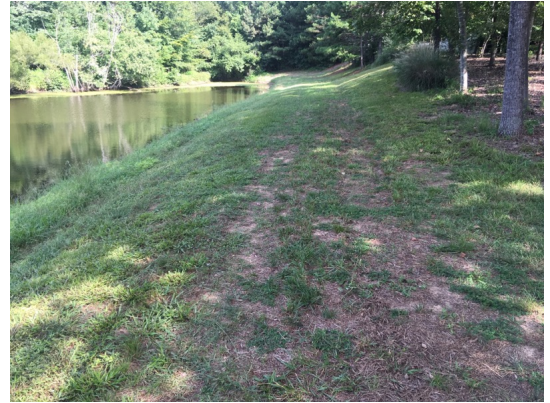
Dam

Treated aggressively for invasive aquatic vegetation. Treated the rip rap for invasive vegetation. Image of the dam shows bare soil spots where vegetation is needed. Image 1 shows where mowing is needed above the outlet.

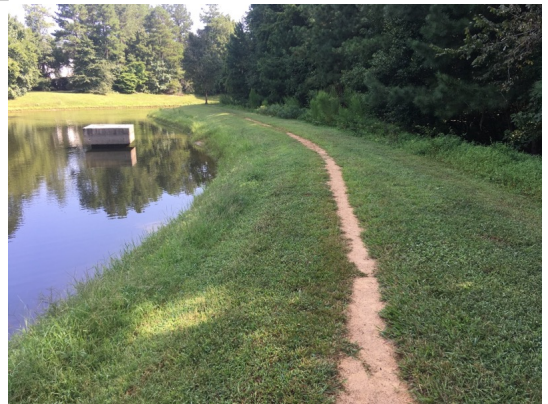
Dam

Treated for invasive vegetation in the rip rap. Image of the dam shows bare soil spots where vegetation is needed. Image of the outlet shows bare soil on the side of the pipe. Water level was below drawdown height upon arrival. Noted image 1 shows leaks in the horizontal outlet pipe. Noted Image 1

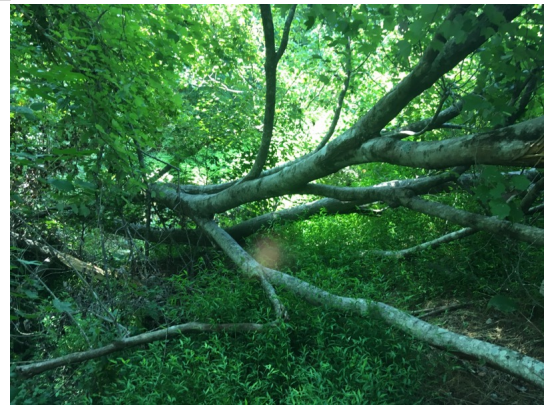
Noted Image 1

Treated for invasive vegetation in the rip rap. Mowing is needed on the site. Noted image 1 shows a fallen tree that is limiting access to the outlet. Noted image 2 shows exposed matting in the inlet rip rap where additional material is needed to cover completely. Noted images 3 and 4 show the additional inlets.

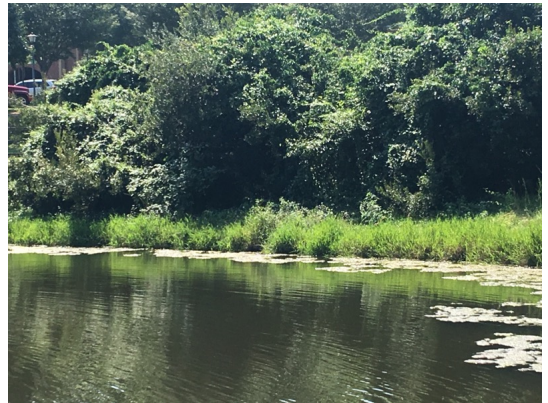
Image 1 shows the additional inlet. Pond was treated for algae. Invasive vegetation in the rip rap was treated.  
Noted Image 1
