Client Log - Triangle

Dragonfly Maintenance Report

Property	SOUTHERN VILLAGE
Client Name	Patsy Smith, Tony Smith
Client Email Address	patsysmith7077@gmail.com
Client Email Address 2	tony@berkeleychapelhill.com
Client Email Address 3	
Client Email Address 4	
Number of Ponds & Pond Type	4 Wet Ponds
Service Type	
Standard	
Mowing Schedule	2 Mowings Per Year
Mowing Service	
Mowing occurs inside of the fence.	
Special Instructions	
Pond 4 #5150	
Pond Locations	https://imageshack.com...

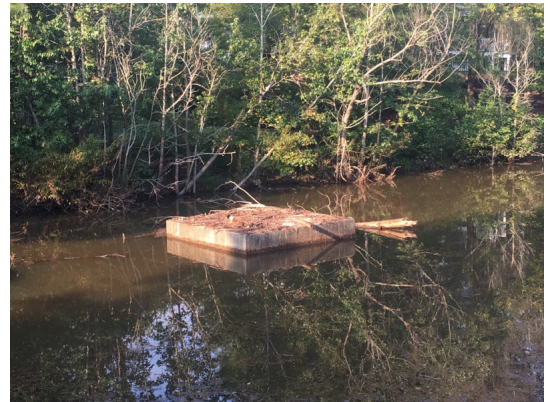
Riprap along outlet treated
Noted images 1 and 2 show before and after riser was cleaned of debris
There was no watermeal in the pond during this visit.
A large amount of thatch, tree limbs, and other organic debris washed in with the recent rain.
Larger limbs and trash were removed from the site.
Mowing is needed above the outlet as seen in image 3.
Noted Image 1

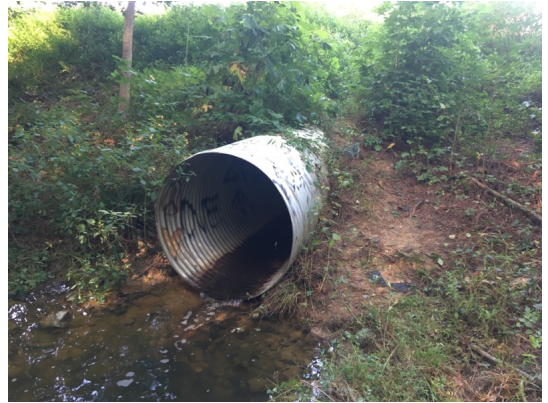
Outlet

- Backside of dam needs mowed
- Bare soil on backside of dam, visible in outlet picture
- Aerator was not running, reset gfci and is running again

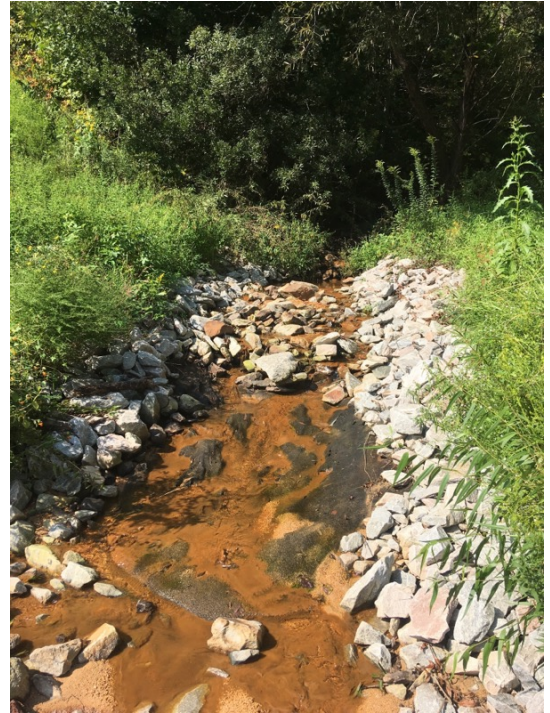
Noted Image 1

Noted image 1 shows secondary inlet and washed out rip rap / exposed matting material where additional rip rap is needed

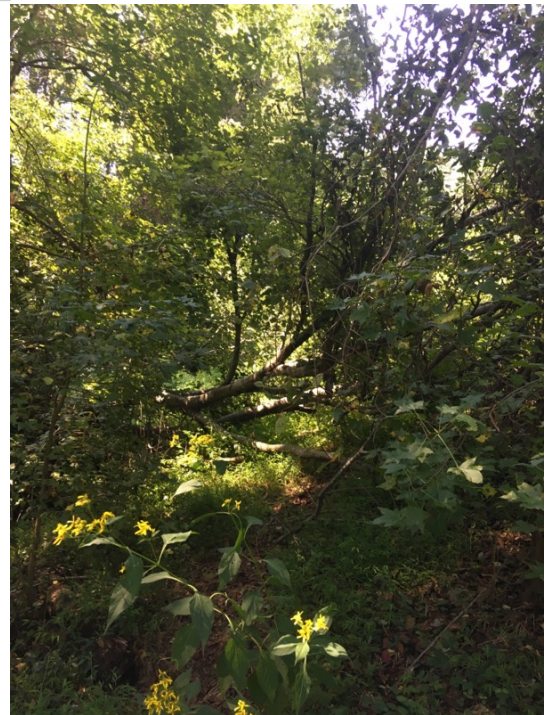
Noted Image 2

Noted image 2 shows fallen tree on back of dam limiting access to the outlet

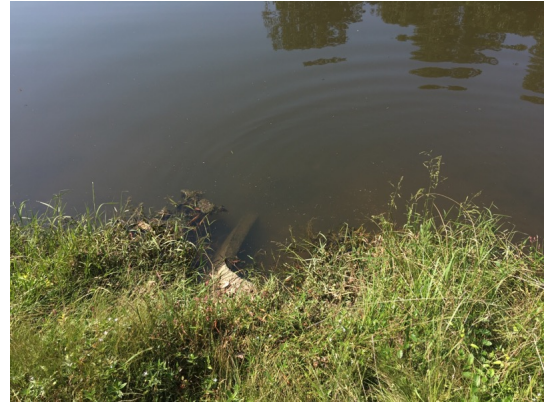
Noted Image 1

Rip rap in the outlet area was treated
Noted image 1 shows a secondary inlet
