Client Log - Triangle

Date: 05/21/2019

### Dragonfly Maintenance Report

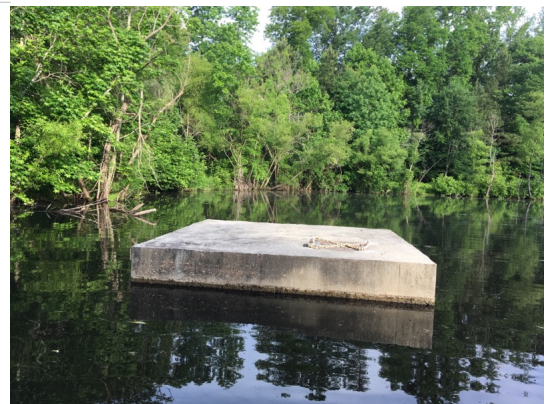
Noted Image 1

Removed trash from system. Noted image 1 shows additional riser. Noted images 2, 3, 4 show erosion on dam.

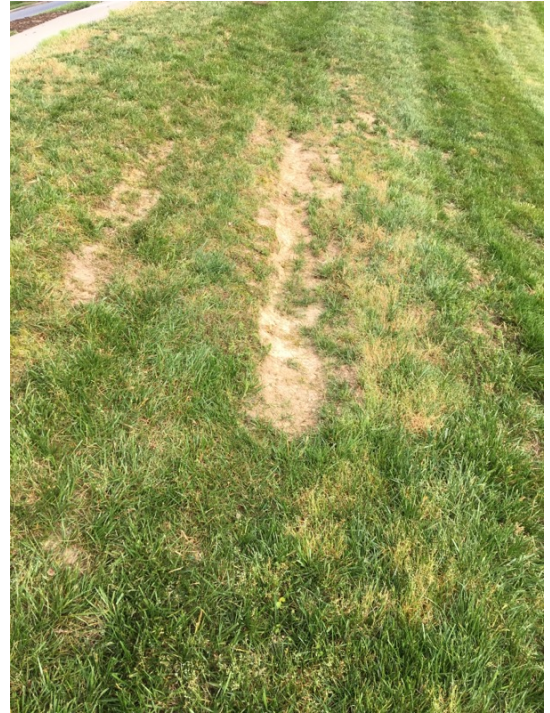
Noted Image 1

Removed trash from system. Noted images 1, 2, and 3 show erosion on dam. Noted image 4 shows erosion on shoreline at riser. Noted image 5 shows erosion on outlet. Noted image 6 shows erosion on shoreline.

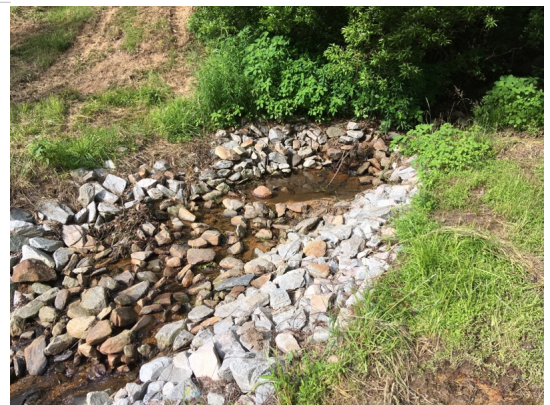
Removed trash from system. Noted images 1, 2, and 3 show additional inlets. Noted image 4 shows large bare area in inlet rip rap that needs repair. Noted images 5, 6, and 7 show erosion on dam. Noted image 8 shows sediment buildup in inlet.  
Noted Image 1

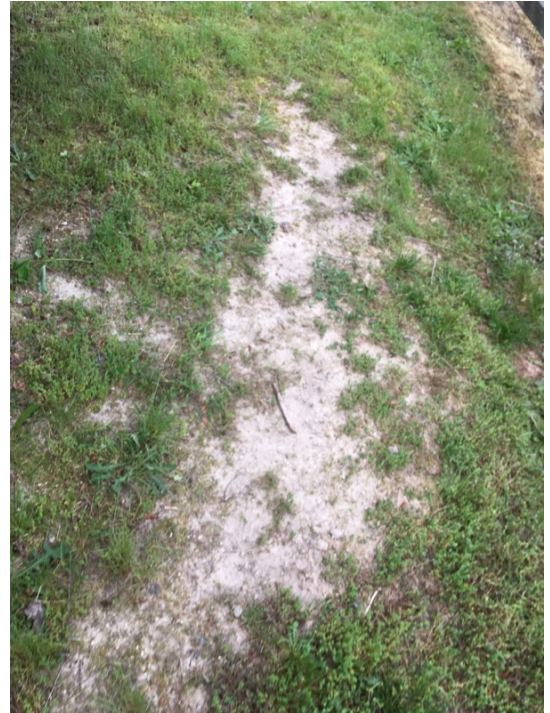
Noted Image 1

Noted images 1 and 2 show erosion on dam. Noted image 3 shows erosion on back side of dam.
