Client Log - Triangle

Date: 07/10/2019

### Dragonfly Maintenance Report

Property	SOUTHERN VILLAGE
Client Name	Patsy Smith, Tony Smith
Client Email Address	patsysmith7077@gmail.com
Client Email Address 2	tony@berkeleychapelhill.com
Client Email Address 3	
Client Email Address 4	
Number of Ponds & Pond Type	4 Wet Ponds
Service Type	
Standard	
Mowing Schedule	2 Mowings Per Year
Mowing Service	
Mowing occurs inside of the fence.	
Special Instructions	
Pond 4 #5150	
Pond Locations	<a href="https://imageshack.com...">https://imageshack.com...</a>

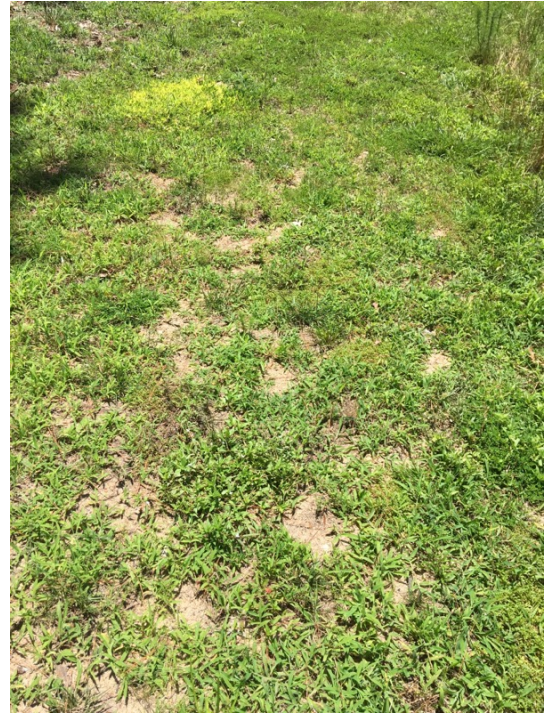
Noted Image 1

Removed trash from the system.  
Treated woody vegetation growing in the buffer. Trace amounts of watermeal observed in the pond. The watermeal was not currently at a nuisance level and therefore no treatment was needed.  
Noted image 1 shows exposed soil on the dam. Noted image 2 shows extensive erosion below the outlet.

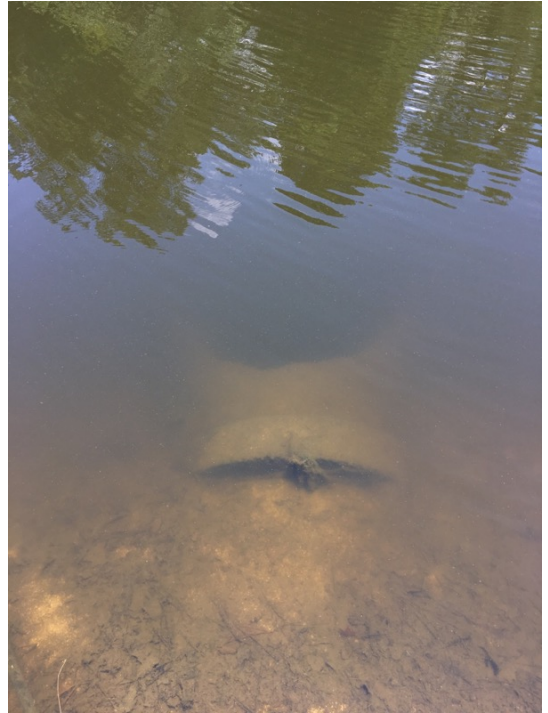
Noted Image 1

Trace amounts of watermeal observed in the pond. Noted image 1 shows an additional inlet.

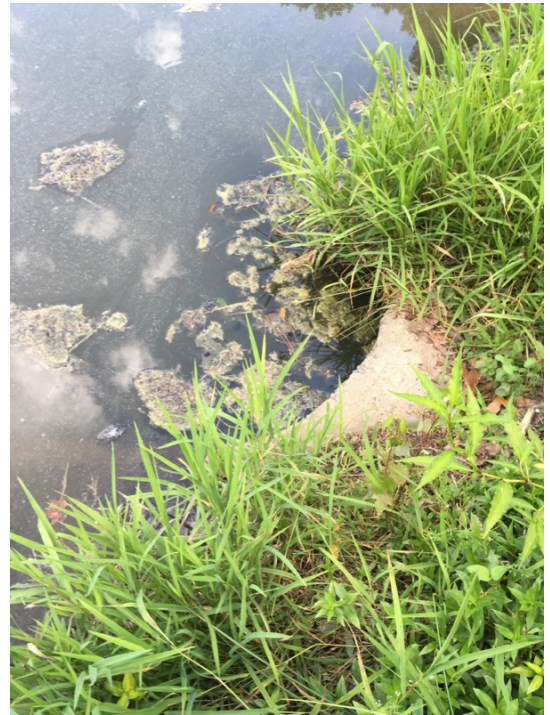
Noted Image 1

- Removed trash from the system.
- Treated filamentous algae growing along the shoreline.
- Treated woody vegetation growing in the buffer. Noted image 1 shows an additional inlet.
- Noted image 2 shows erosion on backside of the dam.

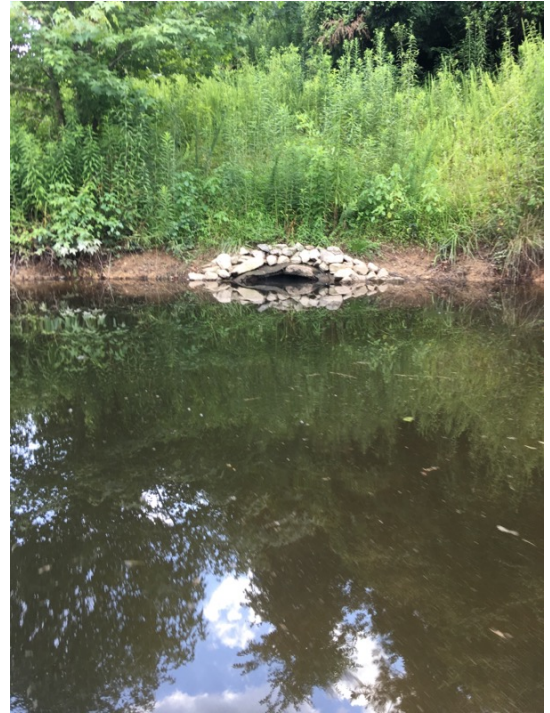
Noted Image 1

Removed trash from the system. Noted image 1 shows an additional inlet. Noted image 2 shows a rip-rap inlet. Noted image 3 shows a large washed out area in the rip-rap inlet.
