**SOUTHERN VILLAGE HOMEOWNERS  
ASSOCIATION  
CHAPEL HILL, NC**

**REVISION #1  
DECEMBER 15, 2023**

**FULL RESERVE STUDY  
with Site Inspection**

**GILES & FLYTHE**  
ENGINEERS

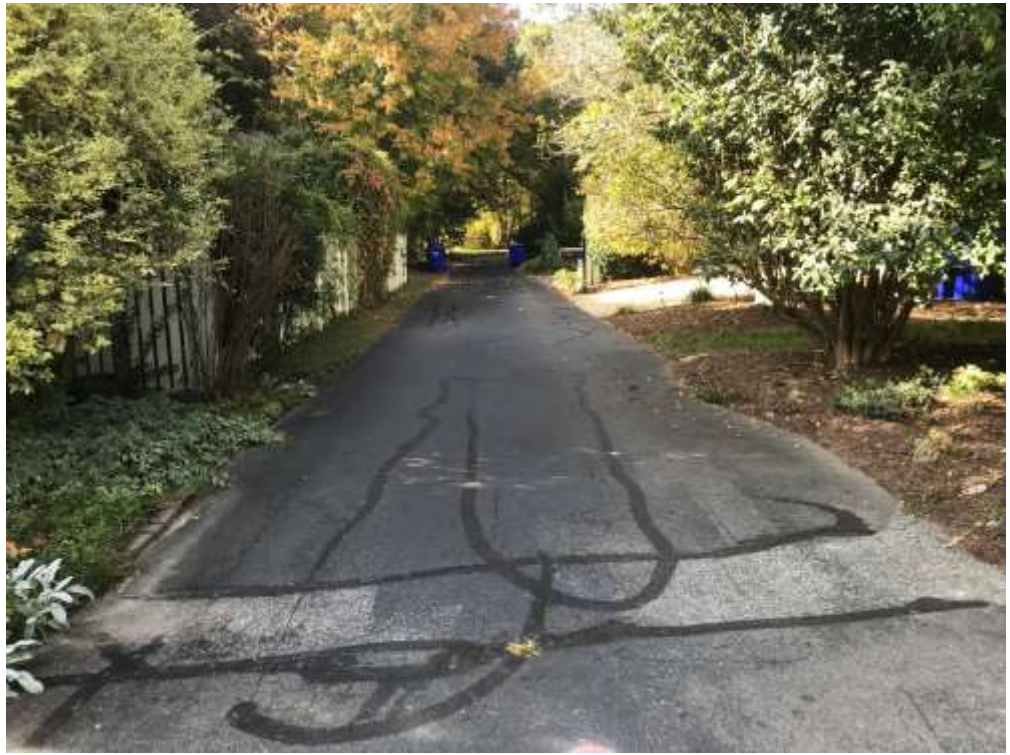
**Photo No.**  
**1**

In the sections of pavement that develop more advanced fatigue as the community ages, full depth repairs will likely be required, and some areas of previous patching were observed while on site. These types of repairs would typically include saw cutting and removing sections of paving, repairing the base course/sub-grade as needed, and installing new 4" thick asphalt paving. We have allocated funds for full depth repairs of sections of the paving on a 7-year cycle beginning in 2025, prior to the crack fill and seal coat applications discussed below. The allocation represents approximately 2.5% of the total pavement in the community every 7 years.

Typical asphalt paved  
alleyways with previous  
repairs

Typically, we recommend the application of an oil resistant sealant to all asphalt paved surfaces on an approximately 7-year cycle. At this same time, all cracks should be properly filled, patched, and sealed. We have allocated funds to reseal all of the pavement in 2025 on an approximately 7-year cycle, after the full depth repairs discussed above are completed.

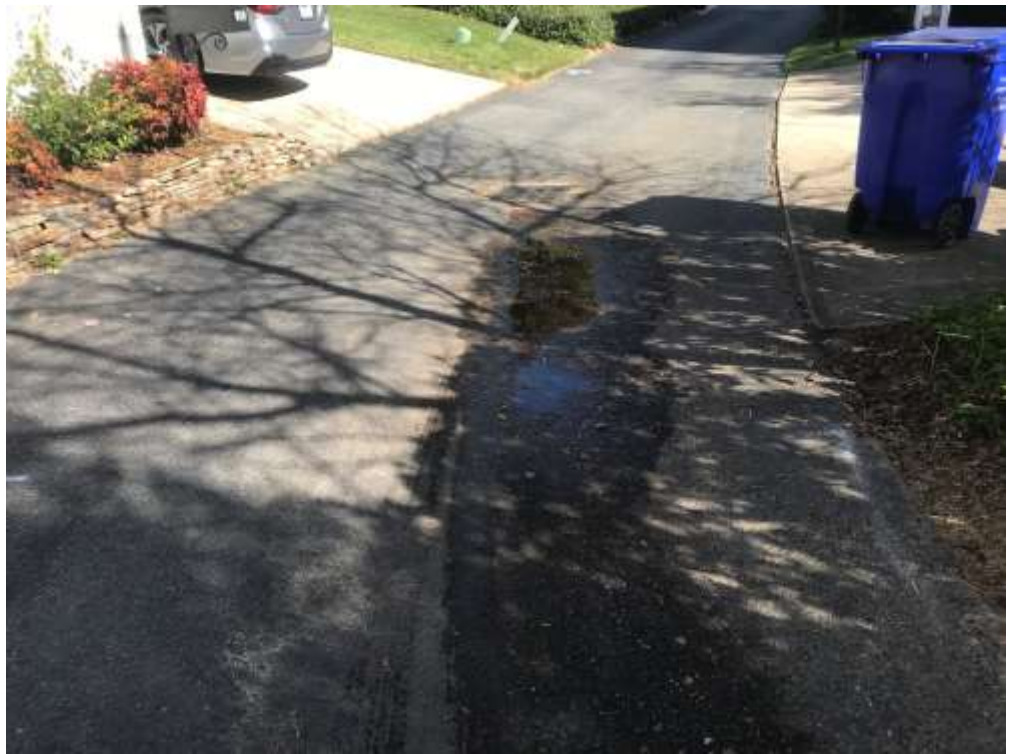
**Photo No.**  
**2**

Ponding in alleyway rear  
of 102 Hillspring Lane

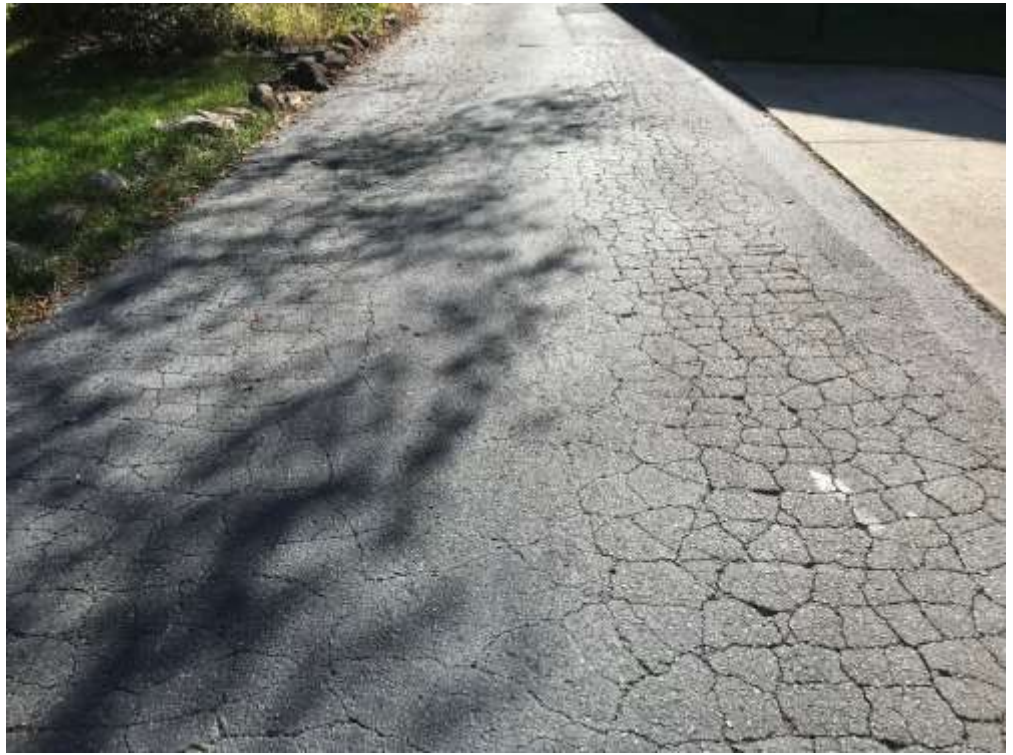
**Photo No.**  
**3**

The main streets and curbing in the community are located in public rights of way and are assumed to be maintained by the municipality. However, the alleyways at the rears of the buildings are privately maintained by the association. Per the community manager, the alleyways behind Edgewater Condos, 900-1020 Highgrove Drive, between Westside Drive and Nolen Lane, and between Nolen Lane and Glade Street are maintained by the Town of Chaple Hill, and we have not included them in this study. The private asphalt paving is in generally fair condition and mostly original to construction, with the exception of the alley south of Parkside Circle, which appeared to be relatively new. Sections of fatigue cracking and ponding due to settlement were observed, such as at the rear-right of 102 Hillspring Lane. Additionally, the catch basins to the rear of 124-126 Hillspring Lane were at the same relative elevation as the surrounding grade, which likely leads to runoff bypassing the inlets. Significant fatigue was also observed behind 309 Glade Street. A pothole was also observed to the rear of 200 Parkside Circle.

Fatigue cracking rear of  
309 Glade Street

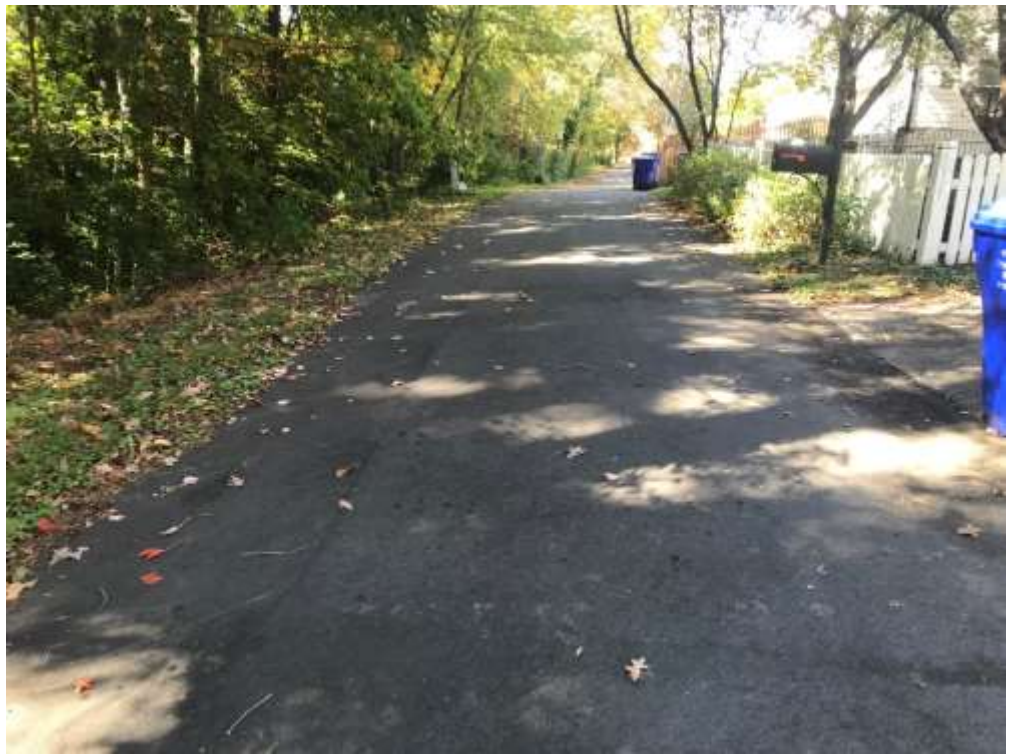
**Photo No.**  
**4**

Newer pavement in alley  
south of Parkside Circle

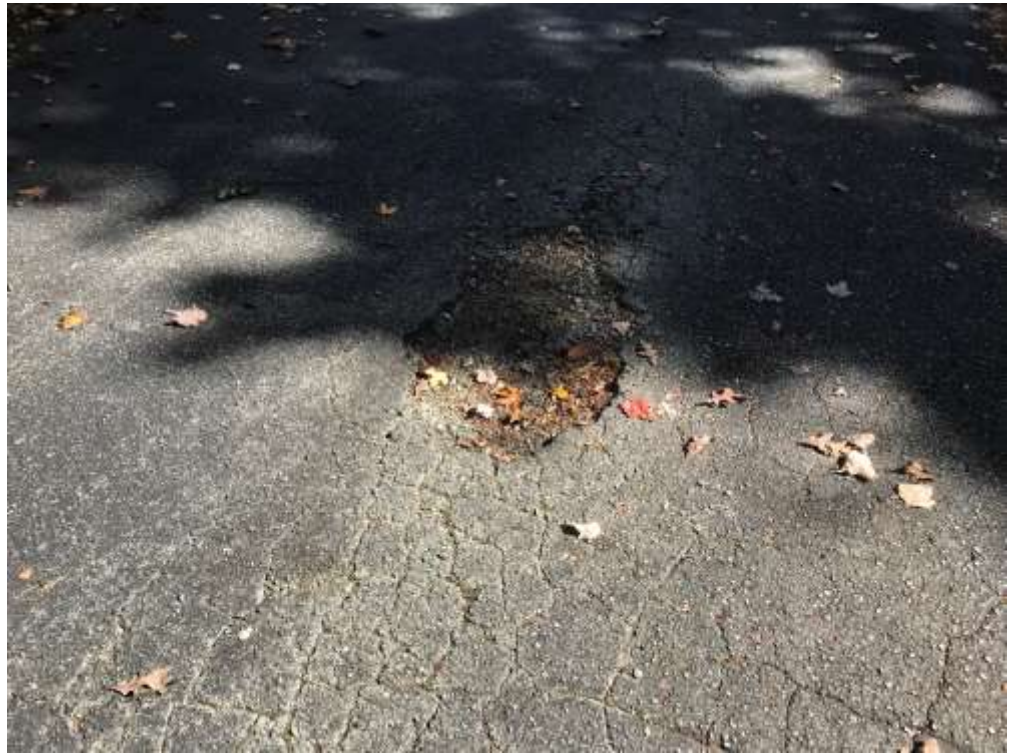
**Photo No.**  
**5**

Pothole rear of 200  
Parkside Circle

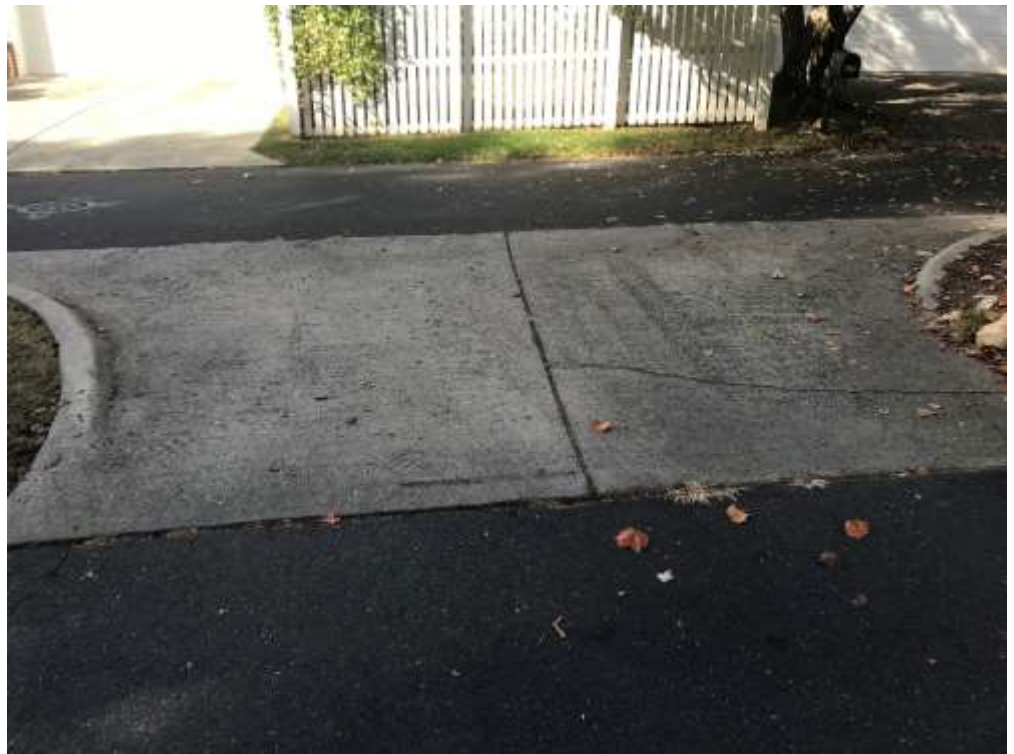
**Photo No.**  
**6**

were in generally fair condition, with sections of cracking observed. As the community ages, cracking and settlement will continue to develop and worsen in concrete surfaces. We have allocated funds for periodic repairs and/or replacement of concrete surfaces (flatwork and curbing), as required, and have assumed that 5% of the surfaces will require maintenance every 8 years beginning in 2027. Repairs may include grinding to reduce unevenness at cracking or saw-cutting, removing and replacing sections of the concrete. We have assumed isolated areas of upheaval or possible trip hazards would be repaired through an annual maintenance budget in the interim.

Typical concrete apron  
leading to alleyways;  
minor cracking

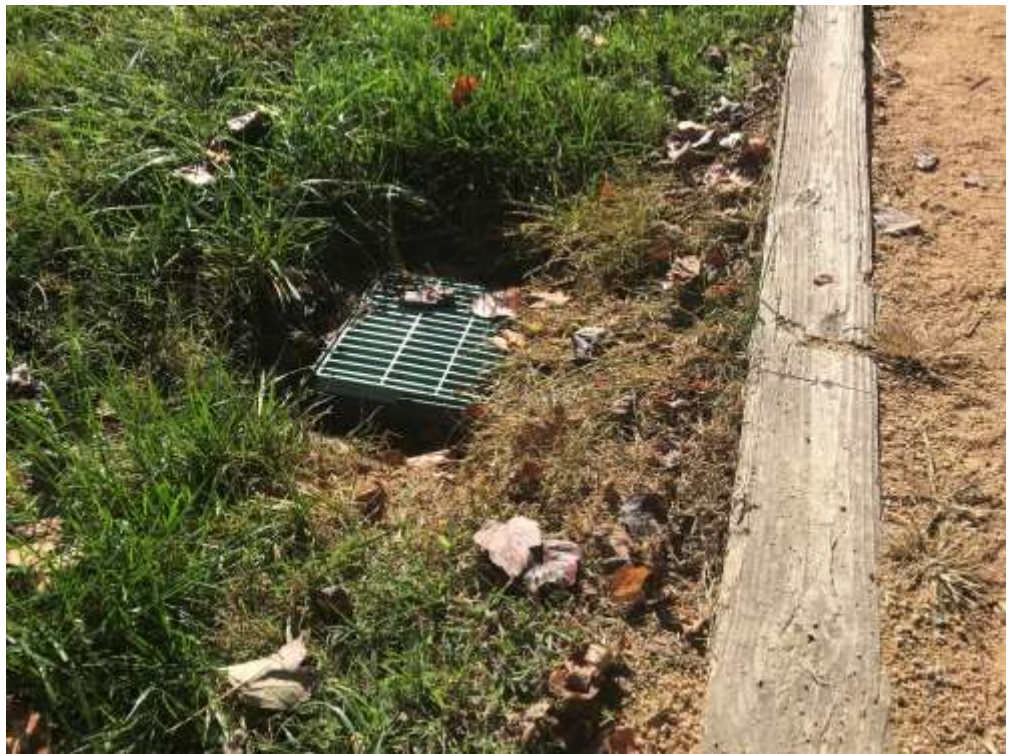
**Photo No.**  
**8**

Erosion around catch  
basin along walking path  
near tennis courts

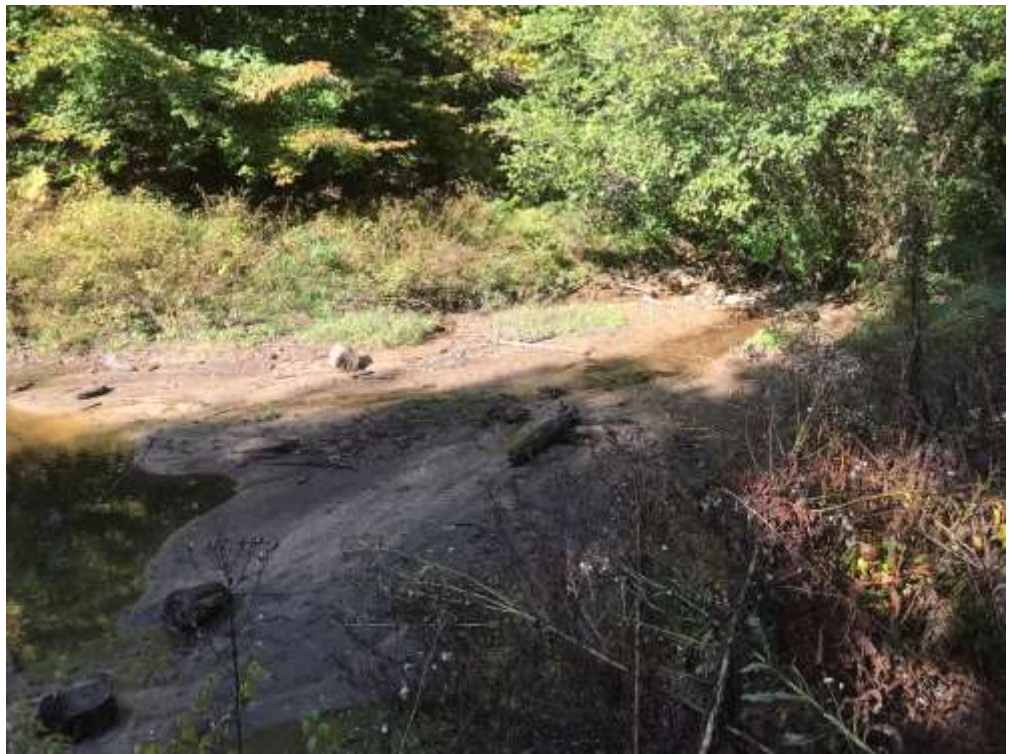
**Photo No.**  
**10**

We noted a total of 4 SCMs (ponds) consisting of wet ponds located throughout the community. The ponds north of Highgrove Drive and southeast of Parkside Circle have significant sediment accumulation at the inlets. Significant erosion was also observed downstream of the outlet pipe from the pond north of Highgrove Drive. Algae growth was observed in the pond east of Brookgreen Drive, and the vegetation was overgrown around the pond southeast of Parkside Circle. In addition to our observations, the community manager provided a quote for work to the ponds that included, dredging and replacing two outlet pipes. We have provided an allocation of funds in 2024 and 2025 to complete these pond repairs, based on the schedule provided by the community manager. Per the provided schedule, work was anticipated to be completed in 2023 at Ponds #3 and #4. However, per the community manager, the work has yet to be completed, so we assume it will be completed in 2024. Work is also scheduled for the outlet pipe of Pond #2 and dredging at Pond #3 in 2024, and dredging at Pond #1 in 2025. Note, a special assessment will be required in order to fund these repairs according to the provided timeframe due to current funding constraints and the significant cost of repairs. More details are provided in the Reserve Fund Analysis and Appendix A of this report.

Sedimentation at inlet of  
Highgrove Drive pond

After the repairs above and over time, sediment and silts will flow from the streets and landscaped areas into the storm sewer systems where they will be deposited in the stormwater ponds. As the sediment accumulates, the SCMs will be in jeopardy of failing the annual inspection by not performing according to the intended design. In addition, drought and other natural stresses will cause the plantings to die and require replacement. We have provided an allocation of funds to remove sediment and replace rip rap, as necessary, in all of the

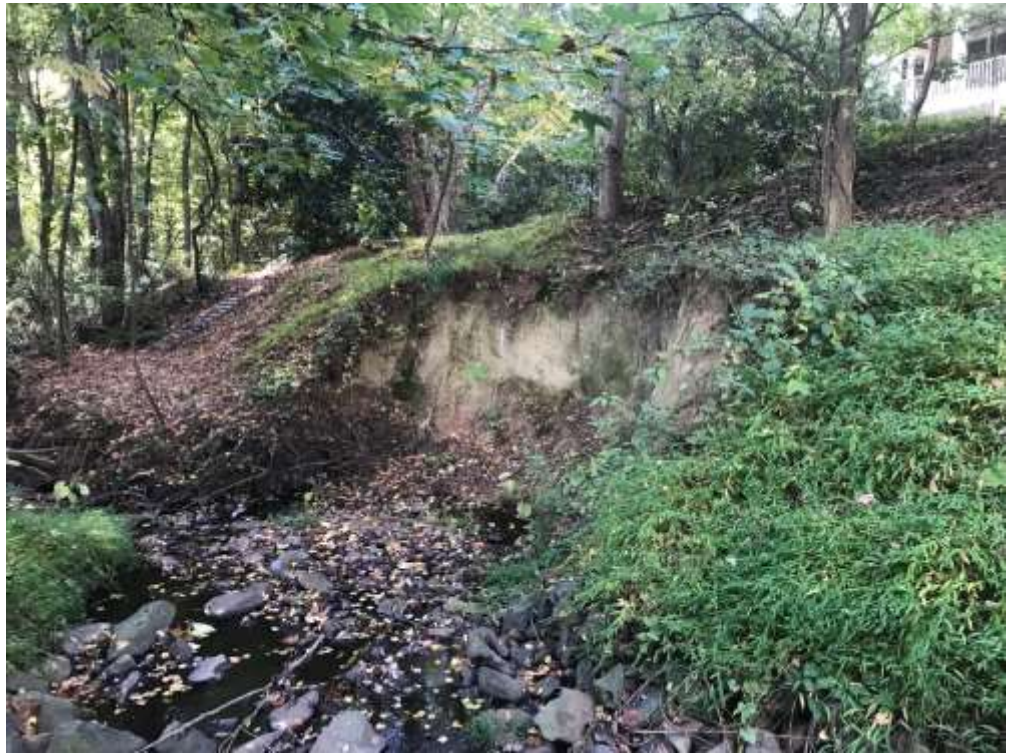
**Photo No.  
11**

Erosion downstream of  
outlet of Highgrove  
Drive pond

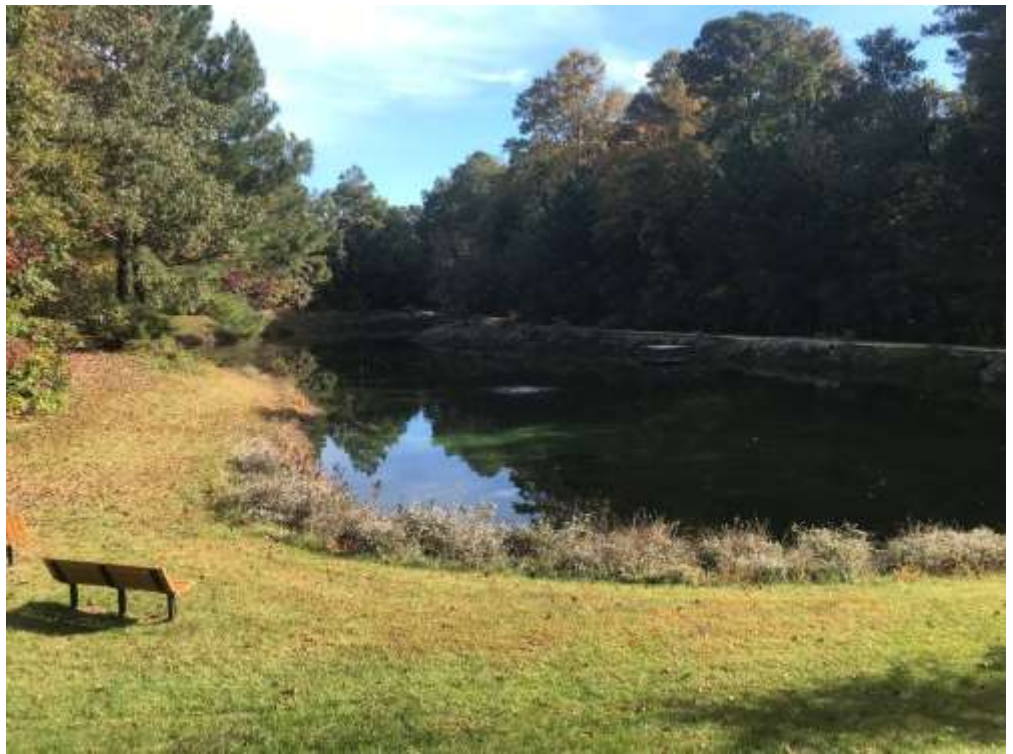
**Photo No.  
12**

Pond east of Brookgreen  
Drive with bubblers;  
minor algae growth

The stormwater ponds south of Aberdeen Drive and east of Brookgreen Drive each contain two aerators/bubblers that will require periodic replacement. We have provided an allocation of funds to replace the bubblers in these ponds on an approximately 7-year cycle beginning in 2029.

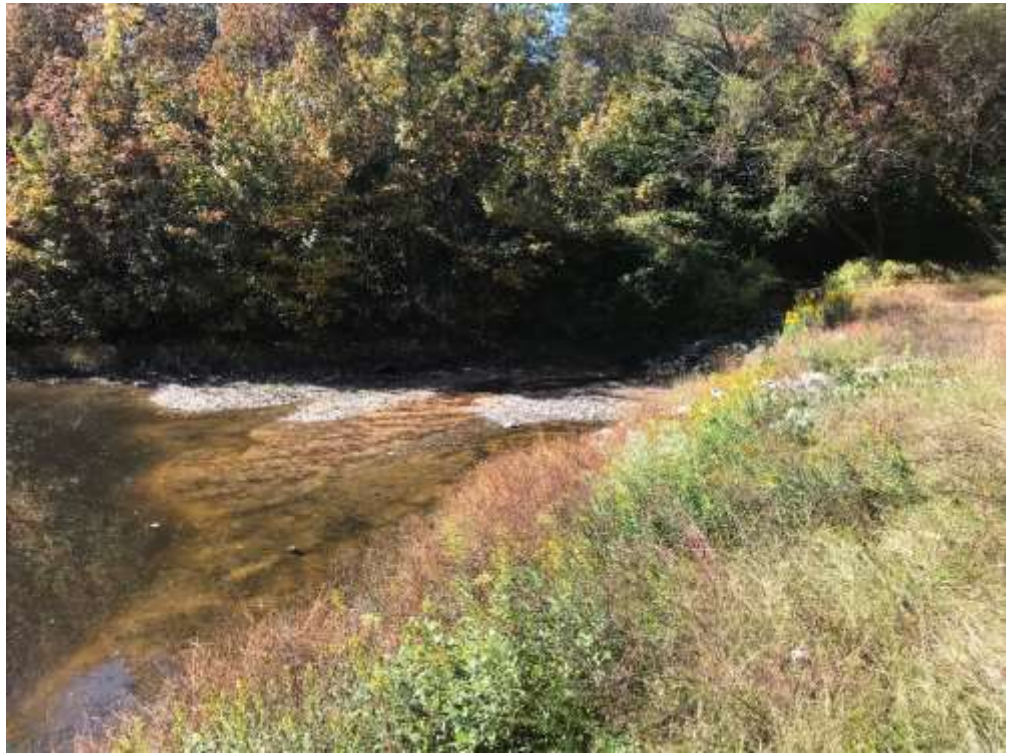
**Photo No.**  
**13**

Sediment at Parkside  
Circle pond inlet

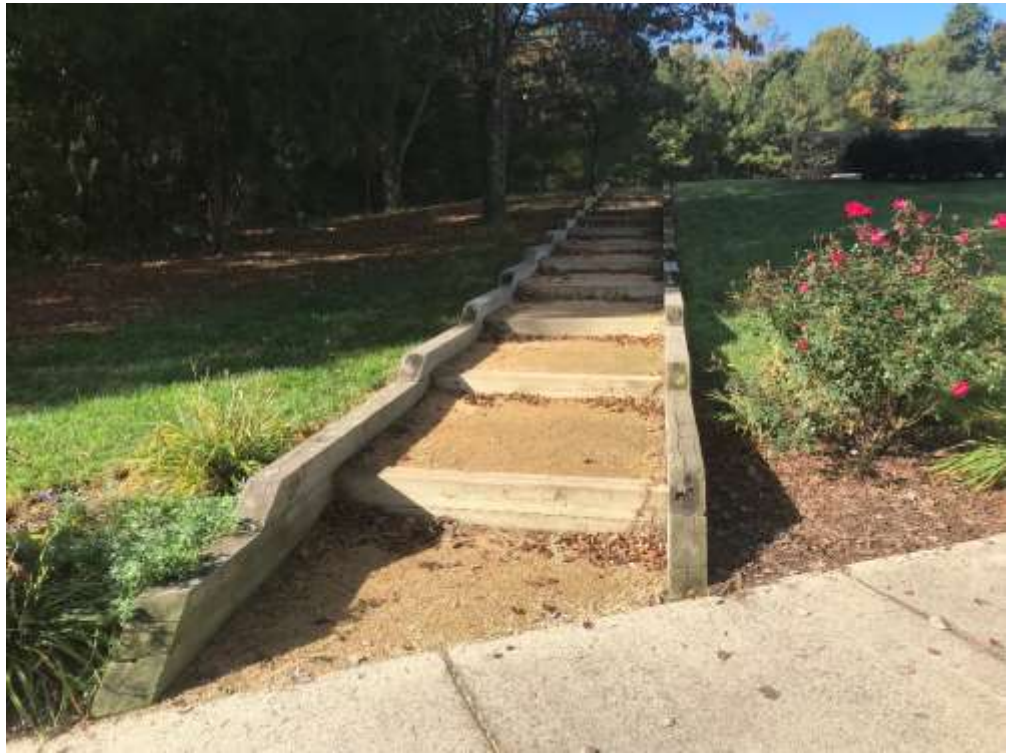
Wood timber stairs are installed at the southeast end of Central Park and across the street leading towards the SCM on the eastern side of Brookgreen Drive. Per historical aerial imagery, the stairs appear to have been installed around 2019. We anticipate the timbers to provide a useful life of approximately 25-30 years prior to replacement. We have provided an allocation of funds to replace the wood timber stairs in 2045.

View of timber stairs at  
Central Park walkway

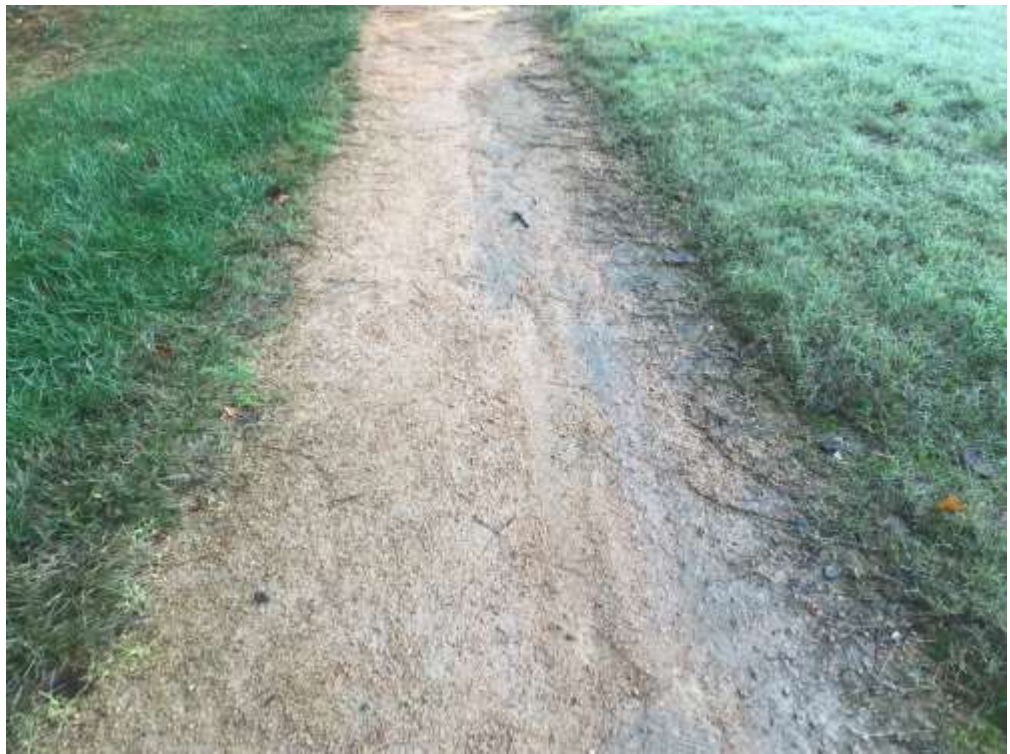
Minor washout in  
Chapel Hill grit walking  
path

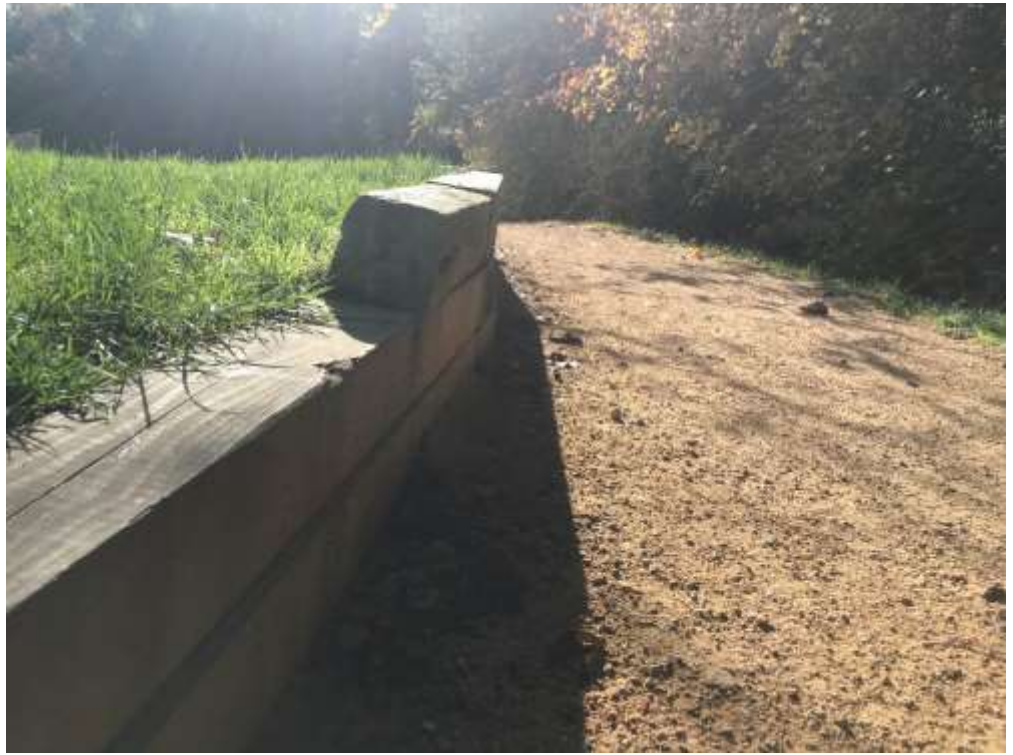
**Photo No.**  
**17**

Leaning timbers along  
Chapel Hill grit walking  
path

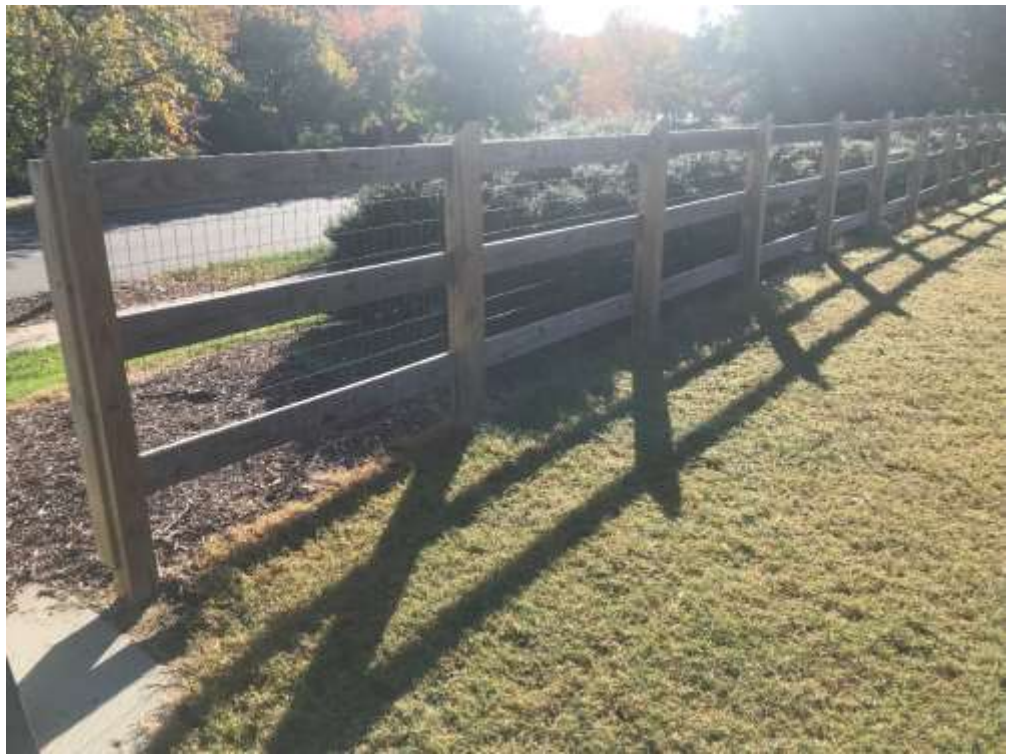
**Photo No.**  
**18**

Wood split-rail fencing is installed along the eastern perimeter of Central Park and around the pond south of Aberdeen Drive. The fencing appeared to be in generally good condition and recently installed. This type of fencing typically provides a useful life of approximately 15-20 years prior to replacement. We have provided an allocation of funds to replace the split-rail fencing on an approximately 18-year cycle beginning in 2039. We assume isolated areas of damage will be repaired using funds from an annual maintenance budget in the interim.

Typical wood split-rail  
fencing; Central Park

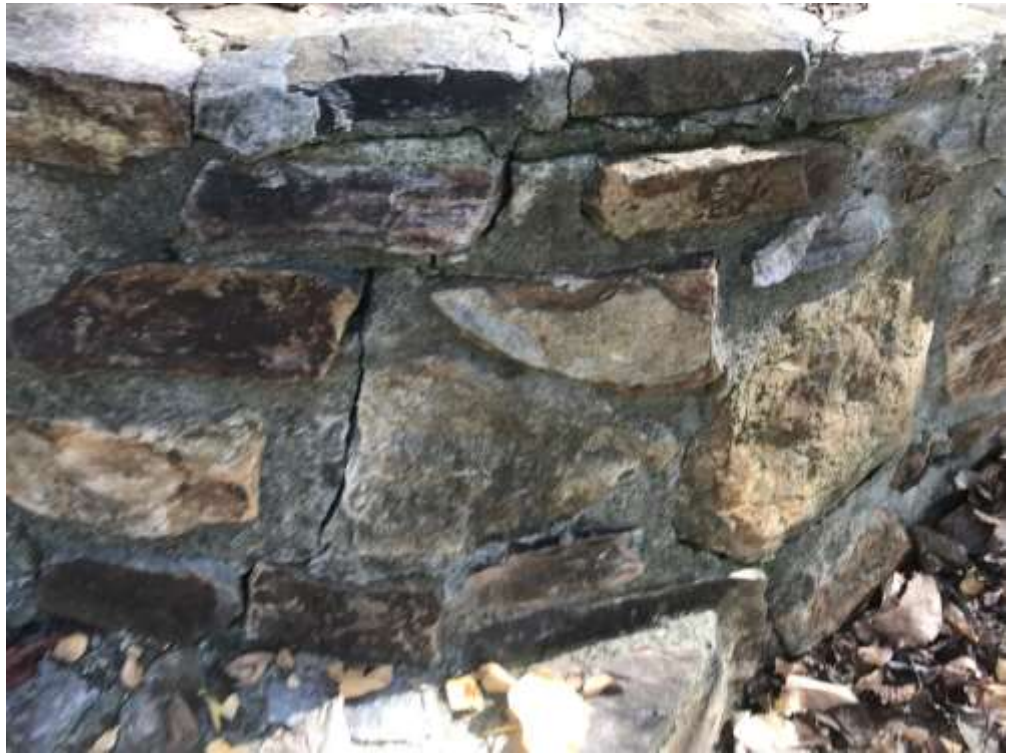
**Photo No.**  
**19**

Masonry walls extend throughout the community that are comprised of stone. Minor cracking was observed in sections, such as in the stairs at Highgrove Park and in the monument at the pond south of Aberdeen Drive. Over time, additional cracking and settlement is likely to occur. We have provided an allowance of funds to repoint sections of the walls, as needed, on an approximately 5-year cycle beginning in 2026.

Typical stone masonry walls; minor cracking in stairs at Highgrove Park

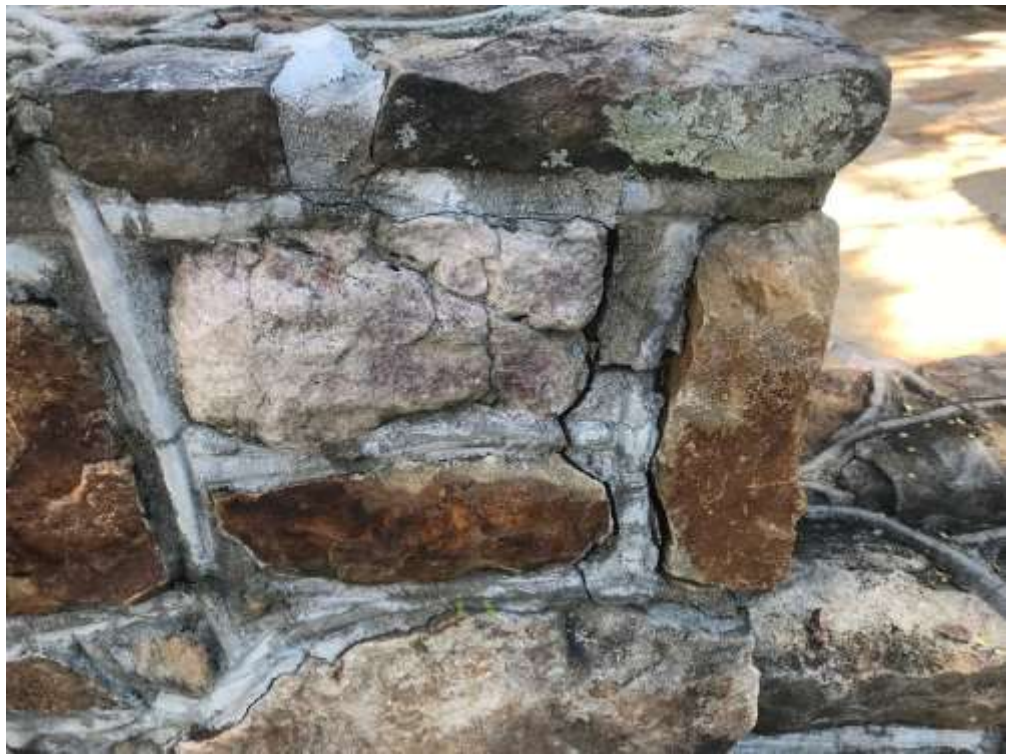
**Photo No.**  
**20**

Cracking in monument at Aberdeen Drive pond

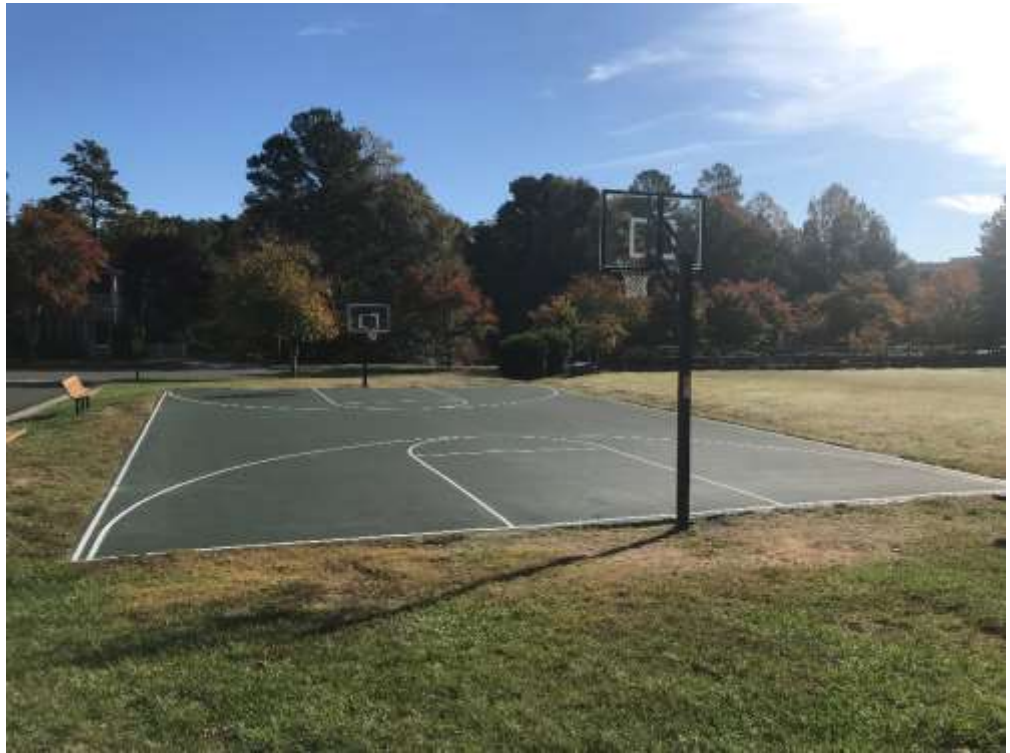
**Photo No.**  
**21**

A basketball court is located adjacent to the parking area at the Southern Village clubhouse and Central Park. The court is comprised of an asphalt base with a polyester fabric membrane finish. Maintenance of the court will include resurfacing on an approximately 5-year cycle and full reconstruction on an approximately 20- to 25-year cycle. Resurfacing is comprised of repairing cracks and filling depressions/birdbaths with a polyester fabric membrane, a finish color coat, and painting the lines. The court appeared to be in generally good condition, and we anticipate resurfacing on an approximately 5-year cycle beginning in 2028. Re-construction will consist of pulverizing the existing asphalt surface and blending it with the subgrade (potentially adding cement for stabilization), installing a new 2" asphalt layer, applying multiple coats of resurfacer and finish coats, and painting the lines. Funds for re-construction have been allocated in 2043. The funds allocated for reconstruction include resurfacing of the court and replacement of the two hoops.

View of basketball court; surface in good condition
