# **Reserve Study**

## **Southern Village HOA**

**Chapel Hill, NC**

**Report Number:**  
121112507

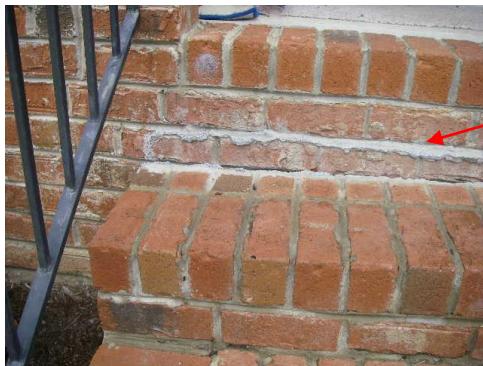
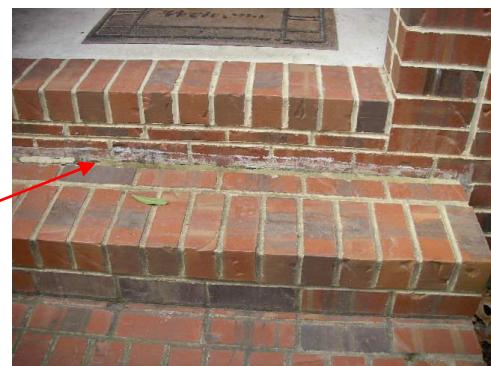
- **Observation:** As noted during the 2007 study the stoops in front of the townhomes located in 500-516 Cooperline have settled. This same type of settlement was noted at the steps in front of the Westgreen townhomes. This may be a safety issue as the first step down is significantly larger than the others (trip hazard) are. This is an individual owner responsibility.

Excessive settlement, 2007 photograph – Copperline  
Excessive settlement, 2012 photograph – Westgreen

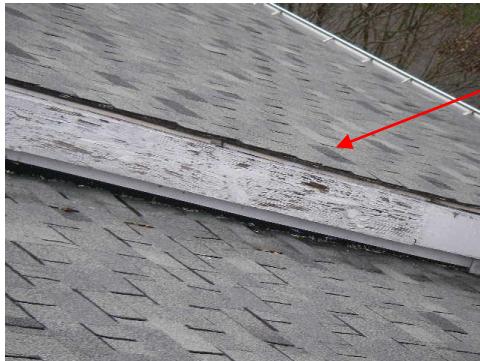
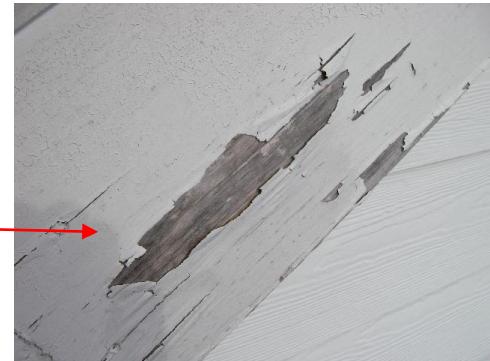
- **Observation:** As reported in 2007, when building exteriors (townhomes) are painted, contractors should include the rake trim between the units. In several areas, this appears to have been left out of the most recent painting. In addition, the painted surfaces that have peeling paint need to be scraped in order to achieve expected life from new paint. Most of the rake trim observed while walking the roofs needs to be scraped.

Sample – rake trim left out of the most recent painting (2007)  
Rake trim needing to be scraped

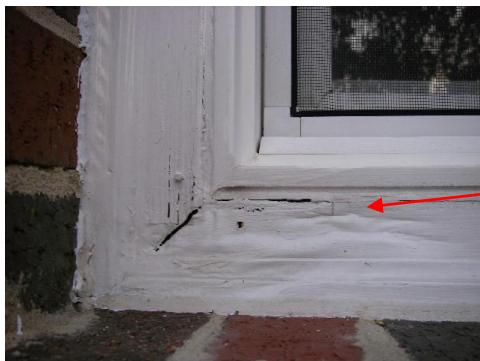
- **Observation:** When buildings are re-painted, all wood rot needs to be addressed. In several locations, it appears that trim rot was over painted.

Sample – painted over rot

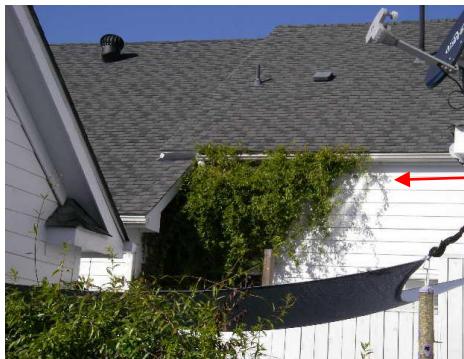
- **Observation:** Vegetation should be removed from areas where it is in contact with buildings. Vegetation too close to building holds moisture next to a building and provides easy egress for insects.

Sample – vegetation too close to building

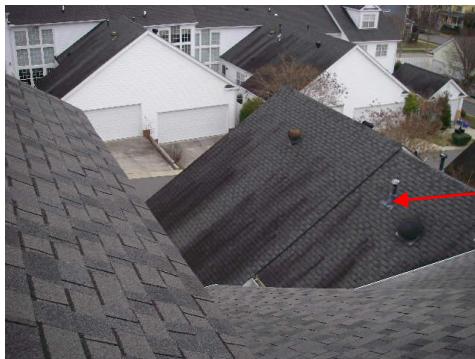
- **Observation:** Roof shingle staining was noted in several areas. Staining rarely causes an issue with roof performance or life. This is a cosmetic issue. Care must be exercised if staining is removed; staining removal can damage or reduce the life of the shingles.

Sample – roof staining

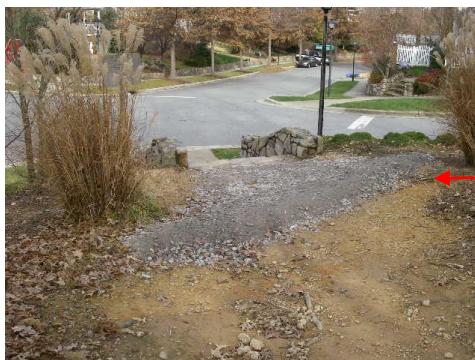
- **Observation:** Good erosion control has been put in place at the entrances to Arlen Park.

Sample – good erosion control

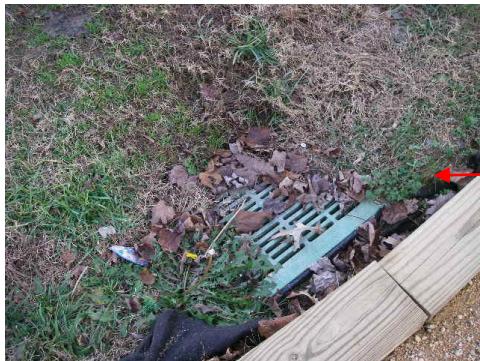
- **Observation:** Catch basins need to be periodically cleaned so that they may function as intended. The catch photographed below is along the trail behind the tennis courts at the Brookgreen complex. **Update:** catch basin has been cleaned.

Sample – catch basin needing cleaning

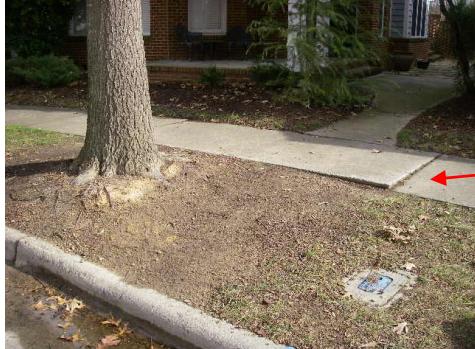
- **Observation:** In many locations, the trees along the sidewalks have lifted sidewalk pads making a trip hazard. This condition was observed in many locations throughout Southern Village. This is not an HOA issue; however, the trip hazard should be noted to the city maintenance department.

Sample: raised side walk

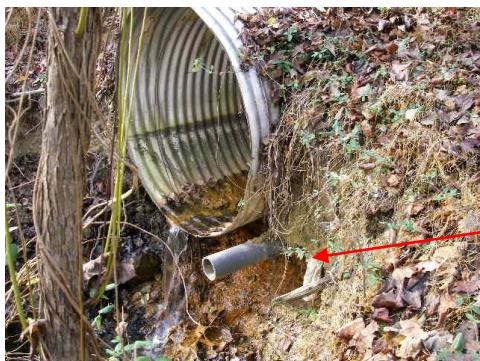
- **Repair:** The overflow outlet pipe from the pond located between US15-501 and Parkside is under eroded. Concrete should be added to prevent further erosion. There is no immediate danger; however, continued erosion will alter this conclusion. **Update:** estimates for repair are being obtained.

Under eroded outlet

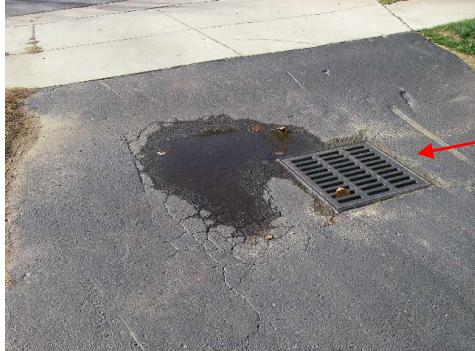
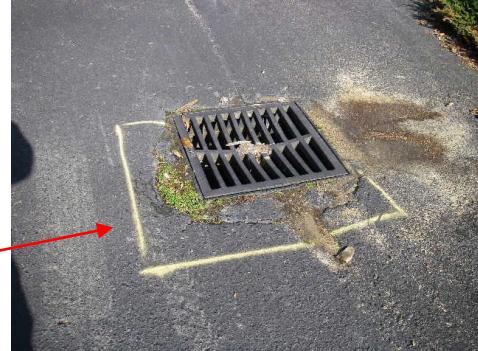
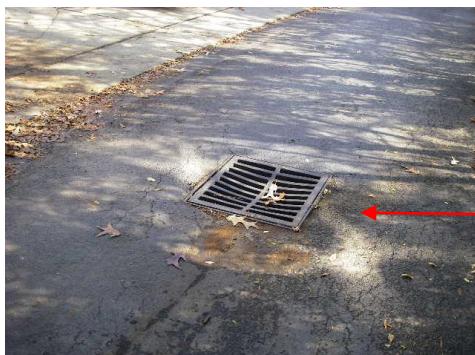
- **Repair:** The pavement at the catch basin at the end of the ally near the Westside/Highgrove intersection needs repair. The pavement has settled and water collects at the low spot. The pavement should be cut and repaired to prevent ponding water. The catch basin in the ally from Parkside to Meeting has been marked presumably for the same repair. The catch basin in the ally paralleling Parkside also needs the same repair. **Update:** estimates for repair are being obtained

Pavement repair needed:  
Ally near Westside/Highgrove intersection  
Ally from Parkside to Meeting

Pavement repair needed:  
Ally paralleling Parkside

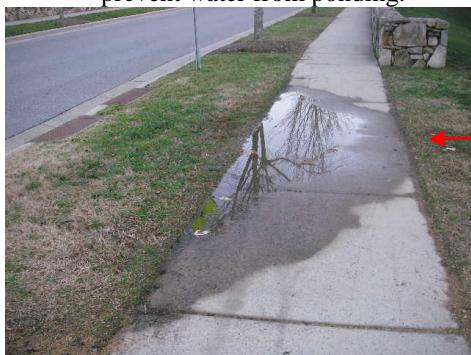
- **Repair:** The sidewalk along Brookgreen at the bridge over Fan Creek (sports complex side) needs to be replaced to prevent water from ponding.

Ponding water on sidewalk

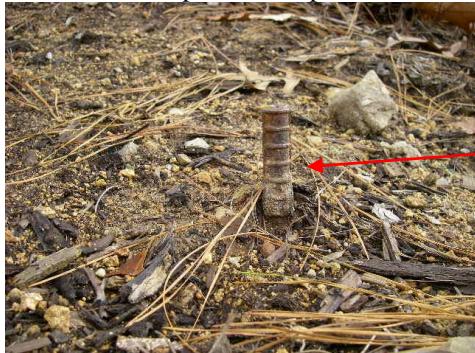
- **Repair:** There is exposed re-bar in Arlen Park (along Westgreen side). This is a safety issue and the exposed re-bar needs to be removed. Exposed re-bar along the Eastgreen side was reported in 2007. **Update:** repair in process, several pieces of exposed re-bar have been removed and work will continue until all have been removed

Sample – exposed  
re-bar (several in  
same area)

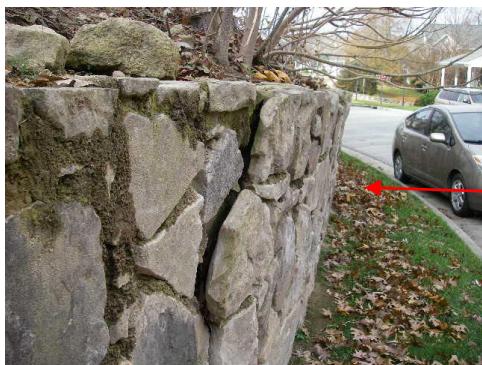
- **Repair:** The retaining wall is leaning and in need of repair along the Eastgreen side of Arlen Park. **Update:** estimates for repair are being obtained

Leaning  
retaining wall

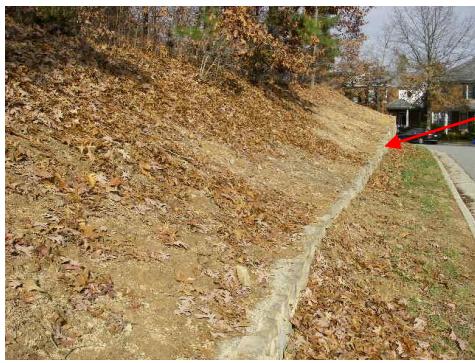
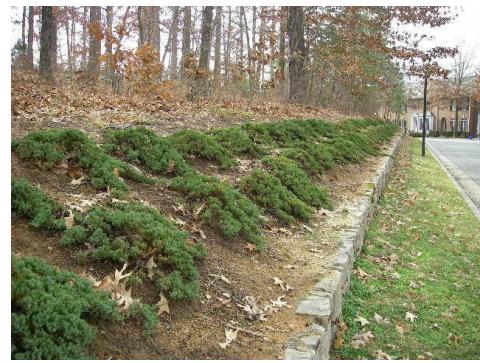
- **Repair:** The hillside in Arlen Park along the Eastgreen side needs stabilization to prevent erosion. The vegetation along Westside near Newell Drive is performing well and can be used as a guide. **Update:** landscaper feels soil is stable due to tree roots

Erosion control  
needed

Good erosion  
control

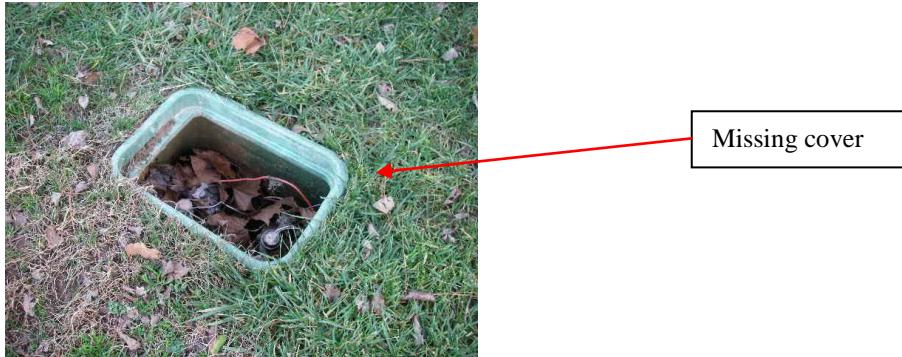
- **Repair:** The cover for the landscape valve enclosure along the trail next to the Brookgreen soccer field is missing (this is a safety issue). The cover needs to be replaced. **Update:** repaired

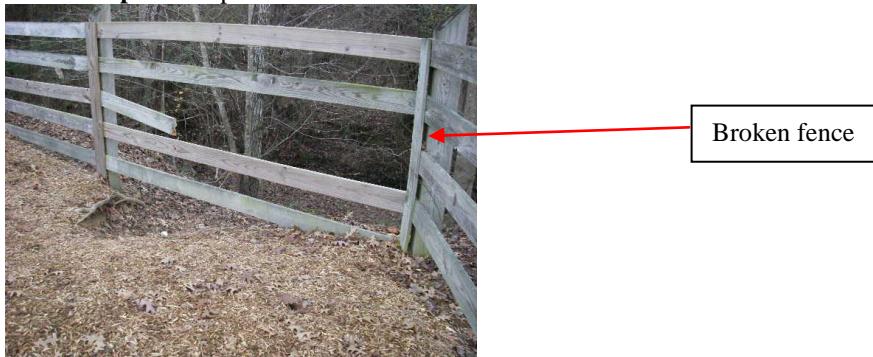
- **Repair:** The fence at the small park next to Edgewater and Fan Creek (south end) is broken and needs to be repaired. **Update:** repaired

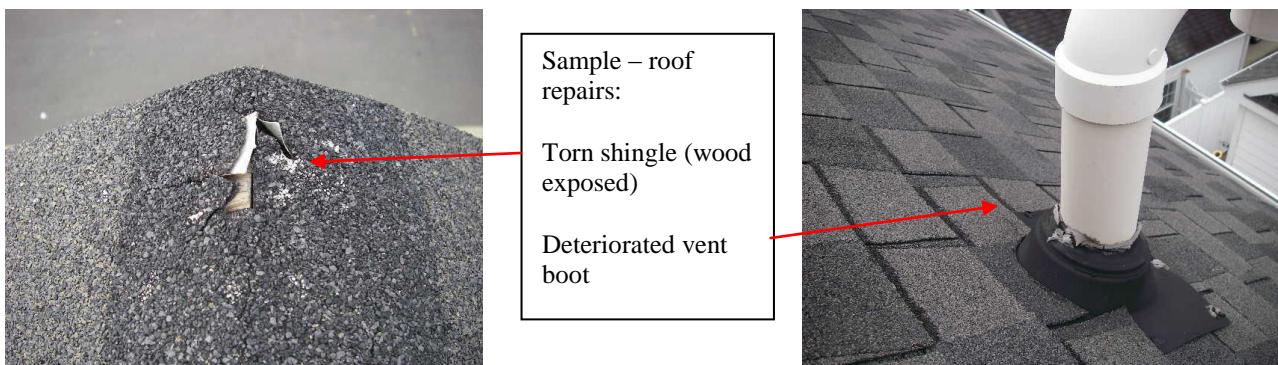
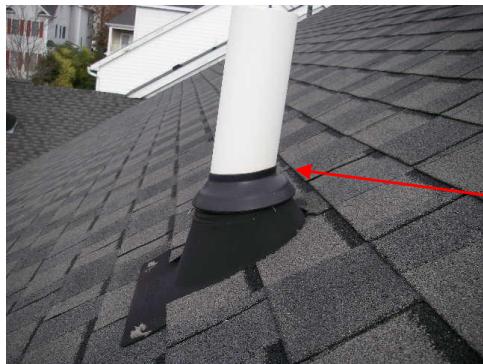
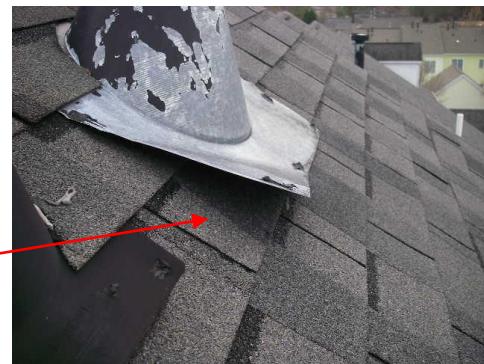
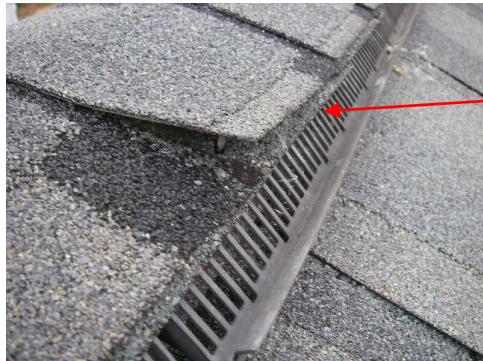
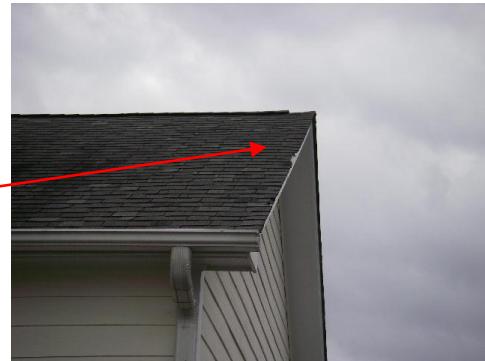
- **Repair:** All of the walked roofs were in need of minor repair: torn shingles at ridges (exposed wood), deteriorated vent boots (some have been re-capped), lifted flashing, raised shingles and damaged shingles (along edges). Table II includes monies to repair all townhome roofs. The estimate assumes that the roofs inspected from the top of a ladder will have similar issues. **Update:** estimates for repair are being obtained

Sample – re-capped  
vent boot

Lifted flashing  
(Middle of  
Westside roof  
walked)

Sample – raised  
shingle

Sample – damaged  
edge shingles

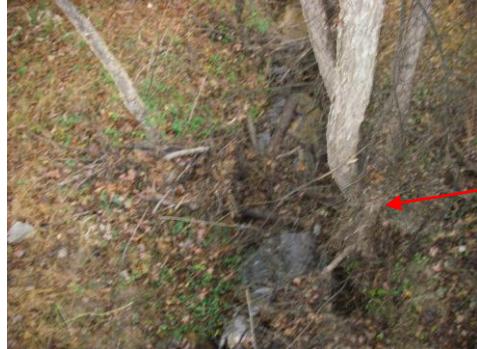
- Creek channels need to be periodically cleaned (remove collected debris and cut small saplings) to assure that the channels flow freely in heavy weather events. **Update:** obtaining estimates.

Channel needing  
cleaning

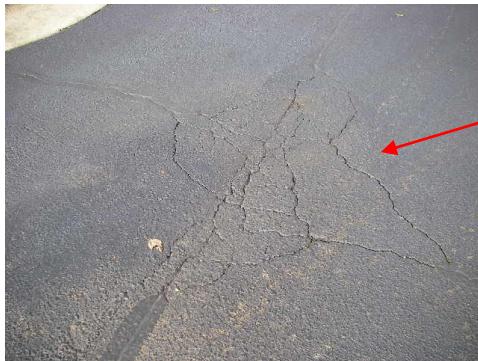
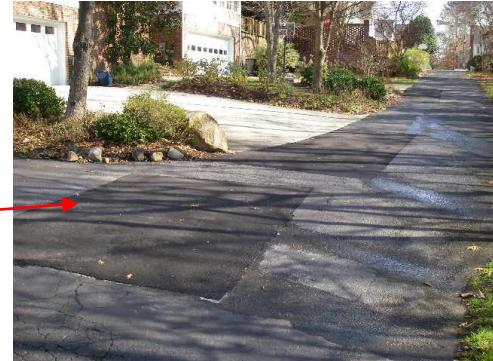
- The alleys are in good condition. Some of the alleys have been over-coated to extend life, others have not. Patching has been performed in many locations. Sealing the cracks in the alley pavement and weed killing the vegetation in the cracks will extend the life of the pavement. Monies to periodically perform this task are included in Table III.

Sample: over-coated alley  
Patching in alley

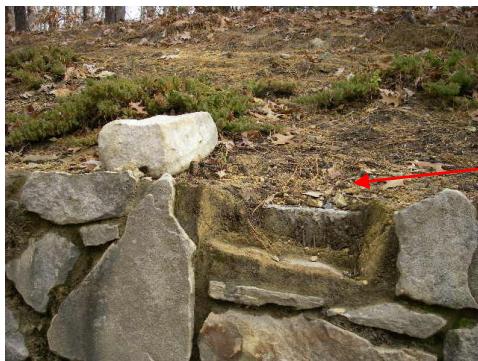
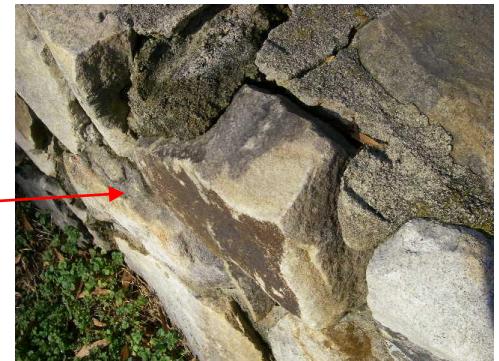
- The landscape dollars are not included in this Reserve Study as they are an operational expense. Ecoscapes (Jimmy Lloyd) provided a monthly estimate of \$6,900 in 2007. According to Mr. Lloyd, leaf removal and mulching costs are not included in the estimate, as both are outside of the contract.
- Park maintenance reserves include minor repairs to playground equipment and painting as needed.
- Some of the rock walls need repair for missing and/or loose stones. Monies have been budgeted to periodically inspect and repair the walls as necessary.

Samples:  
Missing stones  
Loose stones
