Client Log - Triangle

Dragonfly Maintenance Report

Property	SOUTHERN VILLAGE
Client Name	Patsy Smith, Tony Smith
Client Email Address	patsysmith7077@gmail.com
Client Email Address 2	tony@berkeleychapelhill.com
Client Email Address 3	
Client Email Address 4	
Number of Ponds & Pond Type	4 Wet Ponds
Service Type	
Standard	
Mowing Schedule	2 Mowings Per Year
Mowing Service	
Mowing occurs inside of the fence.	
Special Instructions	
Pond 4 #2020	
Pond Locations	https://imageshack.com...

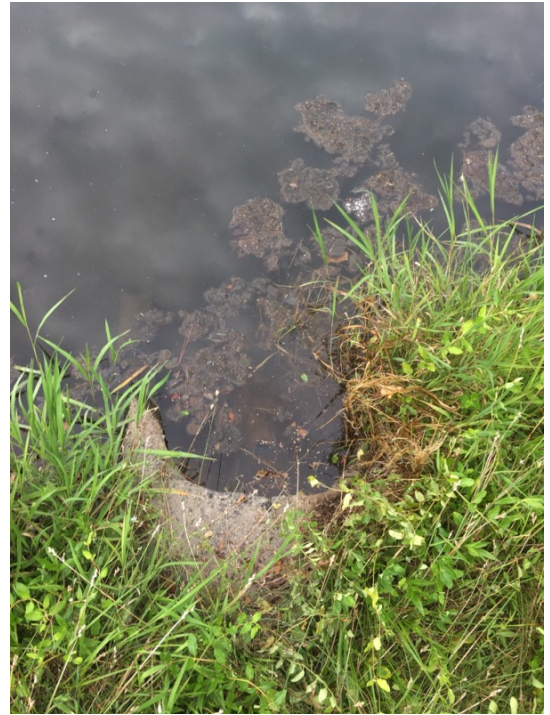
Noted Image 1

Removed the trash from the system. Electrical work needed to repair the aeration unit. Treated for terrestrial vegetation in the outlet riprap. Treated for saplings in the buffer. Treated for filamentous algae along the shoreline. Noted image 1 shows an additional inlet.

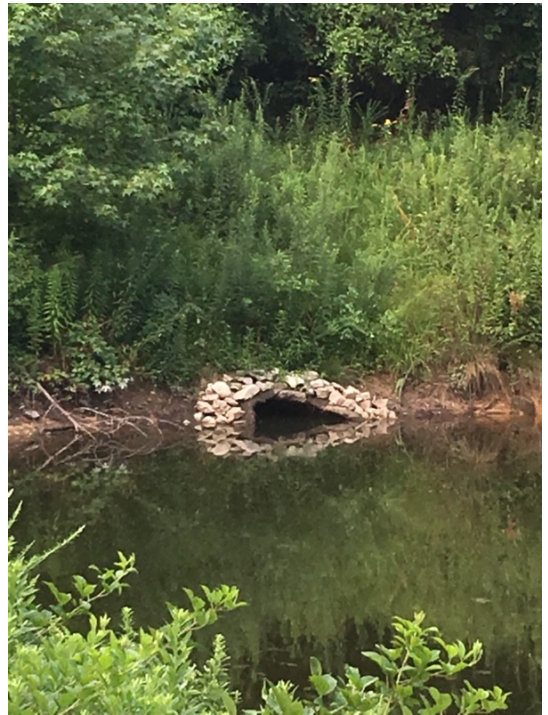
Noted Image 1

Removed the trash from the system. The dam near the outlet needs mowing to allow better access. Continue to monitor for erosion on the shoreline from previously high water. Treated for terrestrial vegetation in the inlet riprap. Treated for saplings in the buffer. Noted image 1 shows an additional inlet. Noted image 2 shows a spillway inlet that needs riprap repair. Noted image 3 shows a natural inlet with large bare spots in the riprap that needs repair.

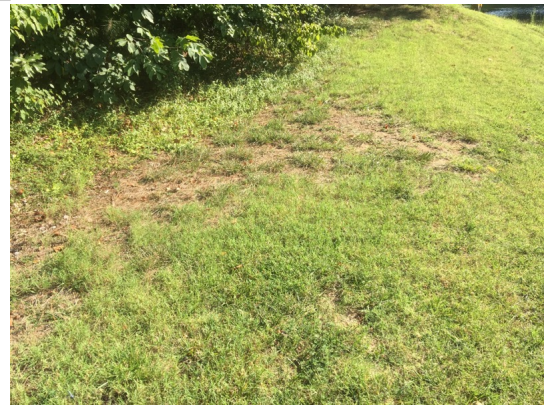
Removed the trash from the system. The dam is exhibiting mild to moderate erosion on the slope opposite of the walking path. Continue to monitor for erosion on the shoreline from previously high water. Treated for watermeal along the shoreline. Noted image 1 shows erosion on the dam.
Noted Image 1

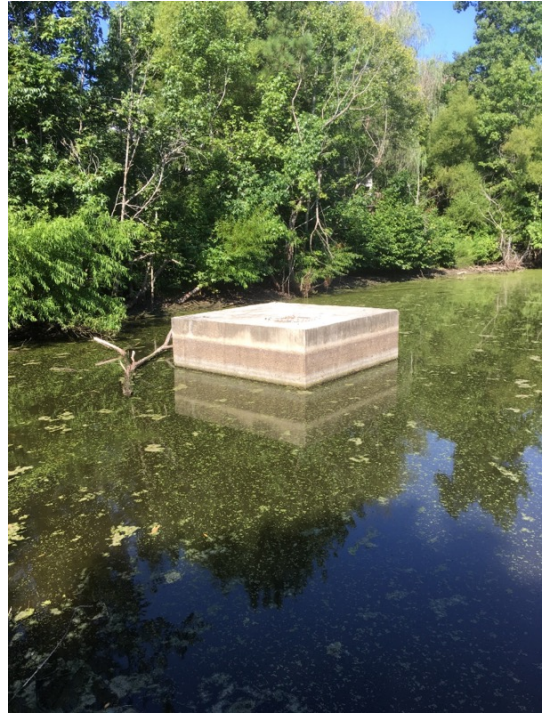
Noted Image 1

Removed the trash from the system. Continue to monitor for erosion on the shoreline from previously high water. Treated for watermeal throughout the pond basin. Treated for duckweed throughout pond basin. Treated for saplings in buffer. Treated for terrestrial vegetation in outlet riprap. Noted image 1 shows an additional riser. Noted image 2 shows erosion on the dam. Noted image 3 shows erosion on the shoreline.
