Client Log - Triangle

Date: 09/13/2019

Dragonfly Maintenance Report

Pond Name	WP 4
Access Address	400 Market St, Chaple Hill, NC
Service Date	08/19/2019
Trash Pickup	SC= Service Completed
Treat Invasives	SC= Service Completed
Inlet service	SC= Service Completed
Outlet Service	SC= Service Completed
Unclog Drain	NN= Service Not Needed
Clean Riser/Trash rack	SC= Service Completed
Add Dye?	NN= Service Not Needed
Fountain/Aerator Condition	FF= Fully Functional
Mow/Weed eat	NN= Service Not Needed
Overview of the pond

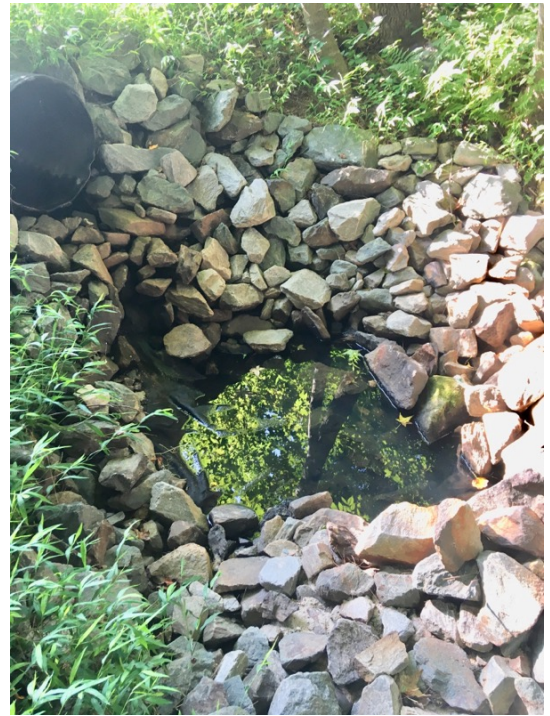
Noted Image 1

Rearranged the rip-rap below the outlet in order to cover the bare areas. Noted images 1 and 2 show the bare area below the outlet before and after rearranging the rip-rap. Noted image 3 shows the inside of the riser. Noted images 4 and 5 show additional inlets.

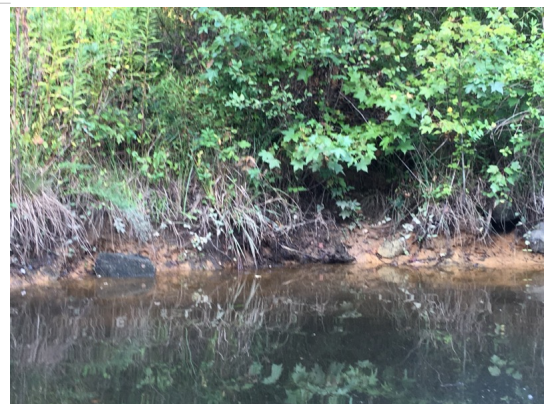
Noted Image 1

Water level was high upon arrival but the riser was draining properly. Noted image 1 shows erosion on the shoreline. Noted image 2 shows an additional inlet. Rearranged the rocks on the rip-rap inlet in order to cover the large washed out area. Noted images 3 and 4 show the washed out area before and after rearranging the rip-rap. Additional rip-rap is needed in order to adequately cover this area. Vegetation is growing tall around the system. Mowing is needed.

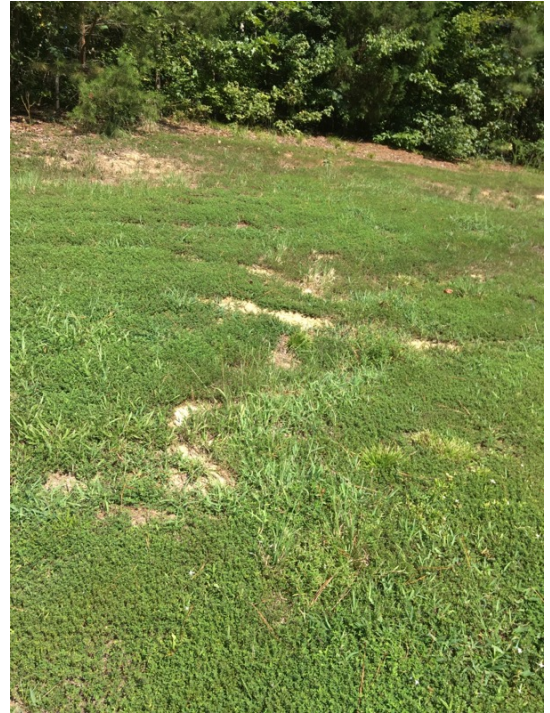
Noted Image 1

Treated for saplings in the buffer. Noted image 1 shows areas of exposed soil on the dam.

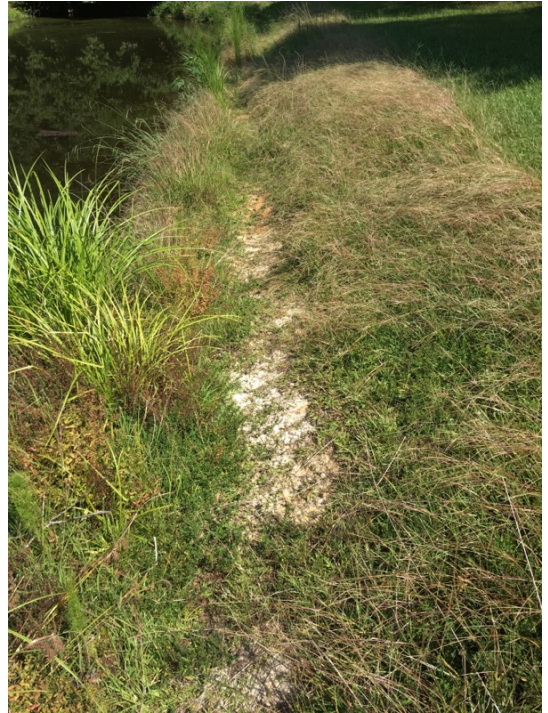
Noted Image 1

Noted image 1 shows erosion on the dam. Noted image 2 shows water evacuating from the orifice after it was unclogged.

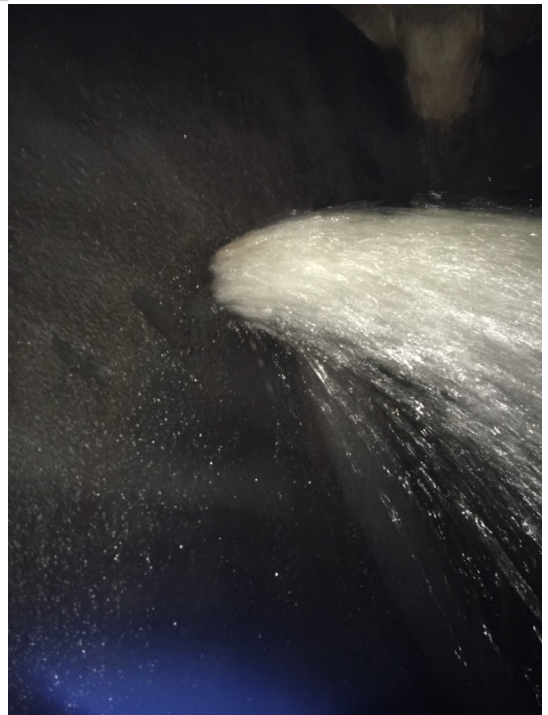
Noted Image 2

Water level was high upon arrival due to a clogged orifice. Unclogged the orifice and restored normal water flow. Treated planktonic algae growing in pond. Treated for saplings in the buffer.
