Client Log - Triangle

Dragonfly Maintenance Report

Property	SOUTHERN VILLAGE
Client Name	Patsy Smith, Tony Smith
Client Email Address	patsysmith7077@gmail.com
Client Email Address 2	tony@berkeleychapelhill.com
Client Email Address 3	
Client Email Address 4	
Number of Ponds & Pond Type	4 Wet Ponds
Service Type	
Standard	
Mowing Schedule	2 Mowings Per Year
Mowing Service	
Mowing occurs inside of the fence.	
Special Instructions	
Pond 4 #2020	
Pond Locations	https://imageshack.com...

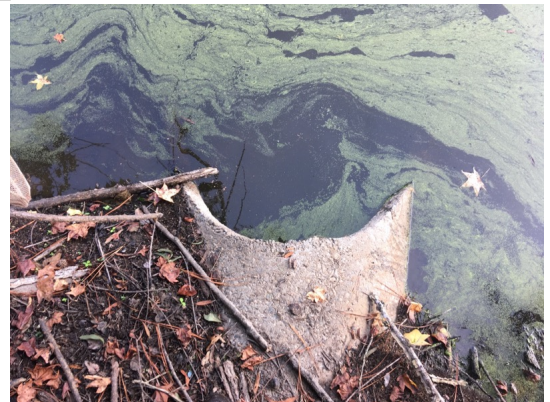
Noted Image 1

Trash was removed from the system and the wet pond was treated for planktonic algae and Watermeal. Recommend a Sonar treatment in the future for better control. Noted image 1 shows a secondary inlet. Noted images 2 and 3 show sedimentation at the creek inlet. Noted image 4 shows exposed soil along the shoreline due to extended periods of high water. Noted image 5 shows a secondary outlet.

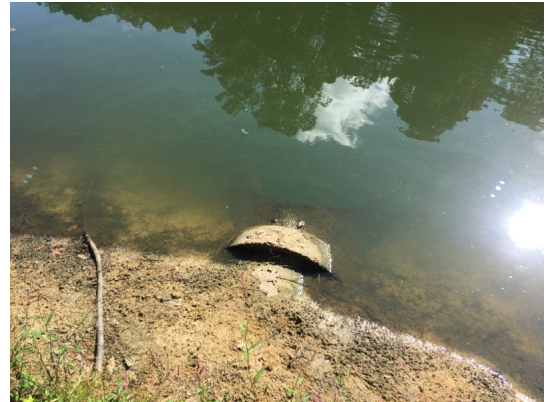
Noted Image 1

Trash was removed from the system and the pond was treated for planktonic algae. The air filter was cleaned for the compressor. Recommend replacing the air filter to improve functionality. Noted image 1 shows a secondary inlet. Noted image 2 shows exposed soil along the pond slope near the road. Noted image 3 shows the air filter for the aeration compressor. Noted image 4 shows exposed soil. Noted image 5 shows exposed soil along the pond slope due to extended periods of high water. Noted image 6 shows exposed aeration lines.

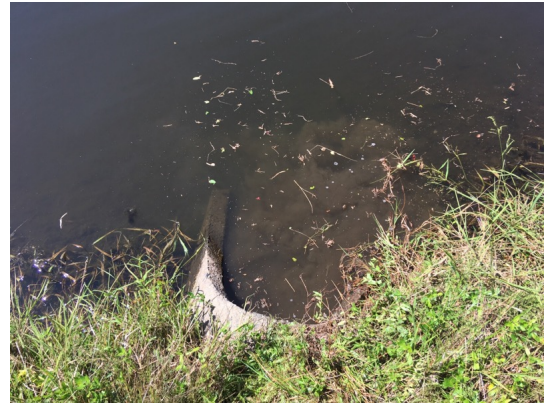
Noted Image 1

Trash was removed from the system and the air compressor filter was cleaned. Recommend replacing the filter. Noted image 1 shows a secondary inlet. Noted image 2 shows exposed soil. Noted image 3 shows the air filter for the aeration system. Noted image 4 shows an area recommended to be weed eaten.

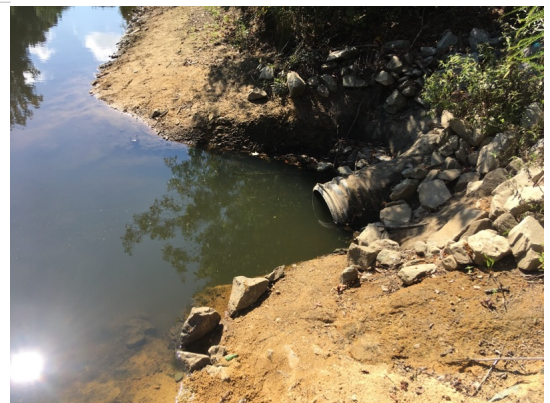
Noted Image 1

Trash was removed from the system and the pond was treated for planktonic algae. Sediment build up at the creek inlet. Noted images 1 and 2 show secondary inlets. Noted image 3 shows the creek inlet with sedimentation. Noted image 4 shows shows sedimentation at the corrugated pipe inlet. Noted image 5 shows a fallen tree at the outlet. Noted image 6 shows a secondary inlet. Noted image 7 shows exposed soil along the shoreline due to extended periods of high water.
