DRAGONFLY MAINTENANCE REPORT

Property	SOUTHERN VILLAGE
Service Date	02/19/2020
Crew Member(s)	Will Feely
Client Name	Adam Jones
Client Email Address	adam@millhouseproperties.com
Client Email Address 2	
Client Email Address 3	
Client Email Address 4	
Number of Ponds & Pond Type	4 Wet Ponds
Mowing Schedule	2 Mowings Per Year
Mowing Service	
Mowing occurs inside of the fence.	
Special Instructions	
Pond 4 #1234	
Pond Locations	https://imageshack.com...

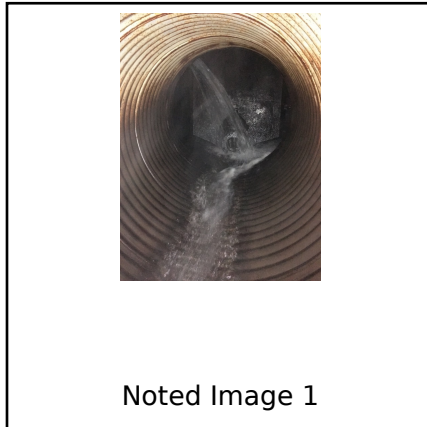
Trash was removed from the system and the drawdown was cleared of debris. Noted image 1 shows the inside of the riser with the drawdown draining properly. Noted image 2 shows an additional stormwater pipe in the outlet area. Noted images 3 and 4 show areas of bare soil around the shoreline. Noted image 5 shows a secondary inlet.

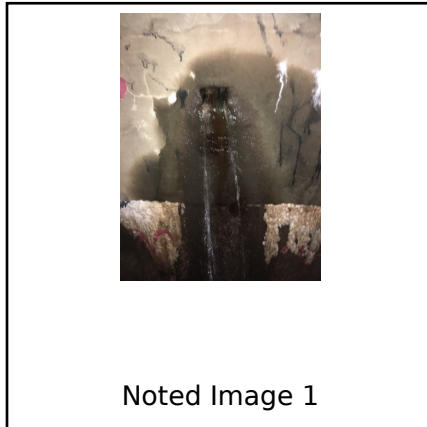
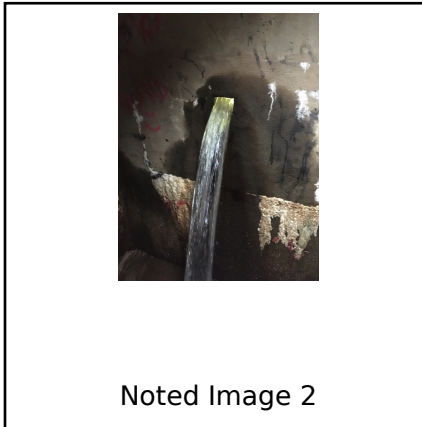
Trash was removed from the system and the drawdown was unclogged. The air filter for the compressor was cleaned. Noted images 1 and 2 show the drawdown before and after clearing the obstruction. Noted image 3 shows the compressor box. Noted image 4 show areas of bare soil that extend around the shoreline. Noted image 5 shows small leaks and rust damage in the outlet pipe.

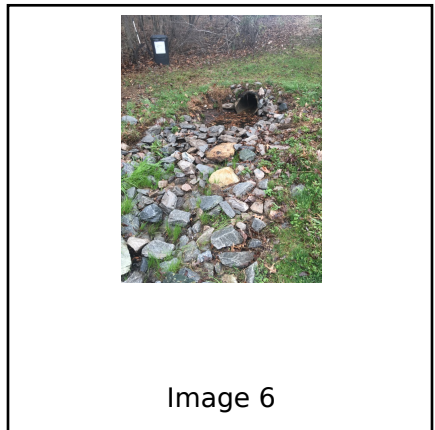
Trash was removed from the system and leaves were cleared from the inlet. The drawdown was unclogged. High water level due to rain events and an obstructed drawdown. Noted images 1 and 2 show the drawdown before and after removing the obstruction. Noted image 3 shows a fallen tree at the outlet area. Noted images 4 through 6 show secondary inlets. Noted image 7 shows a dead tree along the backside of the dam.
