Dragonfly Pond Works
 1-877-POND-WRX
 info@dragonflypondworks.com

Dragonfly Maintenance Report

Property	SOUTHERN VILLAGE
Client Name	Adam Jones
Client Email Address	adam@millhouseproperties.com
Client Email Address 2	
Client Email Address 3	
Client Email Address 4	
Number of Ponds & Pond Type	4 Wet Ponds
Service Type	
Standard	
Mowing Schedule	2 Mowings Per Year
Mowing Service	
Mowing occurs inside of the fence.	
Special Instructions	
Pond 4 #2020	
Pond Locations	https://imageshack.com...

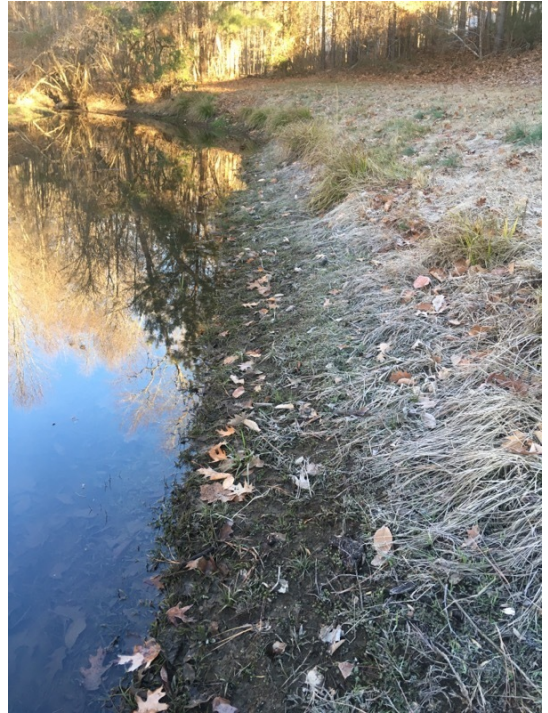
Noted Image 2

Trash was removed from the system. Images 1 and 2 show bare soil on the shoreline. Image 3 shows sediment build up near inlet. Image 4 shows erosion on the slope near the inlet. Image 5 shows minor shoreline erosion along pond slope. Image 6 shows an additional inlet by the riser. Noted Image 1

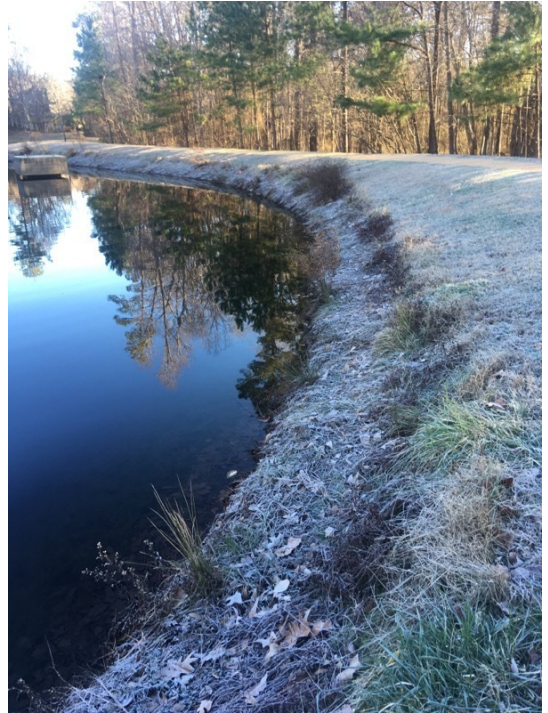
Noted Image 1

Trash was removed from the system. Image 1 shows bare soil around the shoreline. Image 2 shows the compressor box. Image 3 shows a large rut on the slope near the road.

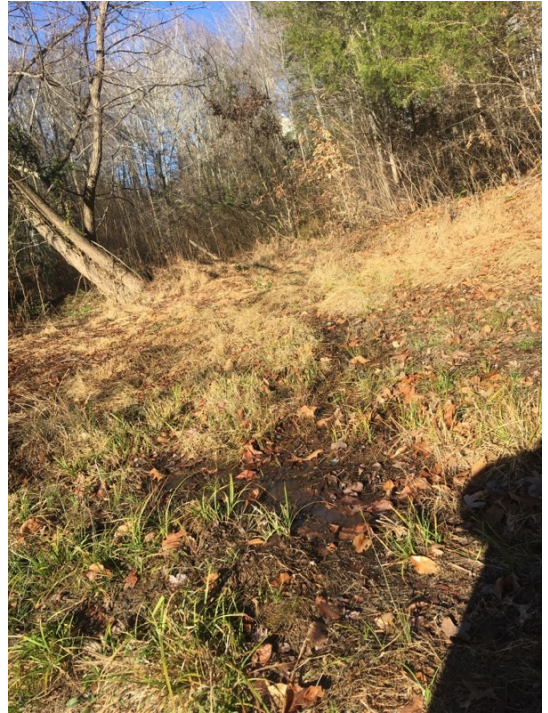
Noted Image 1

Trash was removed from from the system. Image 1 shows channeling to the right of the primary inlet. Images 2-4 show secondary inlets. Image 5 shows exposed soil on backside of the dam. Image 6-7 show before and after unclogging the drawdown in the riser.

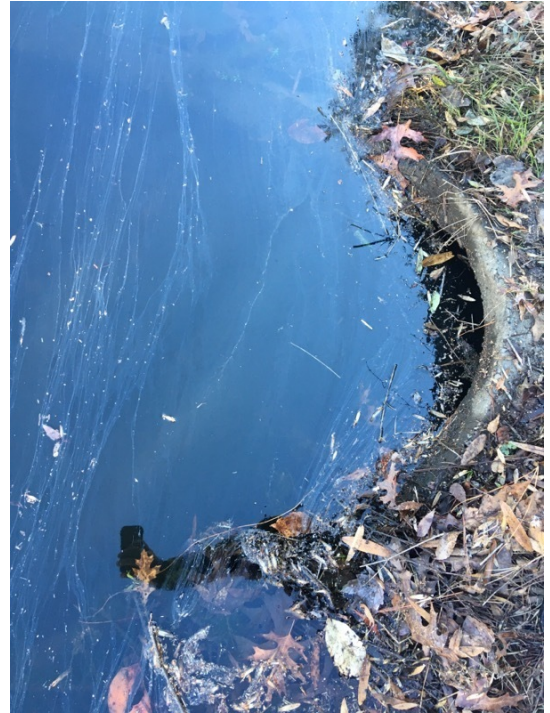
Noted Image 1

Trash was removed from the system. Images 1-2 show secondary inlets. Images 3-4 show areas of shoreline erosion.
