DRAGONFLY MAINTENANCE REPORT

Property	SOUTHERN VILLAGE
Service Date	03/19/2020
Crew Member(s)	WF
Client Name	Adam Jones
Client Email Address	adam@millhouseproperties.com
Client Email Address 2	patsy@millhouseproperties.com
Client Email Address 3	
Client Email Address 4	
Number of Ponds & Pond Type	4 Wet Ponds
Mowing Schedule	2 Mowings Per Year
Mowing Service	
Mowing occurs inside of the fence.	
Special Instructions	
Pond 4 #1234	
Pond Locations	https://imageshack.com...

Pond Name	WP 1
Access Address	1200 Highgrove Dr Chapel Hill, NC 27516
Trash Pickup	SC= Service Completed
Treat Invasives	M= Monitoring (for any potential future problems)
Inlet service	WN= Work Needed
Outlet Service	M= Monitoring (for any potential future problems)
Unclog Drain	M= Monitoring (for any potential future problems)
Clean Riser/Trash rack	M= Monitoring (for any potential future problems)
Add Dye?	N/A= Not Applicable
Fountain/Aerator Condition	N/A= Not Applicable
Mow/Weed eat	M= Monitoring (for any potential future problems)

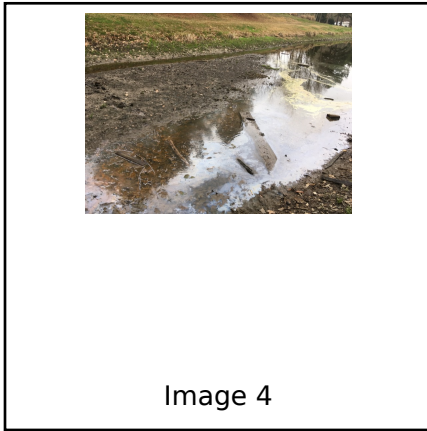
Trash was removed from the system and woody debris was removed from the shoreline. Noted images 1 and 2 show secondary inlets. Noted images 3 and 4 show the sediment delta in the head section.

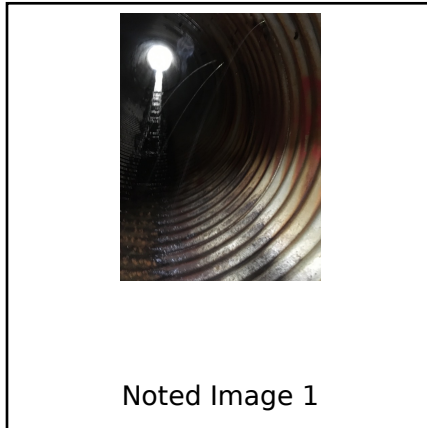
Trash was removed from the system and the drawdown was cleared of debris. Noted image 1 shows leaks in the outlet pipe. Noted image 2 shows disturbed soil along the pond slope. Noted image 3 shows exposed soil on the shoreline. Noted image 4 shows a secondary inlet.

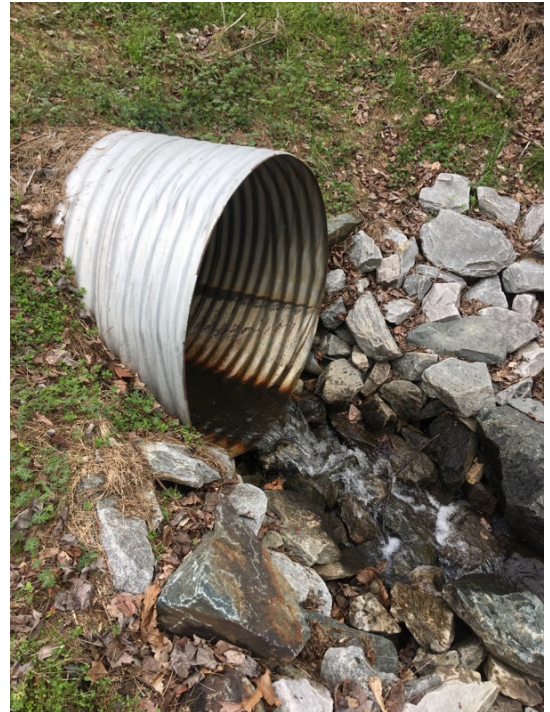
Pond Name	WP 3
Access Address	111 Parkside Cir Chapel Hill, NC 27516
Trash Pickup	SC= Service Completed
Treat Invasives	SC= Service Completed
Invasives Treated (where applicable)	Terrestrial weeds
Inlet service	SC= Service Completed
Outlet Service	WN= Work Needed
Unclog Drain	SC= Service Completed
Clean Riser/Trash rack	M= Monitoring (for any potential future problems)
Add Dye?	N/A= Not Applicable
Fountain/Aerator Condition	N/A= Not Applicable
Mow/Weed eat	M= Monitoring (for any potential future problems)

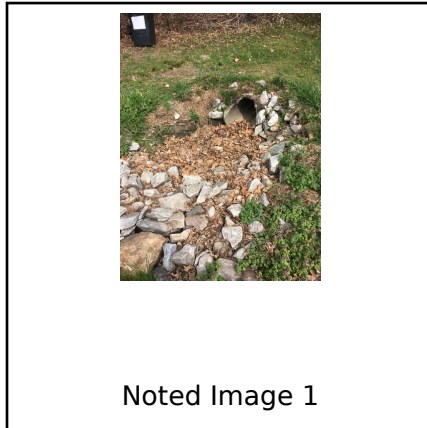
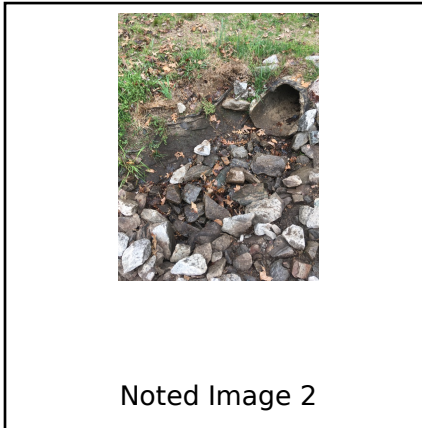
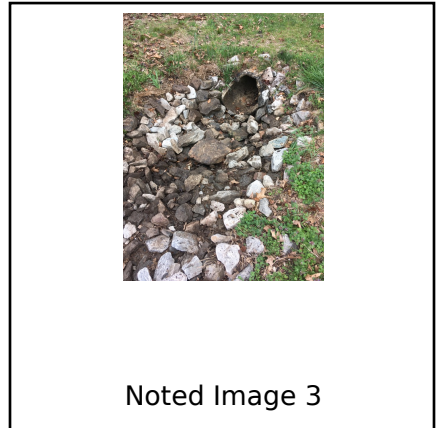
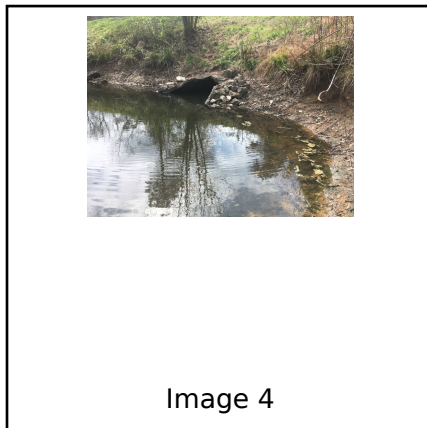
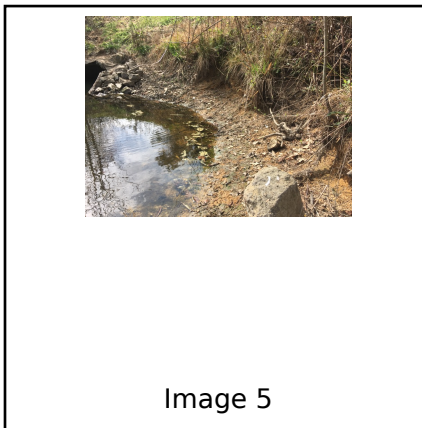
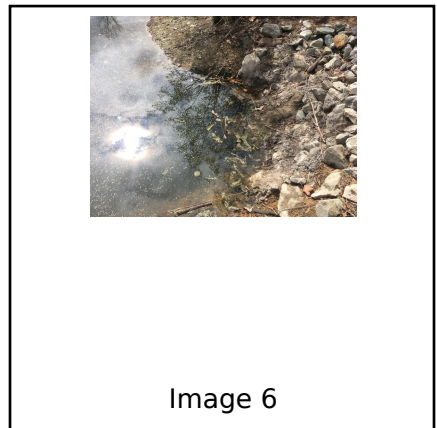
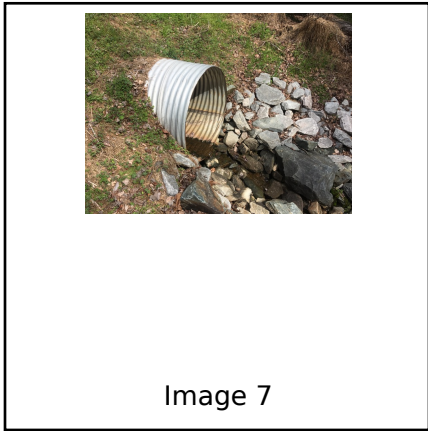
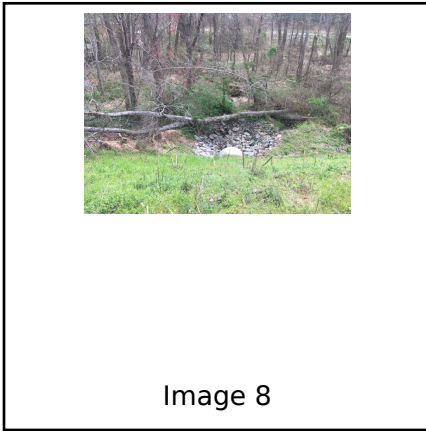
Trash was removed from the system. Unclogged the drawdown to restore normal water flow. Sediment deposition and washout persists at the creek inlet. Recommend additional riprap and T-bars to prevent washout. Noted image 1 shows the secondary inlet. Noted image 2 shows this inlet after the leaves were cleared. Noted through 3 show this inlet after the riprap was rearranged in order to cover the bare areas. Noted images 4 and 5 show a secondary inlet with exposed soil around the shoreline. Noted image 6 shows a secondary submerged inlet. Noted image 7 shows the outlet before unclogging the drawdown. Noted image 8 shows a large fallen tree at the outlet.
