DRAGONFLY MAINTENANCE REPORT

Property	SOUTHERN VILLAGE
Service Date	05/26/2020
Crew Member(s)	WF
Client Name	Adam Jones
Client Email Address	adam@millhouseproperties.com
Client Email Address 2	patsy@millhouseproperties.com
Client Email Address 3	
Client Email Address 4	
Number of Ponds & Pond Type	4 Wet Ponds
Mowing Schedule	2 Mowings Per Year
Mowing Service	
Mowing occurs inside of the fence.	
Special Instructions	
Pond 4 #1234	
Pond Locations	https://imageshack.com...

Pond Name	WP 1
Access Address	1200 Highgrove Dr Chapel Hill, NC 27516
Trash Pickup	SC= Service Completed
Treat Invasives	M= Monitoring (for any potential future problems)
Inlet service	WN= Work Needed
Outlet Service	M= Monitoring (for any potential future problems)
Unclog Drain	M= Monitoring (for any potential future problems)
Clean Riser/Trash rack	M= Monitoring (for any potential future problems)
Add Dye?	N/A= Not Applicable
Fountain/Aerator Condition	N/A= Not Applicable
Mow/Weed eat	M= Monitoring (for any potential future problems)

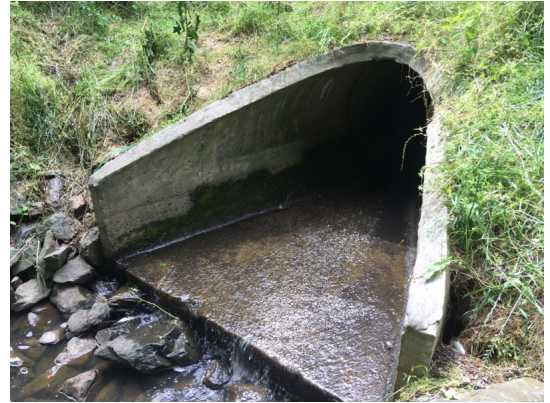
Outlet

Trash was removed from the system. Leaks in the outlet pipe along the manhole access junction persist. Noted image 1 shows the manhole access. Noted image 2 shows an additional outlet. Noted images 3 and 4 show the sediment delta at the creek inlet. Noted image 5 shows some of the woody debris washed in from the recent rainfall. Noted image 6 shows an abundance of vegetation along the backside of the dam recommended to be mowed.

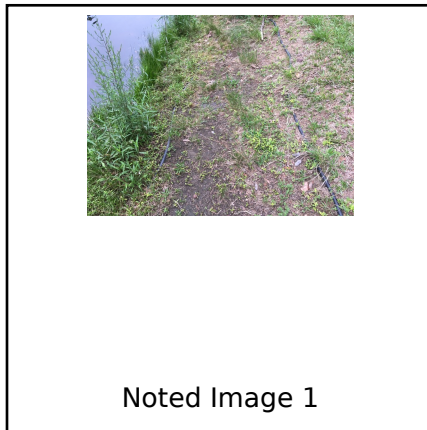
Trash was removed from the system. The air compressor filter was cleaned. Noted image 1 shows exposed aeration line in the pond bank. Noted image 2 shows erosion along the outlet. Noted image 3 shows disturbed areas along the shoreline. Noted image 4 shows an additional submerged inlet. Noted image 5 shows leaks in the outlet pipe that persist.

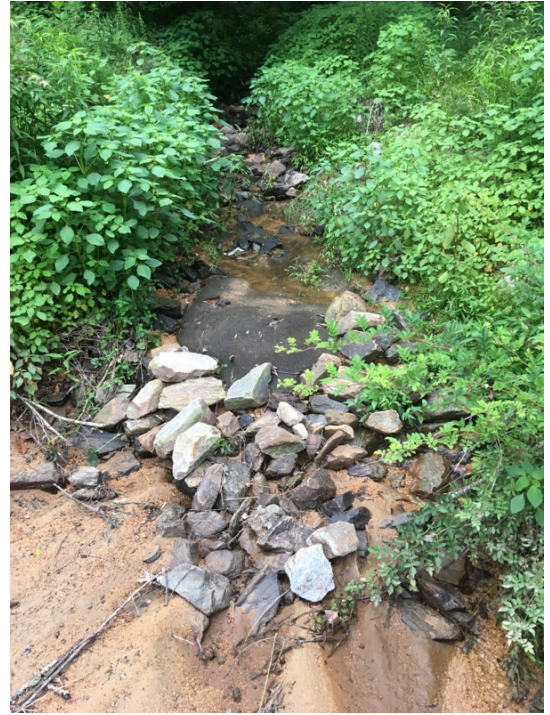
Inlet

Trash was removed from the system. Terrestrial weeds were treated around the riprap at the inlets. Recommend mowing the system to improve access and visibility. The inlet image shows washout in the riprap inlet. Noted images 1 through 4 show additional inlets. Noted image 5 shows sediment accumulation at the primary inlet. Noted image 6 shows tall grass around the shoreline.
