### DRAGONFLY MAINTENANCE REPORT

Property	SOUTHERN VILLAGE
Service Date	06/25/2020
Crew Member(s)	WF
Client Name	Adam Jones
Client Email Address	adam@millhouseproperties.com
Client Email Address 2	patsy@millhouseproperties.com
Client Email Address 3	
Client Email Address 4	
Number of Ponds & Pond Type	4 Wet Ponds
Mowing Schedule	2 Mowings Per Year
Mowing Service	
Mowing occurs inside of the fence.	
Special Instructions	
Pond 4 #1234	
Pond Locations	<a href="https://imageshack.com...">https://imageshack.com...</a>

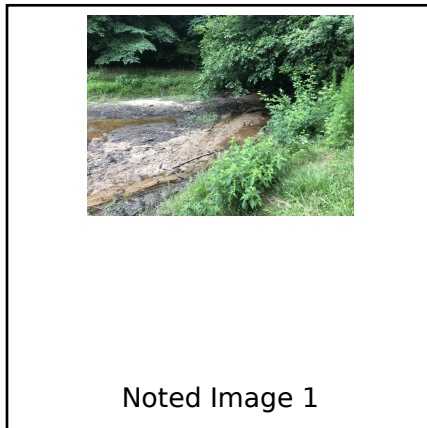
Trash was removed from the system and woody debris was removed from from the shoreline. Recommend mowing the dam and clearing the trees along the shoreline for saplings to improve access. Noted image 1 shows a sediment delta at the creek inlet. Noted images 2 and 3 show additional inlets. Noted image 4 shows shoreline erosion in the head section. Noted image 5 shows the manhole. Leaks along the outlet and junction persist. Noted image 6 shows one of multiple willows along the shoreline. Noted image 7 shows bare soil around the shoreline.

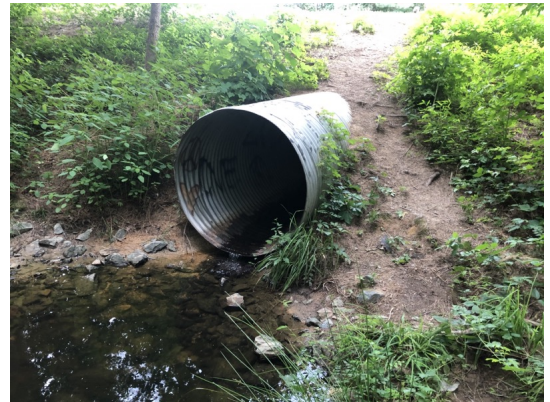
Outlet

Trash was removed from the system and the filter for the air compressor was cleared of debris. Beneficial bacteria was added to the pond. Woody vegetation was hand pulled around the shoreline. Leaks persist along the outlet pipe. Noted image 1 shows bare soil on the slope. Noted image 2 shows exposed aeration line in the bank. Noted image 3 shows exposed soil on the slope. Noted image 4 shows one of multiple iris planted along the shoreline. Noted image 5 shows an area of exposed soil.

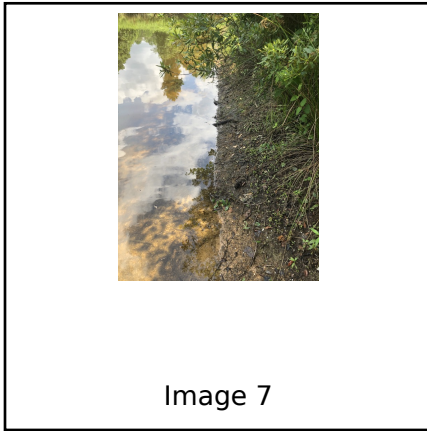
Image 7

Trash was removed from the system. Recommend mowing the dam. Noted images 1 and 2 show disturbed soil around the shoreline. Noted image 3 shows sediment at the primary inlet. Noted images 4 through 6 show secondary inlets. Noted image 7 shows exposed soil around the shoreline. Noted image 8 shows an additional inlet. The fallen tree at the outlet persists.
