DRAGONFLY MAINTENANCE REPORT

Property	SOUTHERN VILLAGE
Service Date	07/23/2020
Crew Member(s)	WF GW
Client Name	Adam Jones
Client Email Address	adam@millhouseproperties.com
Client Email Address 2	patsy@millhouseproperties.com
Client Email Address 3	
Client Email Address 4	
Number of Ponds & Pond Type	4 Wet Ponds
Mowing Schedule	2 Mowings Per Year
Mowing Service	
Mowing occurs inside of the fence.	
Special Instructions	
Pond 4 #1234	
Pond Locations	https://imageshack.com...

Pond Name	WP 1
Access Address	1200 Highgrove Dr Chapel Hill, NC 27516
Trash Pickup	SC= Service Completed
Treat Invasives	SC= Service Completed
Invasives Treated (where applicable)	Filamentous algae, planktonic algae, terrestrial weeds
Inlet service	WN= Work Needed
Outlet Service	M= Monitoring (for any potential future problems)
Unclog Drain	M= Monitoring (for any potential future problems)
Clean Riser/Trash rack	M= Monitoring (for any potential future problems)
Add Dye?	N/A= Not Applicable
Fountain/Aerator Condition	N/A= Not Applicable
Mow/Weed eat	WN= Work Needed

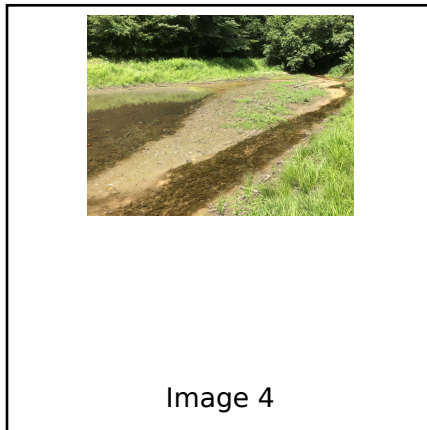
Trash was removed from the system. Mowing needed on the backside of the dam. Noted image 1 shows an additional outlet. Noted image 2 shows an additional inlet. Noted image 3 shows a creek inlet. Noted image 4 shows sediment deposition in the head section. Noted images 5 and 6 show bare soil around the shoreline. Image 7 shows one of the numerous willows surrounding the basin. Figure 8 shows the draw down clear of debris.

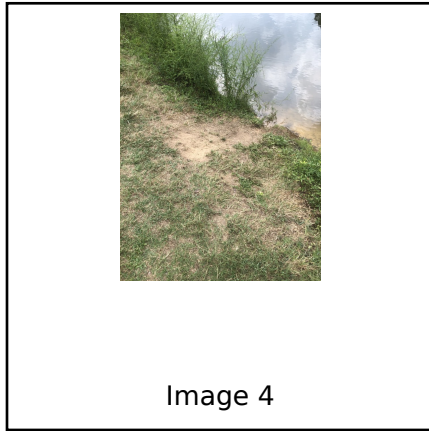
Image 4

Removed trash from the system and inspected the inside of the riser. Noted image 1 shows leaks in the outlet pipe. Noted image 2 shows an additional inlet. Noted image 3 shows bare soil around the outlet pipe. Noted images 4, 5, and 6 show bare soil around the shoreline.

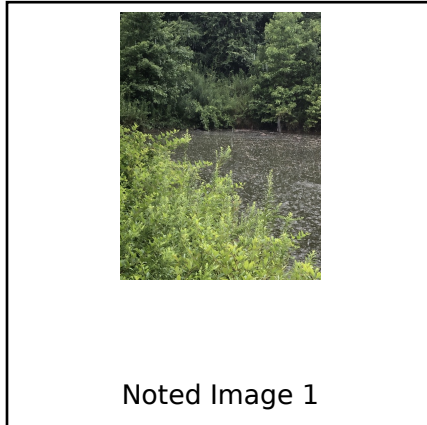
Removed trash from the system. Unclogged the drawdown to restore water flow. Image 1 shows an additional inlet. Image 2 shows erosion and sediment deposits near the creek inlet. Image 3 shows an additional inlet. Image 4 shows woody vegetation and a fallen tree at the backside of the dam.
