DRAGONFLY MAINTENANCE REPORT

Property	SOUTHERN VILLAGE
Service Date	08/25/2020
Crew Member(s)	WF GW
Client Name	Adam Jones
Client Email Address	adam@millhouseproperties.com
Client Email Address 2	patsy@millhouseproperties.com
Client Email Address 3	
Client Email Address 4	
Number of Ponds & Pond Type	4 Wet Ponds
Mowing Schedule	2 Mowings Per Year
Mowing Service	
Mowing occurs inside of the fence.	
Special Instructions	
Pond 4 #1234	
Pond Locations	https://imageshack.com...

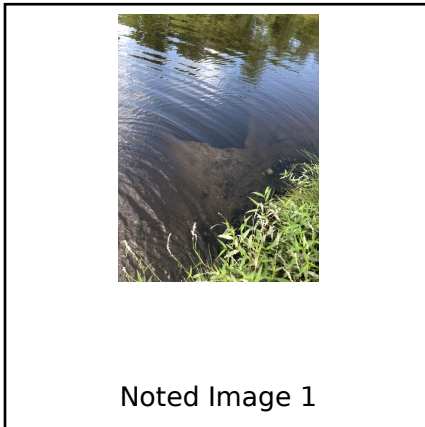
Trash was removed from the system and the system was treated for planktonic algae. Beneficial bacteria was added to the wet pond. Noted images 1 and 2 show secondary inlets. Noted image 3 shows sedimentation and erosion at the creek inlet due to extended periods of high water. Noted image 4 shows sedimentation and planktonic algae. Noted image 5 shows the manhole for the riser access. Slow leaks in the outlet pipe junction and access hatch persist.

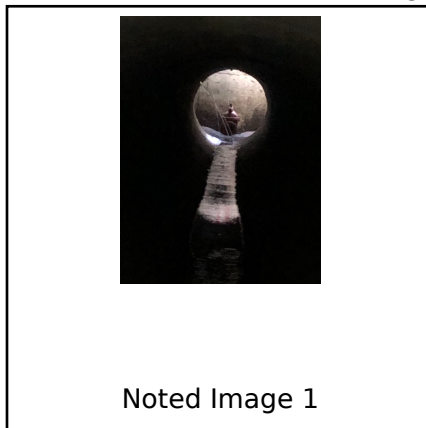
Trash was removed from the system and the riprap at the outlet was treated for terrestrial weeds. The drawdown was unclogged. Noted image 1 shows leaks in the outlet pipe. Noted image 2 shows a disturbed area. Noted image 3 shows washout along the path due to runoff.

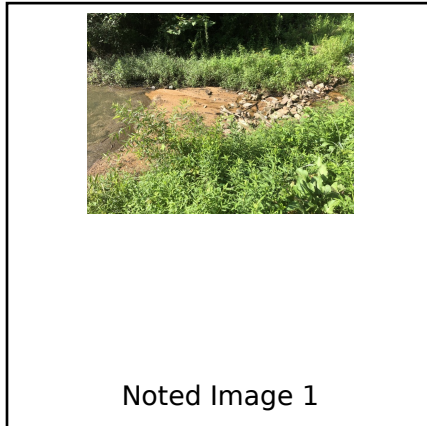
Trash was removed from the system and the riprap at the inlets and the outlet was treated for terrestrial weeds. Highly recommend mowing and creating an access path through the wooded side to improve access and visibility. Recommend dredging around the riser to minimize clogging of the drawdown. Noted image 1 shows erosion and sedimentation along the creek inlet. Noted images 2 through 4 show secondary inlets.
