### DRAGONFLY MAINTENANCE REPORT

Property	SOUTHERN VILLAGE
Service Date	09/21/2020
Crew Member(s)	WF GW
Client Name	Adam Jones
Client Email Address	adam@millhouseproperties.com
Client Email Address 2	patsy@millhouseproperties.com
Client Email Address 3	
Client Email Address 4	
Number of Ponds & Pond Type	4 Wet Ponds
Mowing Schedule	2 Mowings Per Year
Mowing Service	
Mowing occurs inside of the fence.	
Special Instructions	
Pond 4 #1234	
Pond Locations	<a href="https://imageshack.com...">https://imageshack.com...</a>

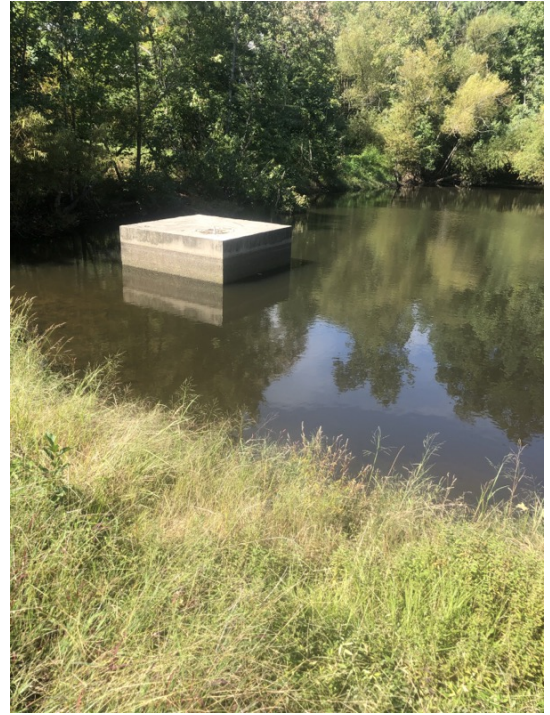
Riser

Trash was removed from the system and the wet pond was treated for planktonic algae. Woody vegetation was hand pulled from the buffer. Recommend regular mowing to control the woody vegetation. Noted image 1 shows a secondary outlet. Noted images 2 and 3 show secondary inlets. Noted image 4 shows shoreline erosion. Noted image 5 shows the riser manhole access. Leaks within the junction persist.

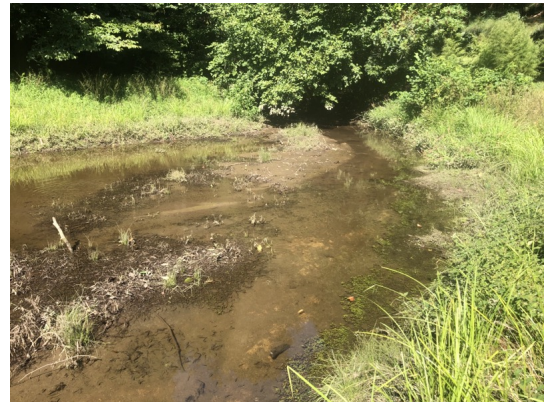
Pond Name	WP 1
Access Address	1200 Highgrove Dr Chapel Hill, NC 27516
Trash Pickup	SC= Service Completed
Treat Invasives	SC= Service Completed
Invasives Treated (where applicable)	Planktonic algae and saplings
Inlet service	WN= Work Needed
Outlet Service	M= Monitoring (for any potential future problems)
Unclog Drain	M= Monitoring (for any potential future problems)
Clean Riser/Trash rack	M= Monitoring (for any potential future problems)
Add Dye?	N/A= Not Applicable
Fountain/Aerator Condition	N/A= Not Applicable
Mow/Weed eat	M= Monitoring (for any potential future problems)

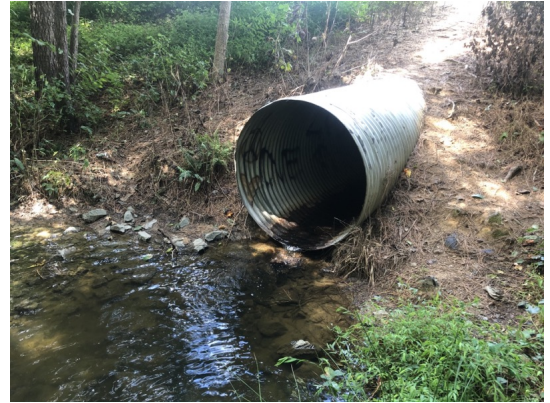
Outlet

Trash was removed from the system and the riprap areas were treated for terrestrial weeds. Leaks along the outlet pipe persist. The air filter in the compressor was cleaned. Noted image 1 shows a secondary inlet. Noted image 2 shows an exposed aeration line. Noted image 3 shows an area of exposed soil.

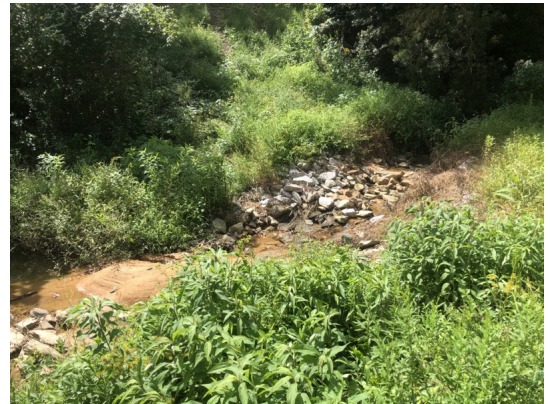
Inlet

Trash was removed from the system and the riprap areas were treated for terrestrial weeds. The wet pond was treated for planktonic algae. Recommend regular mowing. The inlet image shows washout, sedimentation and erosion. Recommend reconstructing the creek inlet. Noted image 2 shows washout and exposed tarp at the creek inlet. Noted images 3 and 4 show secondary inlets.
