### DRAGONFLY MAINTENANCE REPORT

Property	SOUTHERN VILLAGE
Service Date	01/14/2021
Crew Member(s)	WF, DG
Client Name	Adam Jones
Client Email Address	adam@millhouseproperties.com
Client Email Address 2	patsy@millhouseproperties.com
Client Email Address 3	
Client Email Address 4	
Number of Ponds & Pond Type	4 Wet Ponds
Mowing Schedule	2 Mowings Per Year
Mowing Service	
Mowing occurs inside of the fence.	
Special Instructions	
Pond 4 #1234	
Pond Locations	<a href="https://imageshack.com...">https://imageshack.com...</a>

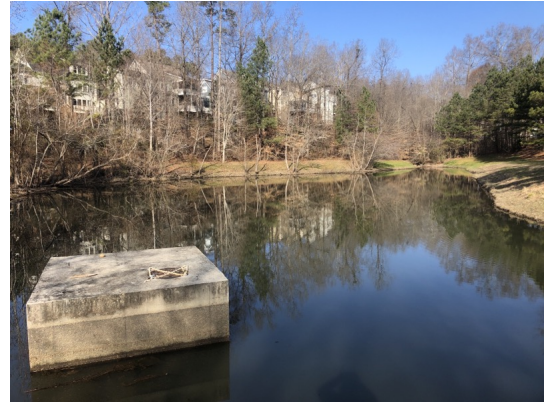
Overview of the pond

Trash and debris were removed from the system. Erosion can be seen along the shoreline due to extended periods of high water. Noted image 1 shows sedimentation in the creek inlet. Noted image 2 shows a secondary submerged inlet. Noted images 3 and 4 show slow leaks inside the access hatch.

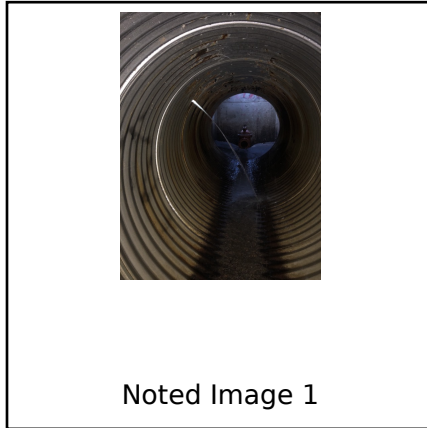
Noted Image 1

Trash was removed from the system. Noted image 1 shows a leak in the outlet pipe close to the riser. Noted image 2 shows a secondary submerged inlet. Noted image 3 shows a rut in the slope beside the road. The tubes for the aerator were buried.

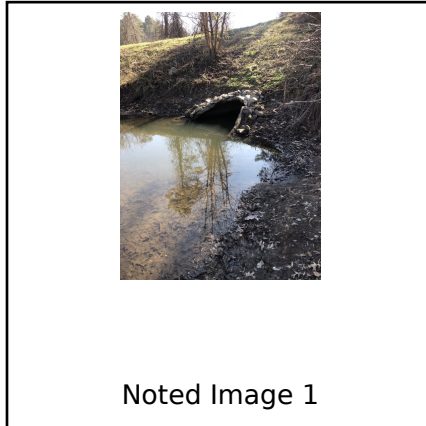
Trash was removed from the system. Erosion along the shoreline persists due to extended periods of high water and a clogged drawdown. Sediment build up can be seen at the creek inlet. Noted images 1 through 4 show the secondary inlets. The inlet shown in image 1 shows chips in the FES. The inlet in image 2 shows sedimentation.

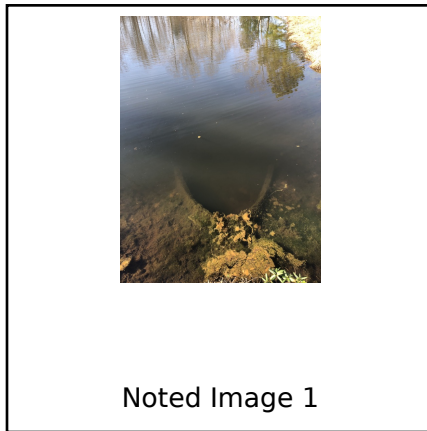
Noted Image 1

Trash was removed from the system. Erosion along the shoreline persists due to periods of high water. Noted 1 and 2 show secondary submerged inlets. Noted image 3 shows after woody vegetation was cleared along the shoreline to improve access to the system. Noted image 4 shows saturated soil.
