### DRAGONFLY MAINTENANCE REPORT

Property	SOUTHERN VILLAGE
Service Date	04/23/2021
Crew Member(s)	GW
Client Name	Adam Jones
Client Email Address	adam@millhouseproperties.com
Client Email Address 2	patsy@millhouseproperties.com
Client Email Address 3	
Client Email Address 4	
Number of Ponds & Pond Type	4 Wet Ponds
Mowing Schedule	2 Mowings Per Year
Mowing Service	
Mowing occurs inside of the fence.	
Special Instructions	
Lock combination for Wet Pond #4 is 5150	
Pond Locations	<a href="https://imageshack.com...">https://imageshack.com...</a>

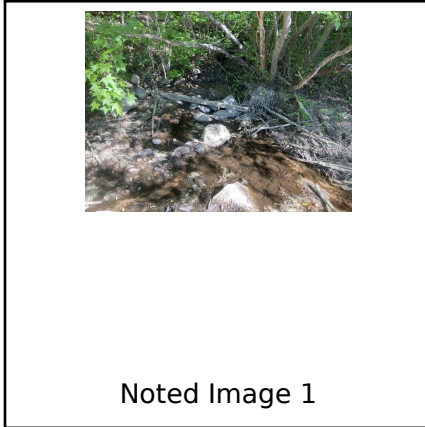
Removed trash from the system and treated terrestrial weeds and filamentous algae. Noted image 1 shows the creek inlet. System would benefit from mowing.

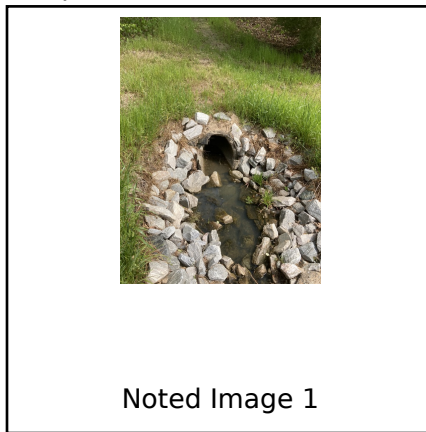
Removed trash from the system and blew debris from the riprap inlet. Noted images 1 and 2 show additional inlets. Noted image 3 shows the riprap inlet; note the washout of the rocks and the exposed fabric.
