DRAGONFLY MAINTENANCE REPORT

Property	SOUTHERN VILLAGE
Service Date	05/28/2021
Crew Member(s)	GW
Client Name	Adam Jones
Client Email Address	adam@millhouseproperties.com
Client Email Address 2	patsy@millhouseproperties.com
Client Email Address 3	
Client Email Address 4	
Number of Ponds & Pond Type	4 Wet Ponds
Mowing Schedule	2 Mowings Per Year
Mowing Service	
Mowing occurs inside of the fence.	
Special Instructions	
Lock combination for Wet Pond #4 is 5150	
Pond Locations	http://

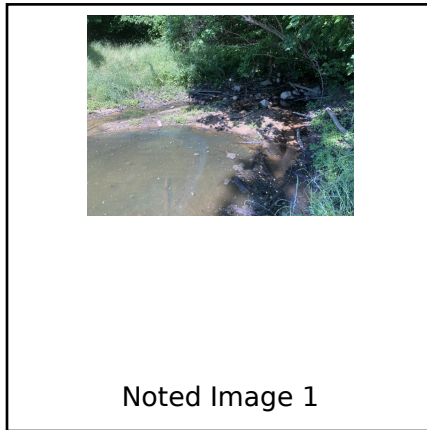
Removed trash from the system and treated terrestrial weeds and woody vegetation. Noted image 1 shows a creek inlet that is depositing sediment in the system, will continue to monitor. Image 2 shows an additional inlet.

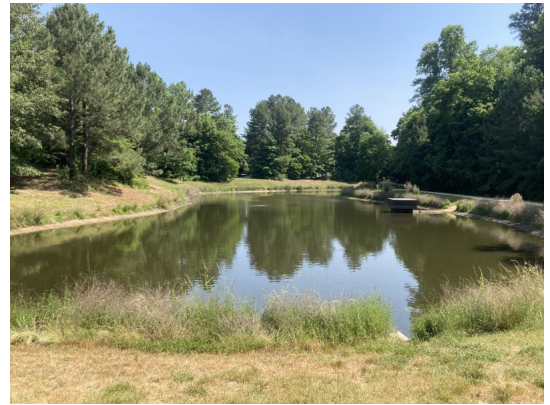
Outlet Service	SC= Service Completed
Unclog Drain	M= Monitoring (for any potential future problems)
Clean Riser/Trash rack	M= Monitoring (for any potential future problems)
Add Dye?	N/A= Not Applicable
Fountain/Aerator Condition	M= Monitoring (for any potential future problems)
Mow/Weed eat	M= Monitoring (for any potential future problems)
Overview of the pond	M= Monitoring (for any potential future problems)

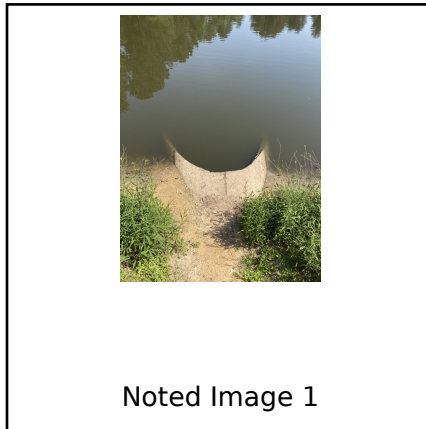
Removed trash from the system and treated terrestrial weeds and woody vegetation. Water level is slightly low due to lack of rain in the area. Noted image 1 shows an additional inlet.

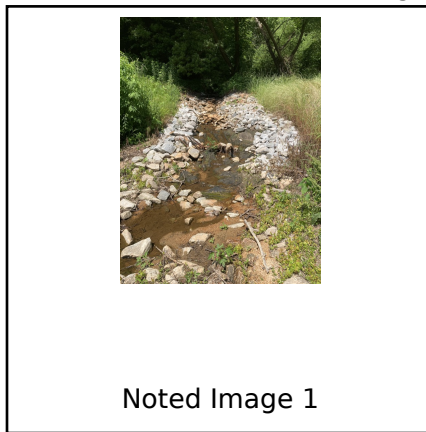
Removed trash from the system and treated terrestrial weeds. Water level is slightly low due to drought conditions. Noted image 1 shows a creek inlet that would benefit from additional riprap to cover the fabric. Noted images 2 and 3 show additional inlets.
