DRAGONFLY MAINTENANCE REPORT

| Property | SOUTHERN VILLAGE |
| Service Date | 07/26/2021 |
| Number of Ponds & Pond Type | 4 Wet Ponds |

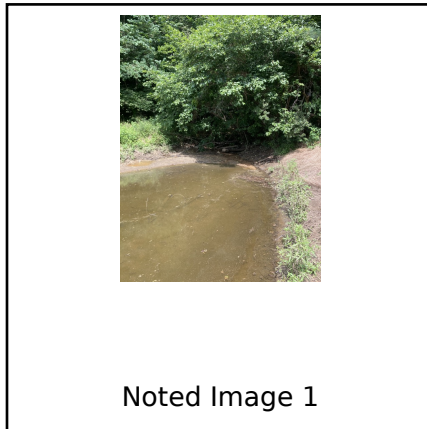
Removed trash from the system and treated terrestrial weeds and woody vegetation. Noted image 1 shows an additional creek inlet.

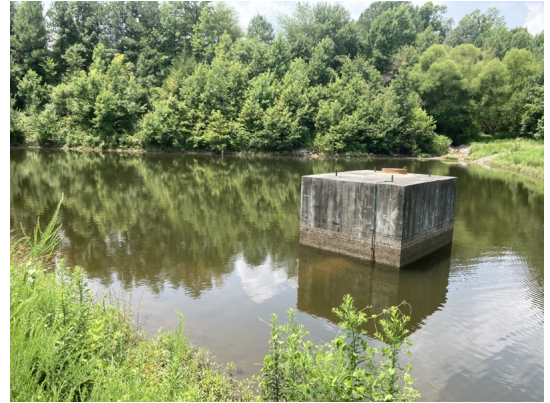
Overview of the pond

| Mow/Weed eat | WN= Work Needed |

Removed trash from the system and treated terrestrial weeds and woody vegetation. System would benefit from more frequent mowing. Noted image 1 shows an additional inlet with exposed fabric. Noted images 2 and 3 show additional inlets.
