Client Log - Triangle

Date: 08/03/2018

Dragonfly Maintenance Report

Property	SOUTHERN VILLAGE
Client Name	Patsy Smith, Tony Smith
Client Email Address	patsysmith7077@gmail.com
Client Email Address 2	tony@berkeleychapelhill.com
Client Email Address 3	
Client Email Address 4	
Number of Ponds & Pond Type	4 Wet Ponds
Service Type	
Standard	
Mowing Schedule	2 Mowings Per Year
Mowing Service	
Mowing occurs inside of the fence.	
Special Instructions	
None	
Pond Locations	https://imageshack.com...

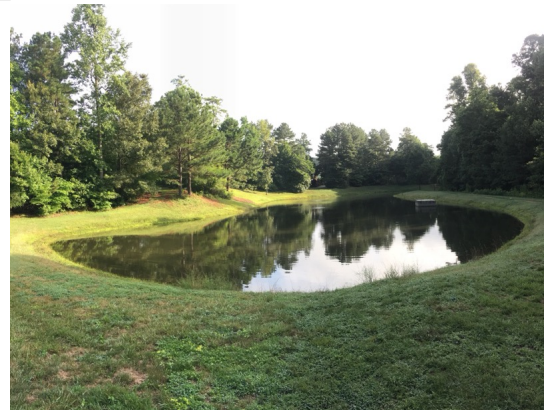
Pond Name	WP 2
Access Address	400 Market St, Chaple Hill, NC
Service Date	07/26/2018
Trash Pickup	SC= Service Completed
Treat Invasives	SC= Service Completed
Inlet service	SC= Service Completed
Outlet Service	SC= Service Completed
Unclog Drain	NN= Service Not Needed
Clean Riser/Trash rack	SC= Service Completed
Add Dye?	NN= Service Not Needed
Fountain/Aerator Condition	FF= Fully Functional
Mow/Weed eat	NN= Service Not Needed
Overview of the pond

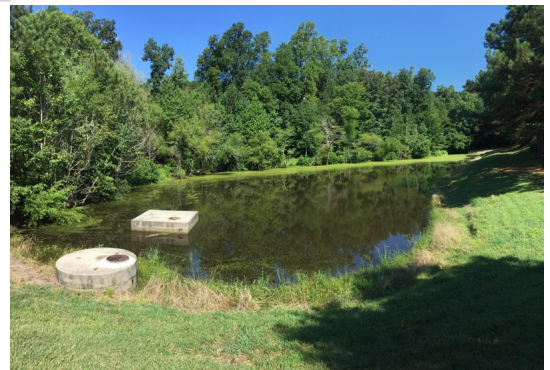
Pond Name	WP 1
Access Address	400 Market St, Chaple Hill, NC
Service Date	07/26/2018
Trash Pickup	SC= Service Completed
Treat Invasives	SC= Service Completed
Inlet service	SC= Service Completed
Outlet Service	SC= Service Completed
Unclog Drain	NN= Service Not Needed
Clean Riser/Trash rack	SC= Service Completed
Add Dye?	NN= Service Not Needed
Fountain/Aerator Condition	N/A= Not Applicable
Mow/Weed eat	NN= Service Not Needed
Overview of the pond

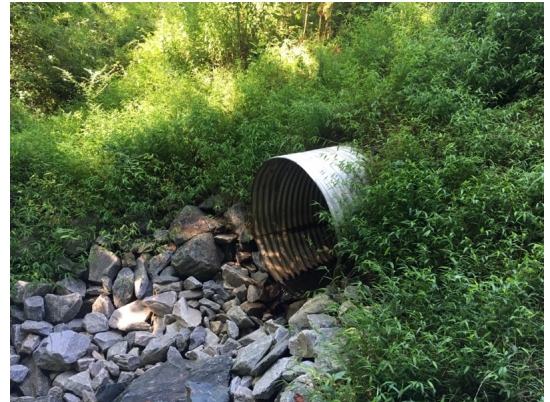
Outlet

Image 1 shows erosion caused by an additional inlet source where rip rap may be needed. Images 2 and 3 show before and after rip rap was rearranged to cover exposed matting. Images 4-6 show the additional inlets. Image 7 shows bare soil on the slope where vegetation is needed. Invasive vegetation in the rip rap was treated. Water level was above drawdown height upon arrival but seems to be draining efficiently.
