Client Log - Triangle

Date: 08/31/2018

### Dragonfly Maintenance Report

Property	SOUTHERN VILLAGE
Client Name	Patsy Smith, Tony Smith
Client Email Address	patsysmith7077@gmail.com
Client Email Address 2	tony@berkeleychapelhill.com
Client Email Address 3	
Client Email Address 4	
Number of Ponds & Pond Type	4 Wet Ponds
Service Type	
Standard	
Mowing Schedule	2 Mowings Per Year
Mowing Service	
Mowing occurs inside of the fence.	
Special Instructions	
Pond 4 #5150	
Pond Locations	<a href="https://imageshack.com...">https://imageshack.com...</a>

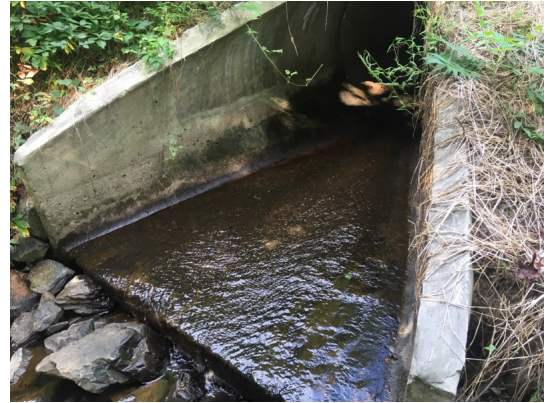
Outlet

Treated aggressively for invasive aquatic vegetation. Treated the rip rap for invasive vegetation. Image of the dam shows bare soil spots where vegetation is needed. Image 1 shows where mowing is needed above the outlet.
