Client Log - Triangle

Dragonfly Maintenance Report

Property	SOUTHERN VILLAGE
Client Name	Patsy Smith, Tony Smith
Client Email Address	patsysmith7077@gmail.com
Client Email Address 2	tony@berkeleychapelhill.com
Client Email Address 3	
Client Email Address 4	
Number of Ponds & Pond Type	4 Wet Ponds
Service Type	
Standard	
Mowing Schedule	2 Mowings Per Year
Mowing Service	
Mowing occurs inside of the fence.	
Special Instructions	
Pond 4 #5150	
Pond Locations	https://imageshack.com...

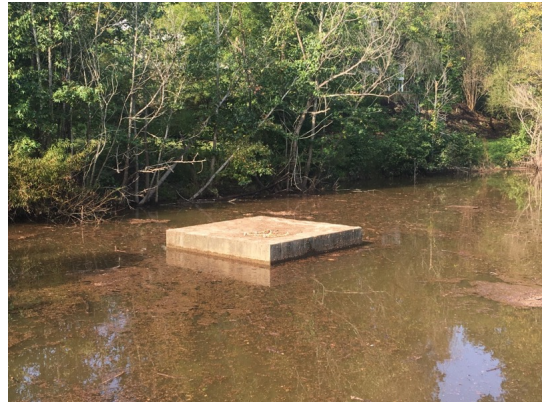
Riser

Riprap along outlet treated
Noted images 1 and 2 show before and after riser was cleaned of debris
There was no watermeal in the pond during this visit.
A large amount of thatch, tree limbs, and other organic debris washed in with the recent rain.
Larger limbs and trash were removed from the site.
Mowing is needed above the outlet as seen in image 3.
Noted Image 1

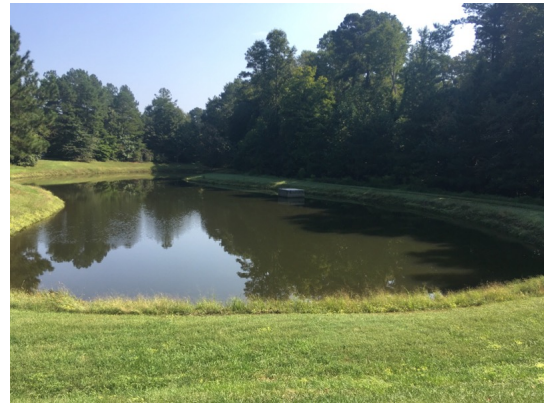
Overview of the pond

- Backside of dam needs mowed
- Bare soil on backside of dam, visible in outlet picture
- Aerator was not running, reset gfci and is running again

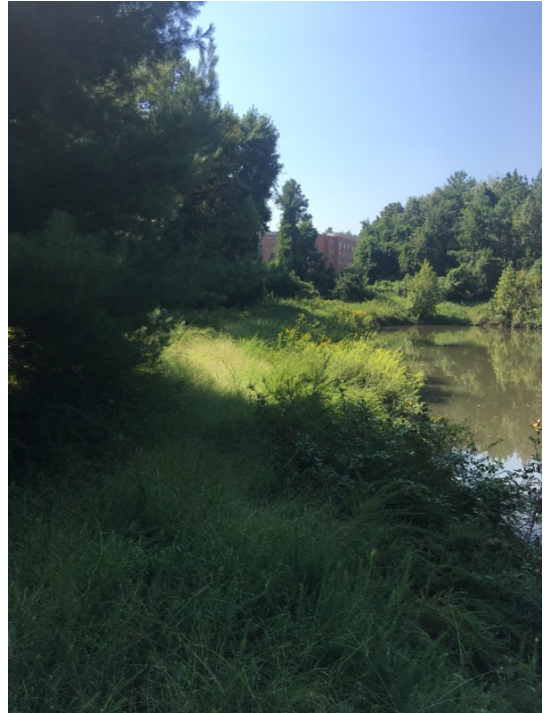
Dam

Back of the dam needs to be mowed

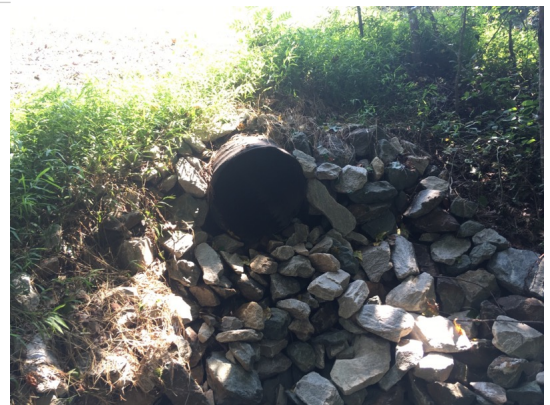
Outlet

Rip rap in the outlet area was treated
Noted image 1 shows a secondary inlet
