Client Log - Triangle

Date: 05/21/2019

### Dragonfly Maintenance Report

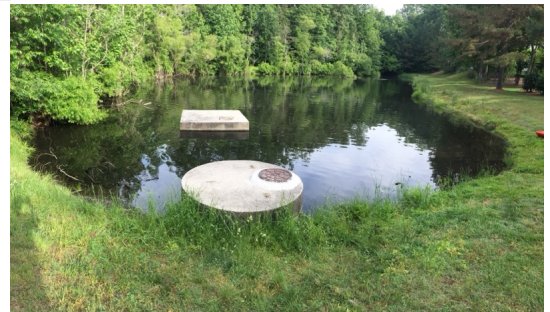
Pond Name	WP 1
Access Address	400 Market St, Chaple Hill, NC
Service Date	05/17/2019
Trash Pickup	SC= Service Completed
Treat Invasives	NN= Service Not Needed
Inlet service	SC= Service Completed
Outlet Service	SC= Service Completed
Unclog Drain	NN= Service Not Needed
Clean Riser/Trash rack	SC= Service Completed
Add Dye?	NN= Service Not Needed
Fountain/Aerator Condition	N/A= Not Applicable
Mow/Weed eat	NN= Service Not Needed
Overview of the pond

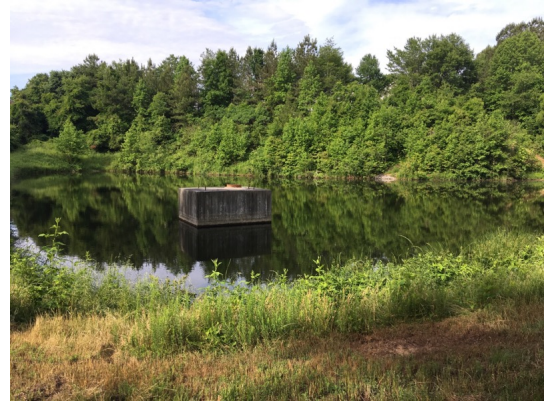
Pond Name	WP 3
Access Address	400 Market St, Chaple Hill, NC
Service Date	05/17/2019
Trash Pickup	SC= Service Completed
Treat Invasives	NN= Service Not Needed
Inlet service	SC= Service Completed
Outlet Service	SC= Service Completed
Unclog Drain	NN= Service Not Needed
Clean Riser/Trash rack	SC= Service Completed
Add Dye?	NN= Service Not Needed
Fountain/Aerator Condition	N/A= Not Applicable
Mow/Weed eat	NN= Service Not Needed
Overview of the pond
