Client Log - Triangle

Dragonfly Maintenance Report

Property	SOUTHERN VILLAGE
Client Name	Patsy Smith, Tony Smith
Client Email Address	patsysmith7077@gmail.com
Client Email Address 2	tony@berkeleychapelhill.com
Client Email Address 3	
Client Email Address 4	
Number of Ponds & Pond Type	4 Wet Ponds
Service Type	
Standard	
Mowing Schedule	2 Mowings Per Year
Mowing Service	
Mowing occurs inside of the fence.	
Special Instructions	
Pond 4 #2020	
Pond Locations	https://imageshack.com...

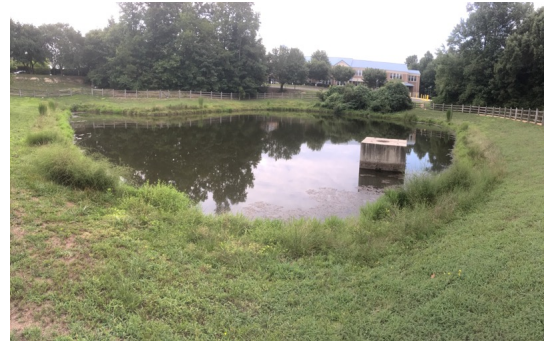
Pond Name	WP 4
Access Address	400 Market St, Chaple Hill, NC
Service Date	07/19/2019
Trash Pickup	SC= Service Completed
Treat Invasives	SC= Service Completed
Inlet service	SC= Service Completed
Outlet Service	SC= Service Completed
Unclog Drain	NN= Service Not Needed
Clean Riser/Trash rack	SC= Service Completed
Add Dye?	NN= Service Not Needed
Fountain/Aerator Condition	WN= Work Needed
Mow/Weed eat	NN= Service Not Needed
Overview of the pond

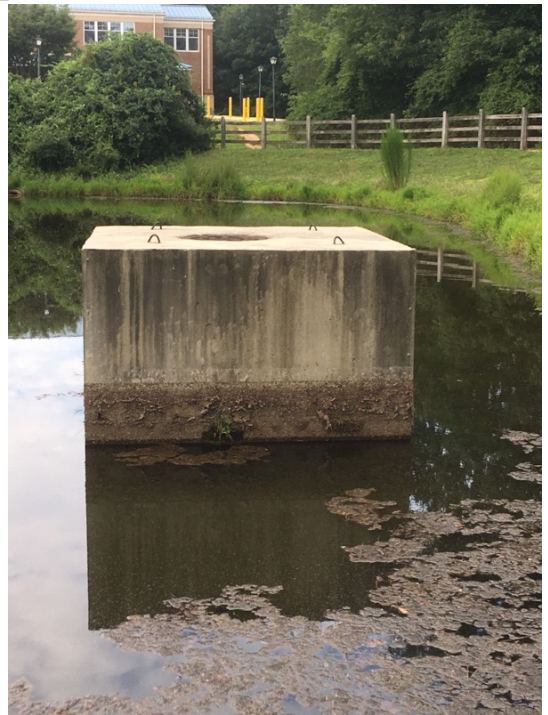
Riser

Removed the trash from the system. Electrical work needed to repair the aeration unit. Treated for terrestrial vegetation in the outlet riprap. Treated for saplings in the buffer. Treated for filamentous algae along the shoreline. Noted image 1 shows an additional inlet.

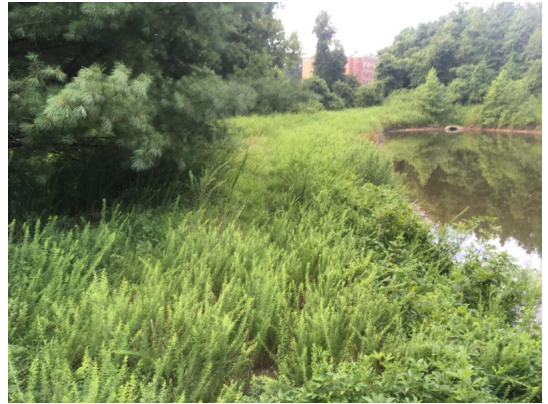
Dam

Removed the trash from the system. The dam near the outlet needs mowing to allow better access. Continue to monitor for erosion on the shoreline from previously high water. Treated for terrestrial vegetation in the inlet riprap. Treated for saplings in the buffer. Noted image 1 shows an additional inlet. Noted image 2 shows a spillway inlet that needs riprap repair. Noted image 3 shows a natural inlet with large bare spots in the riprap that needs repair.

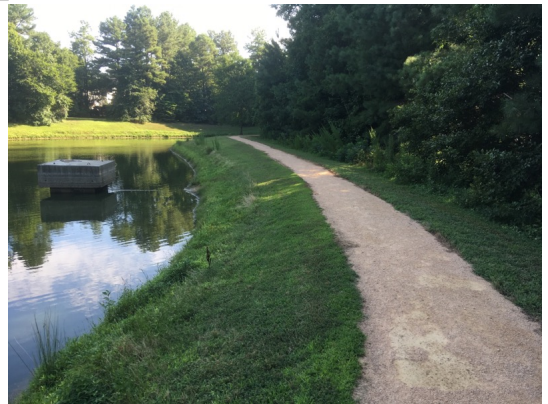
Dam

Removed the trash from the system. The dam is exhibiting mild to moderate erosion on the slope opposite of the walking path. Continue to monitor for erosion on the shoreline from previously high water. Treated for watermeal along the shoreline. Noted image 1 shows erosion on the dam.
Noted Image 1

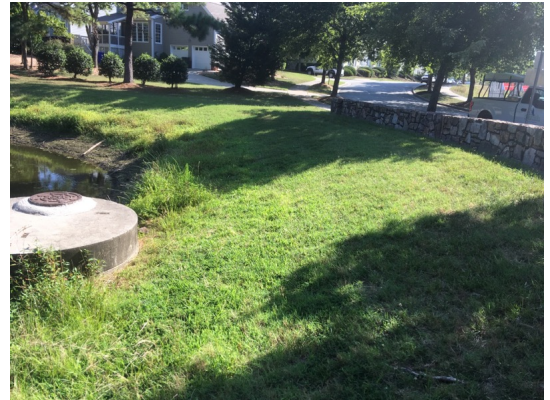
Dam

Removed the trash from the system. Continue to monitor for erosion on the shoreline from previously high water. Treated for watermeal throughout the pond basin. Treated for duckweed throughout pond basin. Treated for saplings in buffer. Treated for terrestrial vegetation in outlet riprap. Noted image 1 shows an additional riser. Noted image 2 shows erosion on the dam. Noted image 3 shows erosion on the shoreline.
