Client Log - Triangle

Date: 09/13/2019

Dragonfly Maintenance Report

Pond Name	WP 4
Access Address	400 Market St, Chaple Hill, NC
Service Date	08/19/2019
Trash Pickup	SC= Service Completed
Treat Invasives	SC= Service Completed
Inlet service	SC= Service Completed
Outlet Service	SC= Service Completed
Unclog Drain	NN= Service Not Needed
Clean Riser/Trash rack	SC= Service Completed
Add Dye?	NN= Service Not Needed
Fountain/Aerator Condition	FF= Fully Functional
Mow/Weed eat	NN= Service Not Needed
Overview of the pond

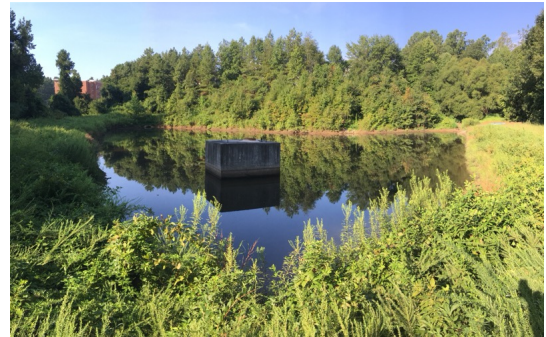
Pond Name	WP 3
Access Address	400 Market St, Chaple Hill, NC
Service Date	08/19/2019
Trash Pickup	SC= Service Completed
Treat Invasives	SC= Service Completed
Inlet service	SC= Service Completed
Outlet Service	SC= Service Completed
Unclog Drain	NN= Service Not Needed
Clean Riser/Trash rack	SC= Service Completed
Add Dye?	N/A= Not Applicable
Fountain/Aerator Condition	N/A= Not Applicable
Mow/Weed eat	WN= Work Needed
Overview of the pond

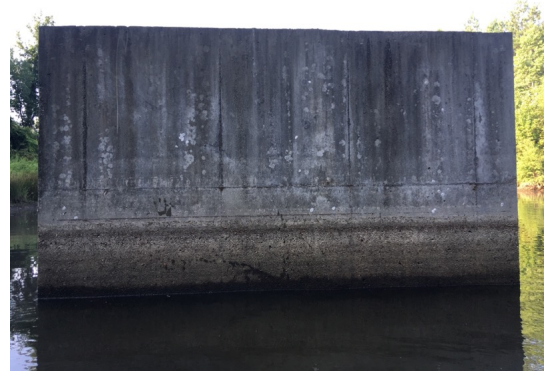
Riser

Water level was high upon arrival but the riser was draining properly. Noted image 1 shows erosion on the shoreline. Noted image 2 shows an additional inlet. Rearranged the rocks on the rip-rap inlet in order to cover the large washed out area. Noted images 3 and 4 show the washed out area before and after rearranging the rip-rap. Additional rip-rap is needed in order to adequately cover this area. Vegetation is growing tall around the system. Mowing is needed.

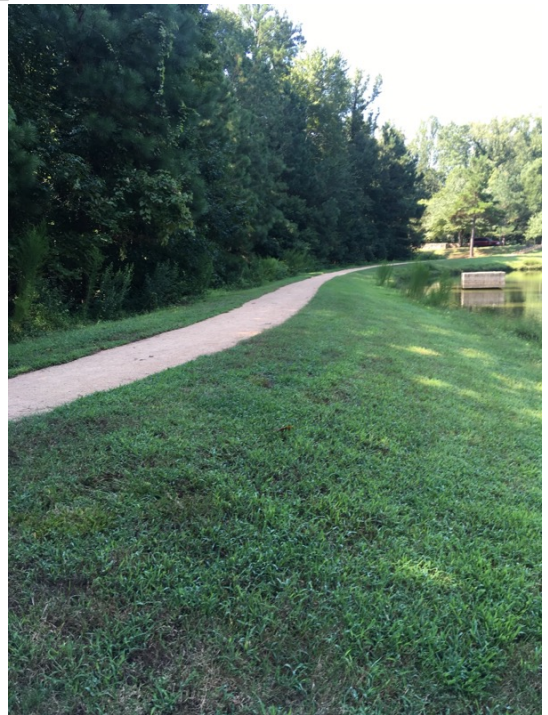
Dam

Treated for saplings in the buffer. Noted image 1 shows areas of exposed soil on the dam.

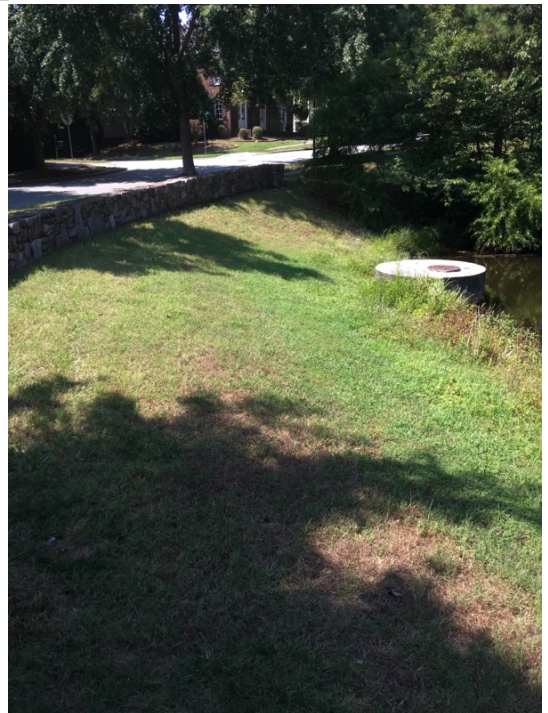
Dam

Noted image 1 shows erosion on the dam. Noted image 2 shows water evacuating from the orifice after it was unclogged.
