Client Log - Triangle

Dragonfly Maintenance Report

Property	SOUTHERN VILLAGE
Client Name	Patsy Smith, Tony Smith
Client Email Address	patsysmith7077@gmail.com
Client Email Address 2	tony@berkeleychapelhill.com
Client Email Address 3	
Client Email Address 4	
Number of Ponds & Pond Type	4 Wet Ponds
Service Type	
Standard	
Mowing Schedule	2 Mowings Per Year
Mowing Service	
Mowing occurs inside of the fence.	
Special Instructions	
Pond 4 #2020	
Pond Locations	https://imageshack.com...

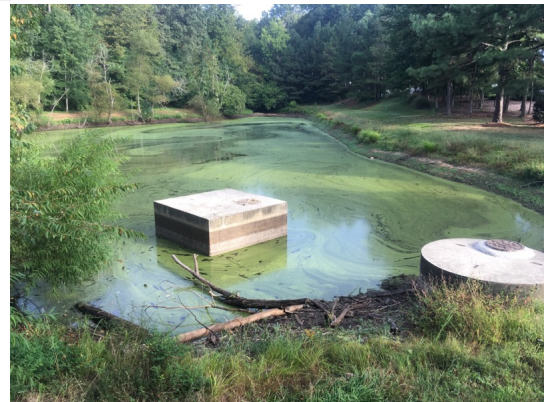
Pond Name	WP 1
Access Address	400 Market St, Chapel Hill, NC
Service Date	09/16/2019
Trash Pickup	SC= Service Completed
Treat Invasives	SC= Service Completed
Inlet service	SC= Service Completed
Outlet Service	SC= Service Completed
Unclog Drain	NN= Service Not Needed
Clean Riser/Trash rack	NN= Service Not Needed
Add Dye?	N/A= Not Applicable
Fountain/Aerator Condition	N/A= Not Applicable
Mow/Weed eat	NN= Service Not Needed
Overview of the pond

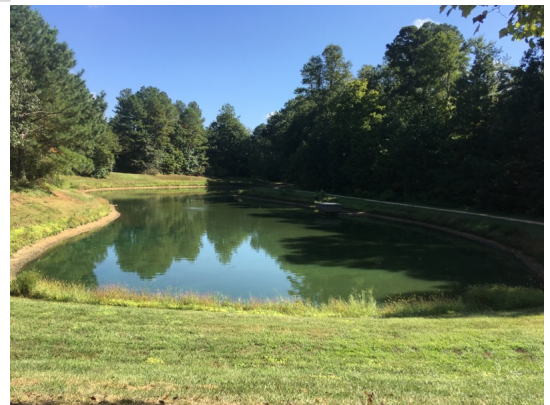
Pond Name	WP 2
Access Address	400 Market St, Chaple Hill, NC
Service Date	09/16/2019
Trash Pickup	SC= Service Completed
Treat Invasives	SC= Service Completed
Inlet service	SC= Service Completed
Outlet Service	SC= Service Completed
Unclog Drain	NN= Service Not Needed
Clean Riser/Trash rack	NN= Service Not Needed
Add Dye?	N/A= Not Applicable
Fountain/Aerator Condition	SC= Service Completed
Mow/Weed eat	NN= Service Not Needed
Overview of the pond
