DRAGONFLY MAINTENANCE REPORT

Property	SOUTHERN VILLAGE
Service Date	02/19/2020
Crew Member(s)	Will Feely
Client Name	Adam Jones
Client Email Address	adam@millhouseproperties.com
Client Email Address 2	
Client Email Address 3	
Client Email Address 4	
Number of Ponds & Pond Type	4 Wet Ponds
Mowing Schedule	2 Mowings Per Year
Mowing Service	
Mowing occurs inside of the fence.	
Special Instructions	
Pond 4 #1234	
Pond Locations	https://imageshack.com...

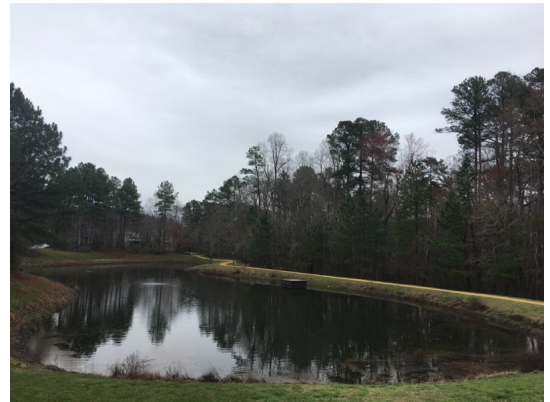
Trash Pickup	SC= Service Completed
Treat Invasives	M= Monitoring (for any potential future problems)
Inlet service	M= Monitoring (for any potential future problems)
Outlet Service	M= Monitoring (for any potential future problems)
Unclog Drain	M= Monitoring (for any potential future problems)
Clean Riser/Trash rack	SC= Service Completed
Add Dye?	N/A= Not Applicable
Fountain/Aerator Condition	M= Monitoring (for any potential future problems)
Mow/Weed eat	M= Monitoring (for any potential future problems)
Overview of the pond	M= Monitoring (for any potential future problems)

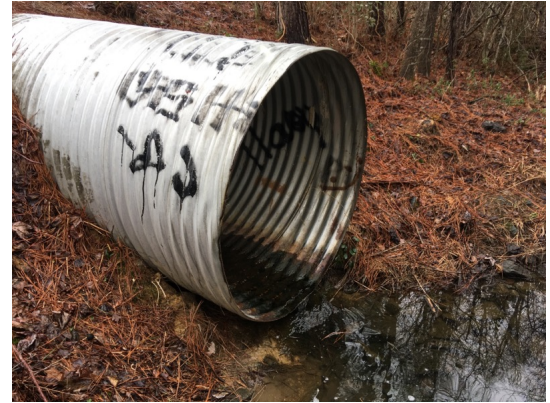
Outlet

Trash was removed from the system and the drawdown was unclogged. The air filter for the compressor was cleaned. Noted images 1 and 2 show the drawdown before and after clearing the obstruction. Noted image 3 shows the compressor box. Noted image 4 show areas of bare soil that extend around the shoreline. Noted image 5 shows small leaks and rust damage in the outlet pipe.

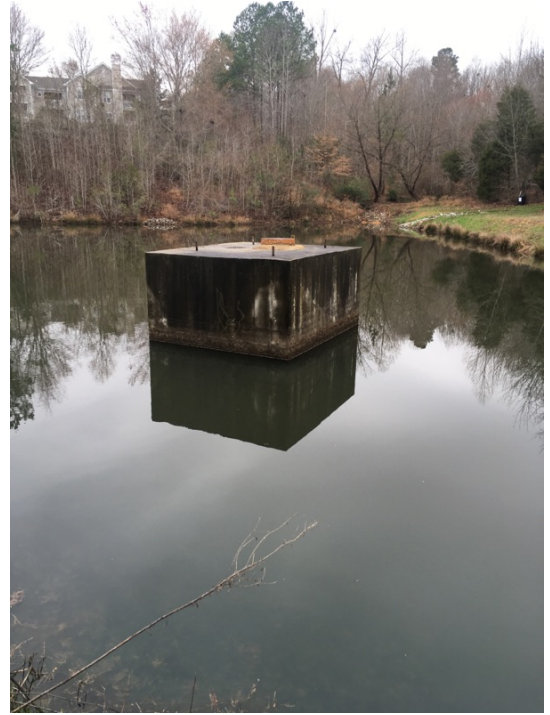
Riser

Trash was removed from the system and leaves were cleared from the inlet. The drawdown was unclogged. High water level due to rain events and an obstructed drawdown. Noted images 1 and 2 show the drawdown before and after removing the obstruction. Noted image 3 shows a fallen tree at the outlet area. Noted images 4 through 6 show secondary inlets. Noted image 7 shows a dead tree along the backside of the dam.

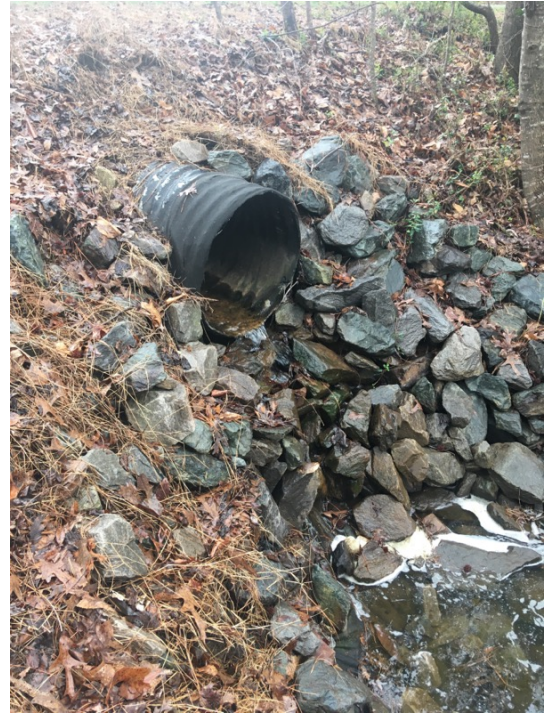
Outlet

Trash was removed from the system and woody debris was removed from the outlet. The air filter for the compressor was cleaned. Noted images 1 and 2 show secondary inlets. Noted image 3 shows a saturated area of the shoreline.
