Dragonfly Pond Works
 1-877-POND-WRX
 info@dragonflypondworks.com

Dragonfly Maintenance Report

Property	SOUTHERN VILLAGE
Client Name	Adam Jones
Client Email Address	adam@millhouseproperties.com
Client Email Address 2	
Client Email Address 3	
Client Email Address 4	
Number of Ponds & Pond Type	4 Wet Ponds
Service Type	
Standard	
Mowing Schedule	2 Mowings Per Year
Mowing Service	
Mowing occurs inside of the fence.	
Special Instructions	
Pond 4 #2020	
Pond Locations	https://imageshack.com...

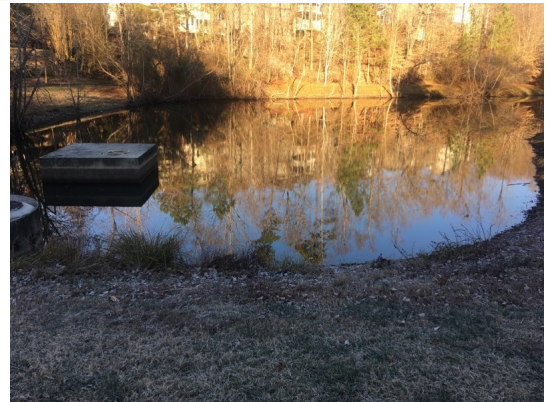
Pond Name	WP 1
Access Address	400 Market St, Chaple Hill, NC
Service Date	01/09/2020
Trash Pickup	SC= Service Completed
Treat Invasives	NN= Service Not Needed
Inlet service	SC= Service Completed
Outlet Service	SC= Service Completed
Unclog Drain	NN= Service Not Needed
Clean Riser/Trash rack	SC= Service Completed
Add Dye?	NN= Service Not Needed
Fountain/Aerator Condition	NN= Service Not Needed
Mow/Weed eat	NN= Service Not Needed
Overview of the pond
