DRAGONFLY MAINTENANCE REPORT

Property	SOUTHERN VILLAGE
Service Date	03/19/2020
Crew Member(s)	WF
Client Name	Adam Jones
Client Email Address	adam@millhouseproperties.com
Client Email Address 2	patsy@millhouseproperties.com
Client Email Address 3	
Client Email Address 4	
Number of Ponds & Pond Type	4 Wet Ponds
Mowing Schedule	2 Mowings Per Year
Mowing Service	
Mowing occurs inside of the fence.	
Special Instructions	
Pond 4 #1234	
Pond Locations	https://imageshack.com...

Pond Name	WP 1
Access Address	1200 Highgrove Dr Chapel Hill, NC 27516
Trash Pickup	SC= Service Completed
Treat Invasives	M= Monitoring (for any potential future problems)
Inlet service	WN= Work Needed
Outlet Service	M= Monitoring (for any potential future problems)
Unclog Drain	M= Monitoring (for any potential future problems)
Clean Riser/Trash rack	M= Monitoring (for any potential future problems)
Add Dye?	N/A= Not Applicable
Fountain/Aerator Condition	N/A= Not Applicable
Mow/Weed eat	M= Monitoring (for any potential future problems)

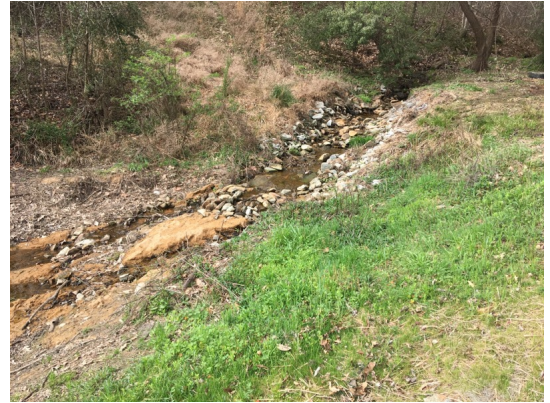
Inlet

Trash was removed from the system. Unclogged the drawdown to restore normal water flow. Sediment deposition and washout persists at the creek inlet. Recommend additional riprap and T-bars to prevent washout. Noted image 1 shows the secondary inlet. Noted image 2 shows this inlet after the leaves were cleared. Noted through 3 show this inlet after the riprap was rearranged in order to cover the bare areas. Noted images 4 and 5 show a secondary inlet with exposed soil around the shoreline. Noted image 6 shows a secondary submerged inlet. Noted image 7 shows the outlet before unclogging the drawdown. Noted image 8 shows a large fallen tree at the outlet.

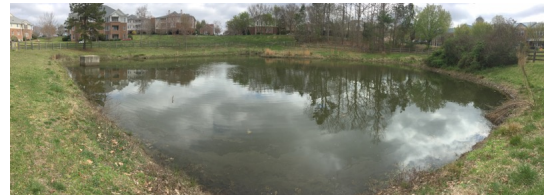
Trash was removed from the system and the drawdown was unclogged. The system was treated for filamentous algae. Noted image 1 shows the inside of the riser after the drawdown was unclogged. Noted image 2 shows the inside of the riser. Noted image 3 shows a secondary inlet. Noted image 4 shows an area of saturated soil.
