DRAGONFLY MAINTENANCE REPORT

Property	SOUTHERN VILLAGE
Service Date	05/26/2020
Crew Member(s)	WF
Client Name	Adam Jones
Client Email Address	adam@millhouseproperties.com
Client Email Address 2	patsy@millhouseproperties.com
Client Email Address 3	
Client Email Address 4	
Number of Ponds & Pond Type	4 Wet Ponds
Mowing Schedule	2 Mowings Per Year
Mowing Service	
Mowing occurs inside of the fence.	
Special Instructions	
Pond 4 #1234	
Pond Locations	https://imageshack.com...

Pond Name	WP 1
Access Address	1200 Highgrove Dr Chapel Hill, NC 27516
Trash Pickup	SC= Service Completed
Treat Invasives	M= Monitoring (for any potential future problems)
Inlet service	WN= Work Needed
Outlet Service	M= Monitoring (for any potential future problems)
Unclog Drain	M= Monitoring (for any potential future problems)
Clean Riser/Trash rack	M= Monitoring (for any potential future problems)
Add Dye?	N/A= Not Applicable
Fountain/Aerator Condition	N/A= Not Applicable
Mow/Weed eat	M= Monitoring (for any potential future problems)

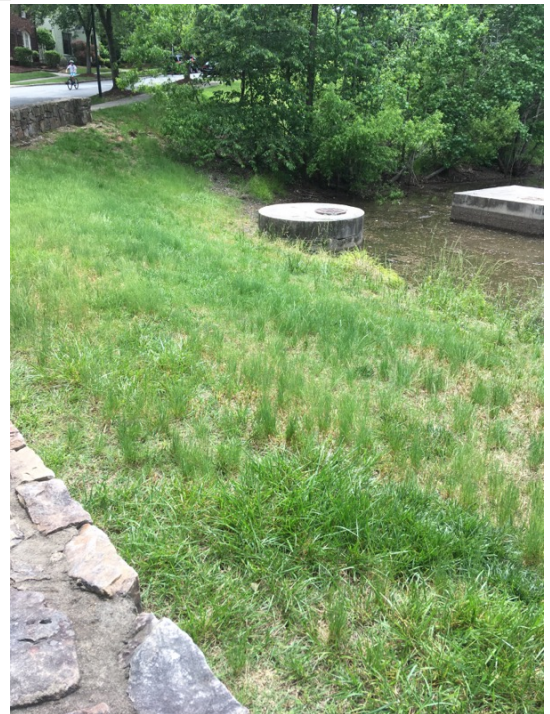
Dam

Trash was removed from the system. Leaks in the outlet pipe along the manhole access junction persist. Noted image 1 shows the manhole access. Noted image 2 shows an additional outlet. Noted images 3 and 4 show the sediment delta at the creek inlet. Noted image 5 shows some of the woody debris washed in from the recent rainfall. Noted image 6 shows an abundance of vegetation along the backside of the dam recommended to be mowed.

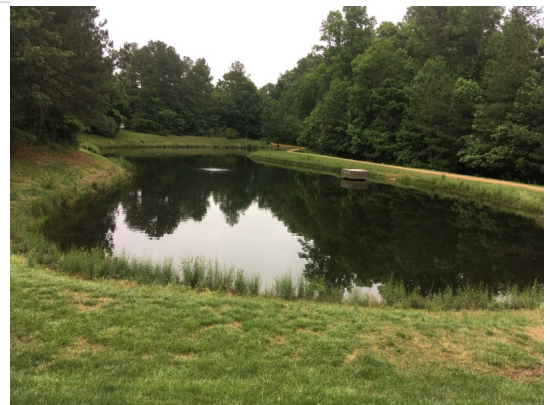
Pond Name	WP 2
Access Address	600 Brookgreen Dr Chapel Hill, NC 27516
Trash Pickup	SC= Service Completed
Treat Invasives	M= Monitoring (for any potential future problems)
Inlet service	M= Monitoring (for any potential future problems)
Outlet Service	M= Monitoring (for any potential future problems)
Unclog Drain	M= Monitoring (for any potential future problems)
Clean Riser/Trash rack	M= Monitoring (for any potential future problems)
Add Dye?	N/A= Not Applicable
Fountain/Aerator Condition	M= Monitoring (for any potential future problems)
Mow/Weed eat	M= Monitoring (for any potential future problems)
Overview of the pond	M= Monitoring (for any potential future problems)

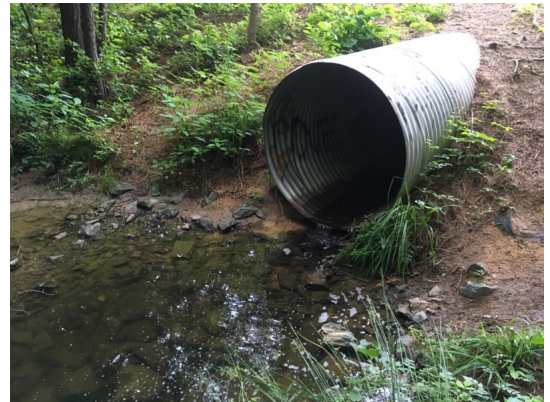
Outlet

Trash was removed from the system. The air compressor filter was cleaned. Noted image 1 shows exposed aeration line in the pond bank. Noted image 2 shows erosion along the outlet. Noted image 3 shows disturbed areas along the shoreline. Noted image 4 shows an additional submerged inlet. Noted image 5 shows leaks in the outlet pipe that persist.
