### DRAGONFLY MAINTENANCE REPORT

Property	SOUTHERN VILLAGE
Service Date	06/25/2020
Crew Member(s)	WF
Client Name	Adam Jones
Client Email Address	adam@millhouseproperties.com
Client Email Address 2	patsy@millhouseproperties.com
Client Email Address 3	
Client Email Address 4	
Number of Ponds & Pond Type	4 Wet Ponds
Mowing Schedule	2 Mowings Per Year
Mowing Service	
Mowing occurs inside of the fence.	
Special Instructions	
Pond 4 #1234	
Pond Locations	<a href="https://imageshack.com...">https://imageshack.com...</a>

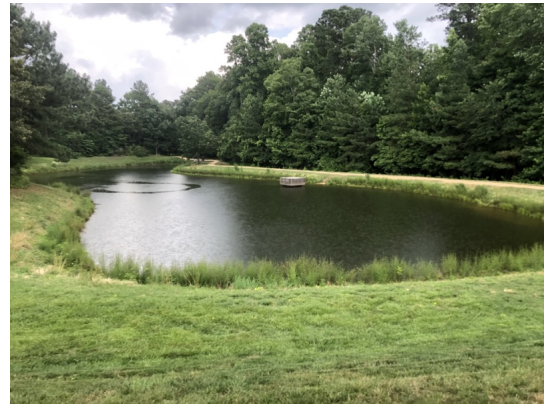
Inlet service	M= Monitoring (for any potential future problems)
Outlet Service	M= Monitoring (for any potential future problems)
Unclog Drain	M= Monitoring (for any potential future problems)
Clean Riser/Trash rack	M= Monitoring (for any potential future problems)
Add Dye?	N/A= Not Applicable
Fountain/Aerator Condition	M= Monitoring (for any potential future problems)
Mow/Weed eat	WN= Work Needed
Overview of the pond

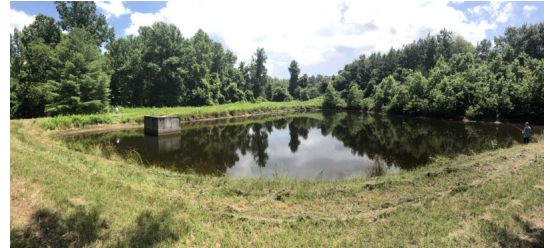
Add Dye?	N/A= Not Applicable
Fountain/Aerator Condition	N/A= Not Applicable
Mow/Weed eat	WN= Work Needed
Overview of the pond

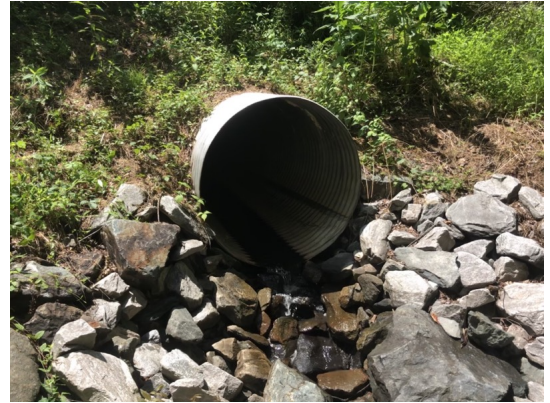
Outlet

Trash was removed from the system. Recommend mowing the dam. Noted images 1 and 2 show disturbed soil around the shoreline. Noted image 3 shows sediment at the primary inlet. Noted images 4 through 6 show secondary inlets. Noted image 7 shows exposed soil around the shoreline. Noted image 8 shows an additional inlet. The fallen tree at the outlet persists.

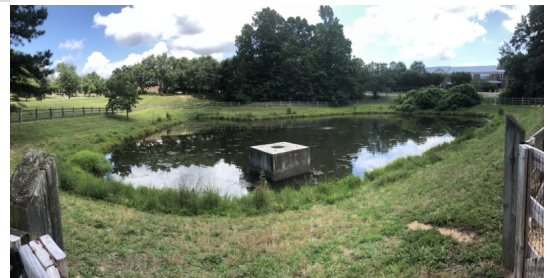
Pond Name	WP 4
Access Address	501 Kildaire Rd, Chapel Hill, NC 27516
Trash Pickup	SC= Service Completed
Treat Invasives	N/A= Not Applicable
Inlet service	M= Monitoring (for any potential future problems)
Outlet Service	SC= Service Completed
Unclog Drain	M= Monitoring (for any potential future problems)
Clean Riser/Trash rack	M= Monitoring (for any potential future problems)
Add Dye?	N/A= Not Applicable
Fountain/Aerator Condition	M= Monitoring (for any potential future problems)
Mow/Weed eat	M= Monitoring (for any potential future problems)
Overview of the pond
