DRAGONFLY MAINTENANCE REPORT

Property	SOUTHERN VILLAGE
Service Date	07/23/2020
Crew Member(s)	WF GW
Client Name	Adam Jones
Client Email Address	adam@millhouseproperties.com
Client Email Address 2	patsy@millhouseproperties.com
Client Email Address 3	
Client Email Address 4	
Number of Ponds & Pond Type	4 Wet Ponds
Mowing Schedule	2 Mowings Per Year
Mowing Service	
Mowing occurs inside of the fence.	
Special Instructions	
Pond 4 #1234	
Pond Locations	https://imageshack.com...

Pond Name	WP 1
Access Address	1200 Highgrove Dr Chapel Hill, NC 27516
Trash Pickup	SC= Service Completed
Treat Invasives	SC= Service Completed
Invasives Treated (where applicable)	Filamentous algae, planktonic algae, terrestrial weeds
Inlet service	WN= Work Needed
Outlet Service	M= Monitoring (for any potential future problems)
Unclog Drain	M= Monitoring (for any potential future problems)
Clean Riser/Trash rack	M= Monitoring (for any potential future problems)
Add Dye?	N/A= Not Applicable
Fountain/Aerator Condition	N/A= Not Applicable
Mow/Weed eat	WN= Work Needed

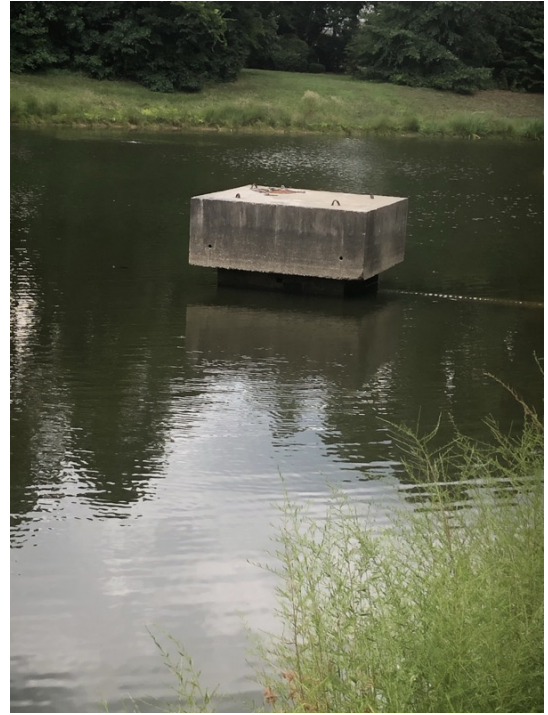
Riser

Removed trash from the system and inspected the inside of the riser. Noted image 1 shows leaks in the outlet pipe. Noted image 2 shows an additional inlet. Noted image 3 shows bare soil around the outlet pipe. Noted images 4, 5, and 6 show bare soil around the shoreline.
