DRAGONFLY MAINTENANCE REPORT

Property	SOUTHERN VILLAGE
Service Date	08/25/2020
Crew Member(s)	WF GW
Client Name	Adam Jones
Client Email Address	adam@millhouseproperties.com
Client Email Address 2	patsy@millhouseproperties.com
Client Email Address 3	
Client Email Address 4	
Number of Ponds & Pond Type	4 Wet Ponds
Mowing Schedule	2 Mowings Per Year
Mowing Service	
Mowing occurs inside of the fence.	
Special Instructions	
Pond 4 #1234	
Pond Locations	https://imageshack.com...

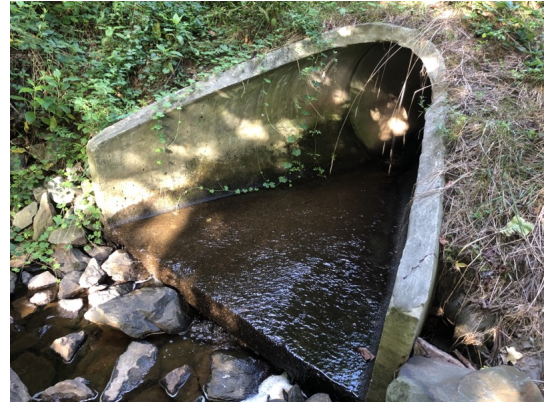
Outlet

Trash was removed from the system and the system was treated for planktonic algae. Beneficial bacteria was added to the wet pond. Noted images 1 and 2 show secondary inlets. Noted image 3 shows sedimentation and erosion at the creek inlet due to extended periods of high water. Noted image 4 shows sedimentation and planktonic algae. Noted image 5 shows the manhole for the riser access. Slow leaks in the outlet pipe junction and access hatch persist.

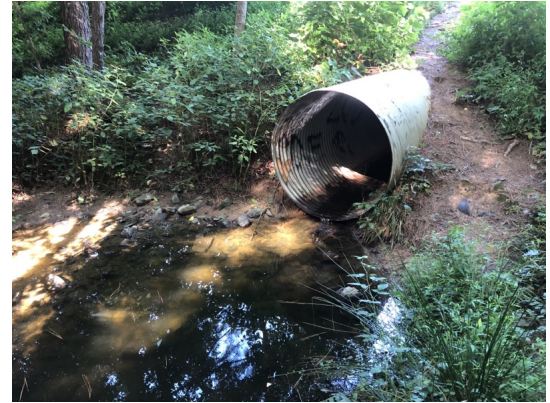
Outlet

Trash was removed from the system and the riprap at the outlet was treated for terrestrial weeds. The drawdown was unclogged. Noted image 1 shows leaks in the outlet pipe. Noted image 2 shows a disturbed area. Noted image 3 shows washout along the path due to runoff.

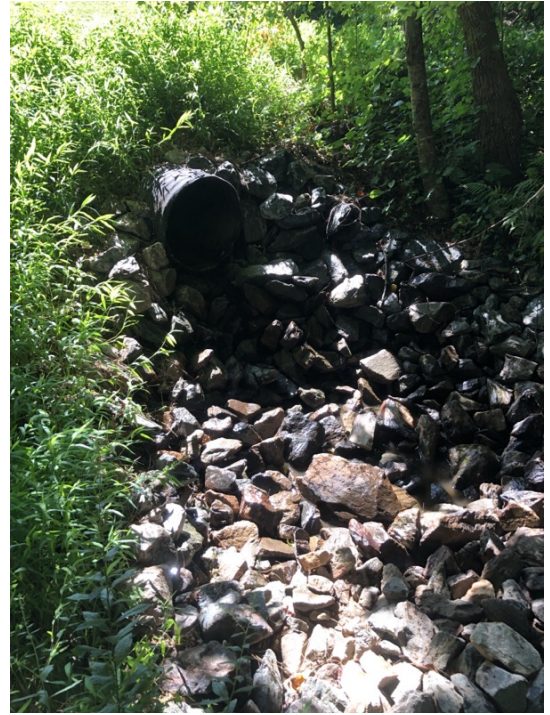
Outlet

Trash was removed from the system and the riprap at the outlet was rearranged. The riprap at the outlet was treated for terrestrial weeds. Noted images 1 and 2 show secondary inlets.
