### DRAGONFLY MAINTENANCE REPORT

Property	SOUTHERN VILLAGE
Service Date	01/14/2021
Crew Member(s)	WF, DG
Client Name	Adam Jones
Client Email Address	adam@millhouseproperties.com
Client Email Address 2	patsy@millhouseproperties.com
Client Email Address 3	
Client Email Address 4	
Number of Ponds & Pond Type	4 Wet Ponds
Mowing Schedule	2 Mowings Per Year
Mowing Service	
Mowing occurs inside of the fence.	
Special Instructions	
Pond 4 #1234	
Pond Locations	<a href="https://imageshack.com...">https://imageshack.com...</a>

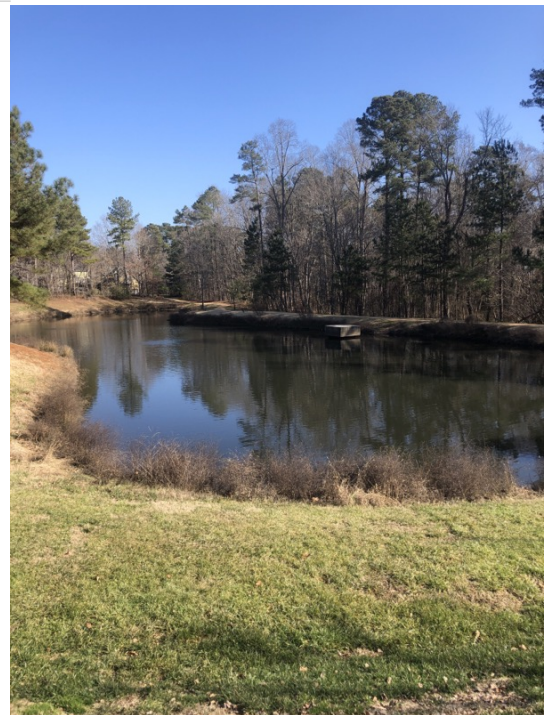
Access Address	600 Brookgreen Dr Chapel Hill, NC 27516
Trash Pickup	SC= Service Completed
Treat Invasives	M= Monitoring (for any potential future problems)
Inlet service	M= Monitoring (for any potential future problems)
Outlet Service	M= Monitoring (for any potential future problems)
Unclog Drain	M= Monitoring (for any potential future problems)
Clean Riser/Trash rack	M= Monitoring (for any potential future problems)
Add Dye?	N/A= Not Applicable
Fountain/Aerator Condition	M= Monitoring (for any potential future problems)
Mow/Weed eat	M= Monitoring (for any potential future problems)
Overview of the pond	M= Monitoring (for any potential future problems)

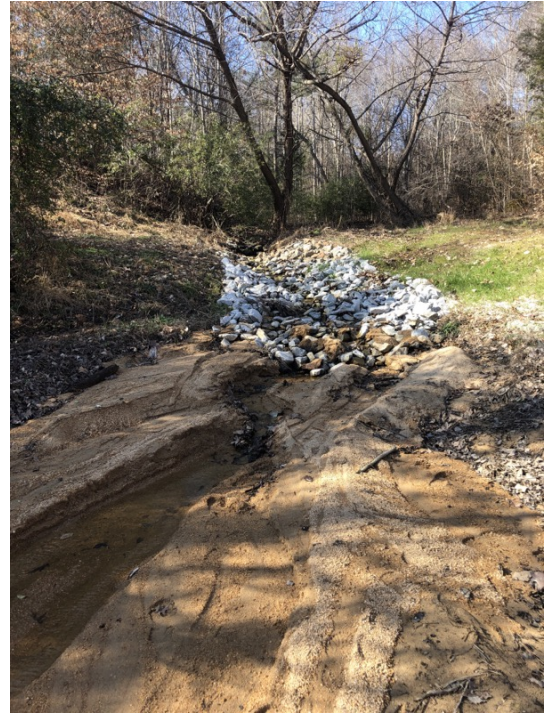
Inlet

Trash was removed from the system. Erosion along the shoreline persists due to extended periods of high water and a clogged drawdown. Sediment build up can be seen at the creek inlet. Noted images 1 through 4 show the secondary inlets. The inlet shown in image 1 shows chips in the FES. The inlet in image 2 shows sedimentation.

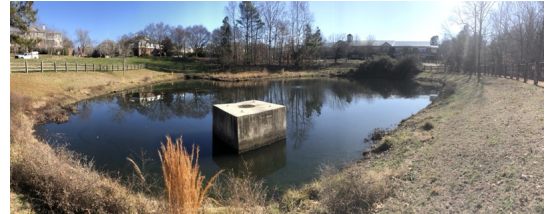
Overview of the pond

Trash was removed from the system. Erosion along the shoreline persists due to periods of high water. Noted 1 and 2 show secondary submerged inlets. Noted image 3 shows after woody vegetation was cleared along the shoreline to improve access to the system. Noted image 4 shows saturated soil.
