### DRAGONFLY MAINTENANCE REPORT

Property	SOUTHERN VILLAGE
Service Date	04/23/2021
Crew Member(s)	GW
Client Name	Adam Jones
Client Email Address	adam@millhouseproperties.com
Client Email Address 2	patsy@millhouseproperties.com
Client Email Address 3	
Client Email Address 4	
Number of Ponds & Pond Type	4 Wet Ponds
Mowing Schedule	2 Mowings Per Year
Mowing Service	
Mowing occurs inside of the fence.	
Special Instructions	
Lock combination for Wet Pond #4 is 5150	
Pond Locations	<a href="https://imageshack.com...">https://imageshack.com...</a>

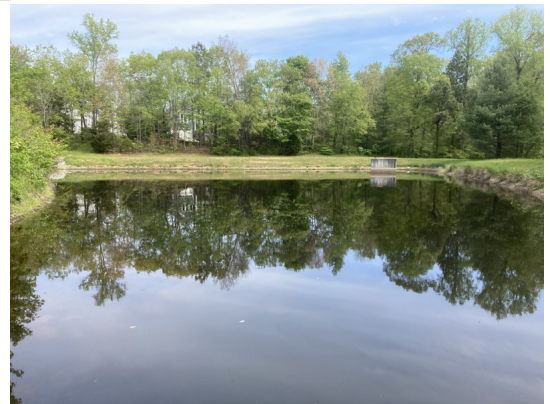
Pond Name	WP 3
Access Address	111 Parkside Cir Chapel Hill, NC 27516
Trash Pickup	SC= Service Completed
Treat Invasives	SC= Service Completed
Invasives Treated (where applicable)	Terrestrial weeds and woody vegetation
Inlet service	SC= Service Completed
Outlet Service	SC= Service Completed
Unclog Drain	M= Monitoring (for any potential future problems)
Clean Riser/Trash rack	M= Monitoring (for any potential future problems)
Add Dye?	N/A= Not Applicable
Fountain/Aerator Condition	N/A= Not Applicable
Mow/Weed eat	M= Monitoring (for any potential future problems)
Overview of the pond

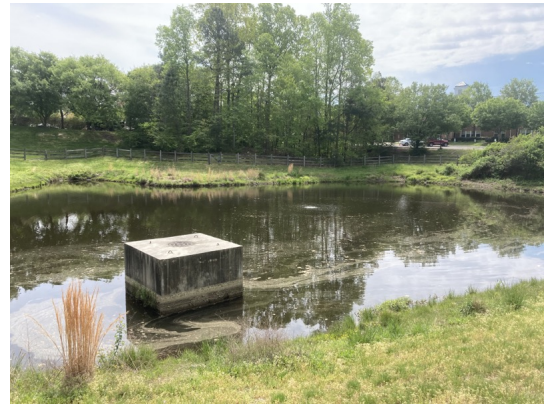
Outlet Service	SC= Service Completed
Unclog Drain	M= Monitoring (for any potential future problems)
Clean Riser/Trash rack	M= Monitoring (for any potential future problems)
Add Dye?	N/A= Not Applicable
Fountain/Aerator Condition	M= Monitoring (for any potential future problems)
Mow/Weed eat	M= Monitoring (for any potential future problems)
Overview of the pond	M= Monitoring (for any potential future problems)
